# TECHNICAL MEMO

**TO:** Jackson Hydroelectric Project (FERC No. 2157) file

**RE:** License Article 404: Side Channel Enhancements, Maintenance 2016

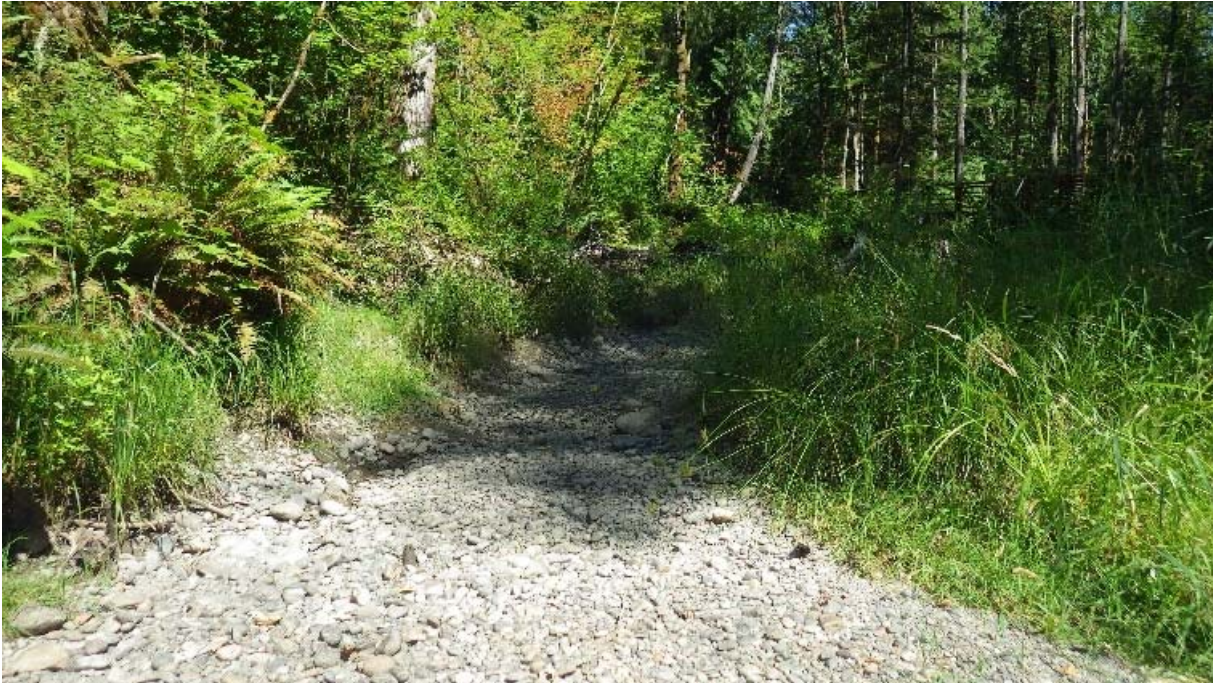
Though more complex in terms of number of distinct units that constitute the channel, the ability for SC 1 to maintain channel connectivity has been compromised due to the decreasing depths and channel widths, and the observed stretches of dry channels and intermittent pools. The following photo was taken in the new outlet to SC 1 in July 2016 when mainstem flow of the Sultan River was approximately 320 cfs. (Figure 2).

**Figure 2. Photo taken in July, 2016 depicting dry reach in new outlet to Side Channel 1.**

The approach to resolving the identified dewatering issue was to remove or modify the intentional "plug" installed during initial construction. A review of as-built set with the Project Engineer indicated that this could be accomplished through removal of approximately 8 inches of material within the upper 300 feet of the new channel. The channel was surveyed and staked prior to excavation and monitored continually through the process to ensure that the area was not over excavated.

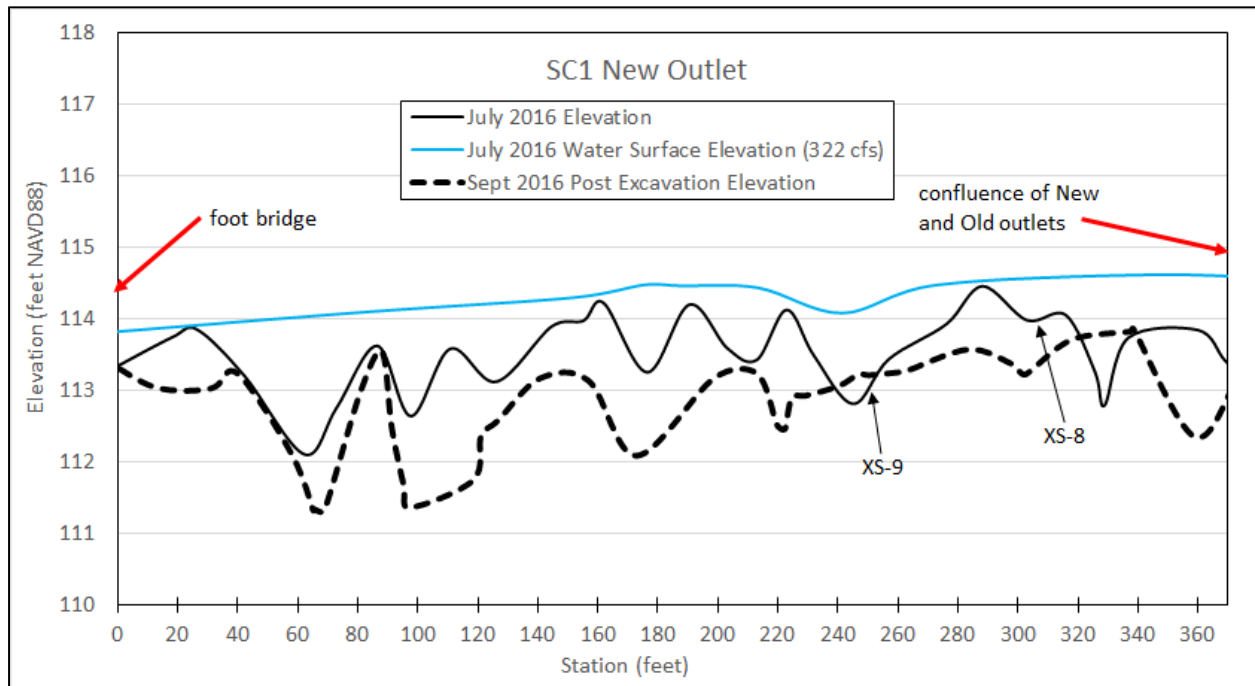
The distribution of flow observed at the confluence on 10/3/16 (Table 3) is reflective of the channel modifications made within the upper portion of the new outlet and demonstrates the initial success at resolution of the dewatering issue. Figure 4 quantifies changes in channel elevation and updates the longitudinal profile for habitat related purposes. Similarly, modified changes at Cross Sections 8 and 9 are documented in Figures 5 and 6, respectively.

**Figure 4. SC 1 New Outlet profile from confluence with Old Outlet to foot-bridge downstream.**

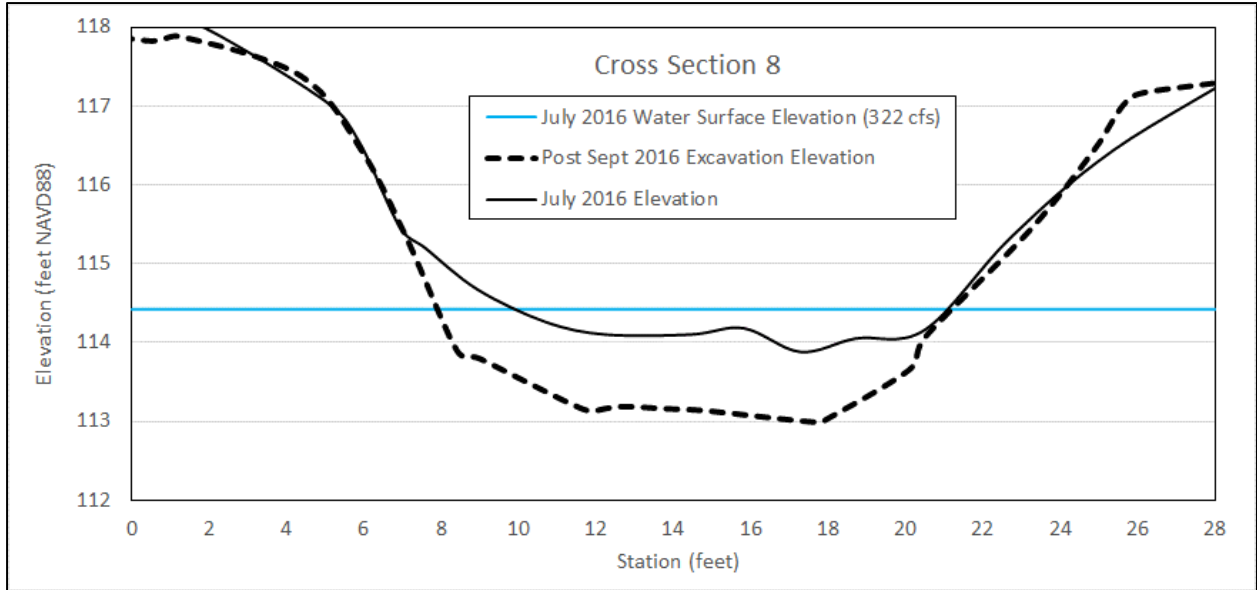
Figure 5. SC 1 Ramping Rate Study Cross Section 8 near the upstream end of the New Outlet.

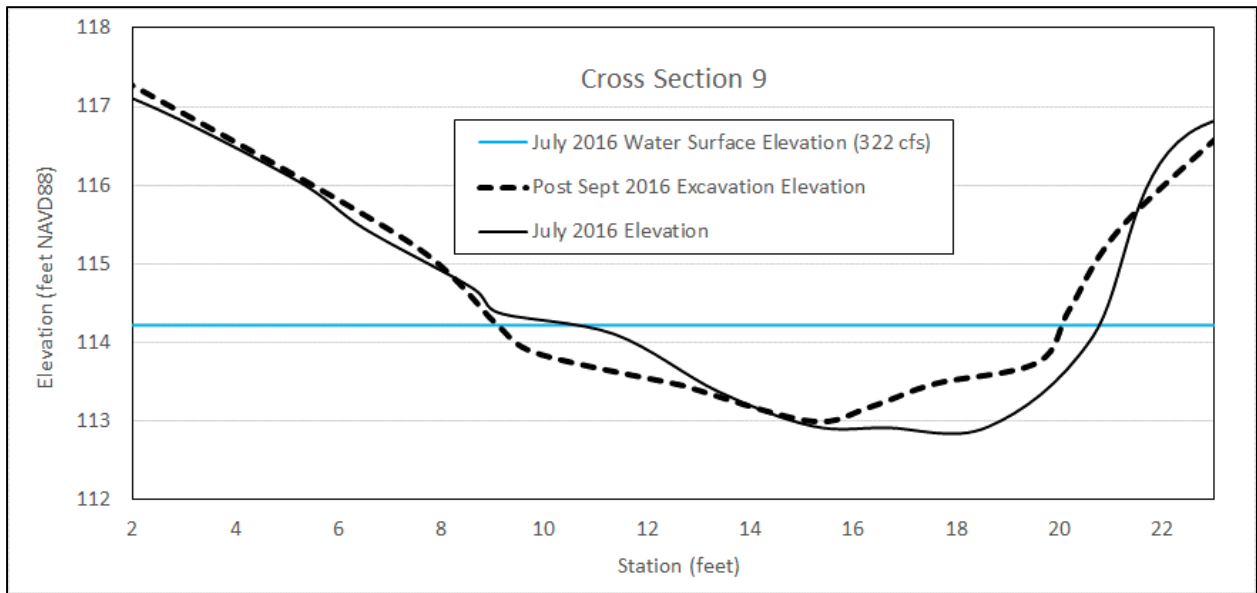
Figure 6. SC 1 Ramping Rate Study Cross Section 9 near the upstream end of the New Outlet.
