Re: Jackson Hydroelectric Project, FERC No. 2157-221 License Article 405 – Ramping Rate Evaluation Plan Supplement Final Report

Sultan River Side Channel Enhancements Ramping Rate Evaluation Updated Supplement Final Report

November 2016

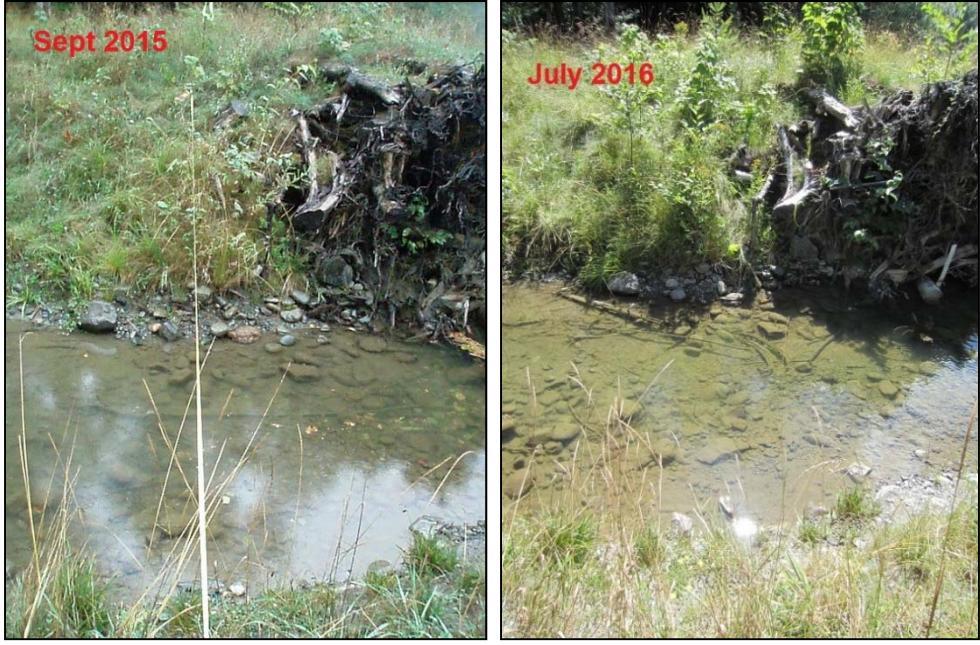
Photo Collection 3. SC1 Cross Section 1 at upstream end of New Inlet.

Cross Section 1 is located at the upstream entrance to the New Inlet; relatively little adjustment of the cross section is apparent between the September 2015 and July 2016 measurements (Figure 7, Photo Collection 3).

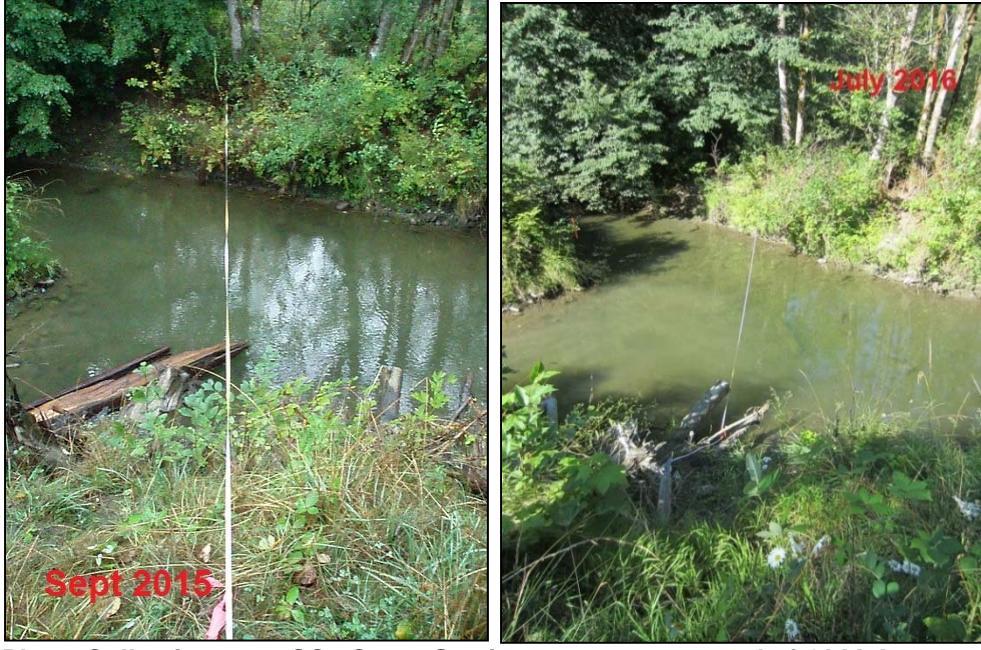
Photo Collection 4. SC1 Cross Section 2 at upstream end of Old Inlet.

Cross Section 2 is located at the upstream entrance to the Old Inlet; relatively little adjustment of the cross section is apparent between the September 2015 and July 2016 measurements (Figure 8, Photo Collection 4).

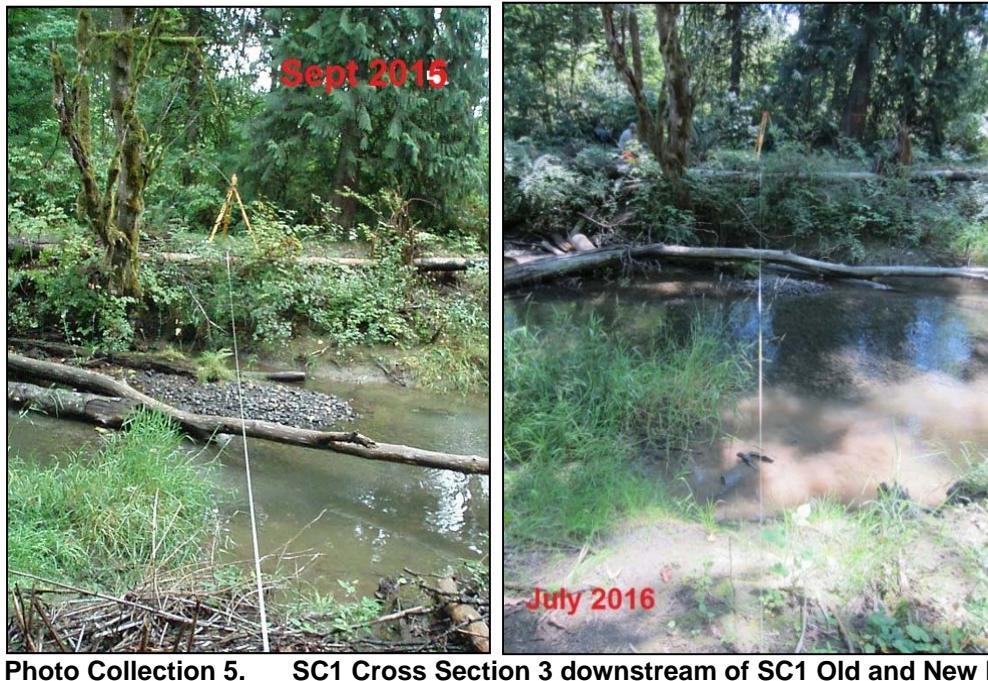
SC1 Cross Section 3 downstream of SC1 Old and New Inlets within the SC1 Middle Mainstem.

Cross Section 3 is located at the Middle Mainstem a short distance downstream of the Old and New Inlet confluence; some adjustment of the cross section is apparent between the September 2015 and July 2016 measurements (Figure 9, Photo Collection 5).

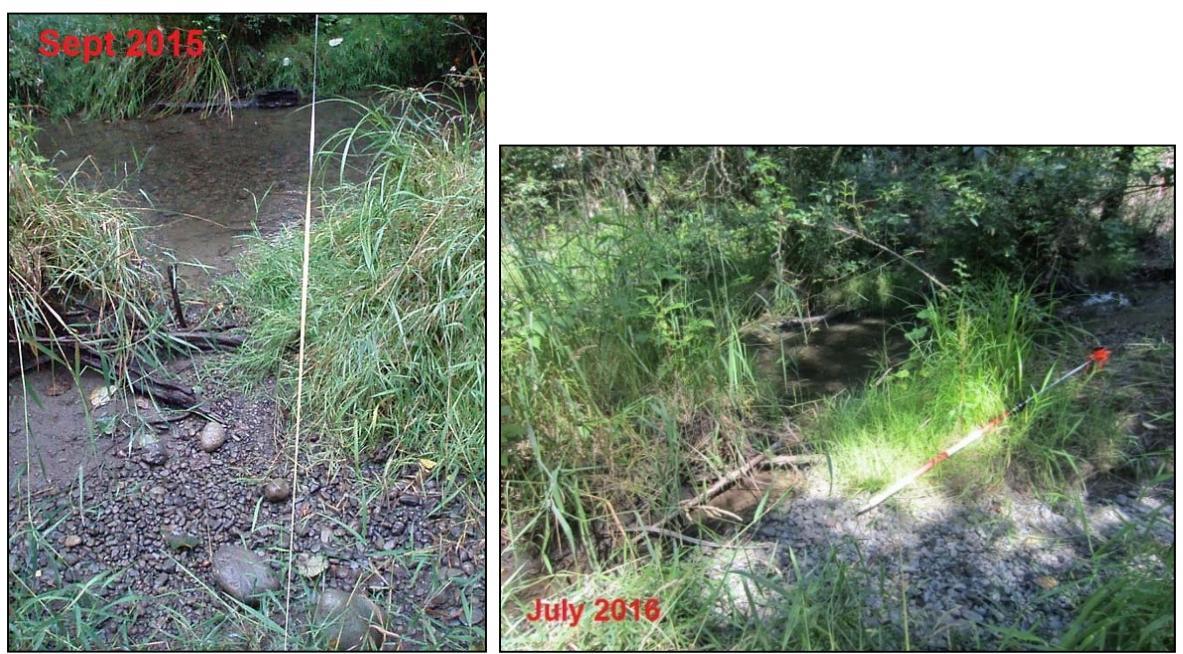
Photo Collection 6. SC1 Cross Section 4 within SC1 Middle Mainstem.

Cross Section 4 is located within the Middle Mainstem in an area with a relatively wide potential floodplain with what appears to be a legacy channel system to the east that has been blocked by a large boulder/log structure. The cross section contains a portion of a small side channel. Some adjustment of the cross section is apparent between the September 2015 and July 2016 measurements (Figure 10, Photo Collection 6).

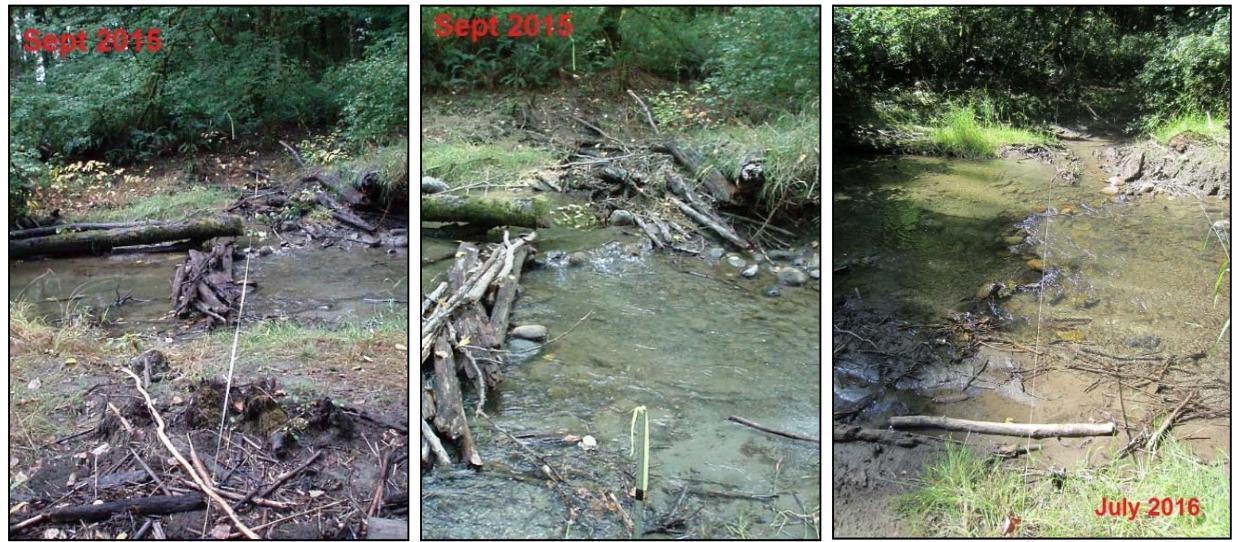
Photo Collection 7. SC1 Cross Section 5 within SC1 Middle Mainstem.

Cross Section 5 is located within the Middle Mainstem in an area with a relatively wide potential floodplain. The cross section contains the inlet to a side channel. Some adjustment of the cross section is apparent between the September 2015 and July 2016 measurements (Figure 11, Photo Collection 7).

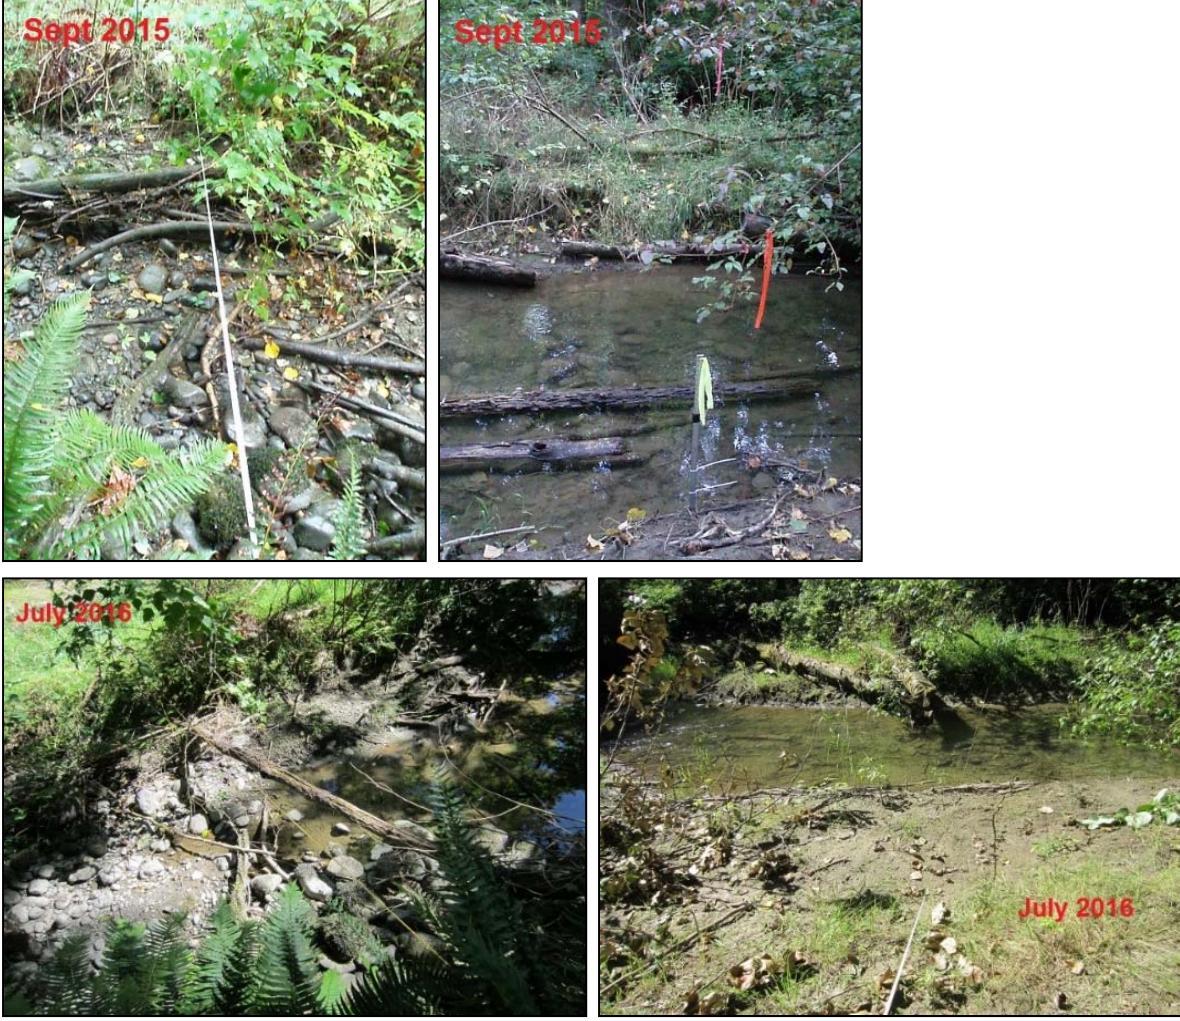
Photo Collection 8. SC1 Cross Section 6 within SC1 Middle Mainstem.

Cross Section 6 is located within the Middle Mainstem in an area with a relatively wide potential floodplain. The cross section contains a side channel (same side channel that is part of Cross Section 5). Little adjustment of the cross section is apparent between the September 2015 and July 2016 measurements (Figure 12, Photo Collection 8).

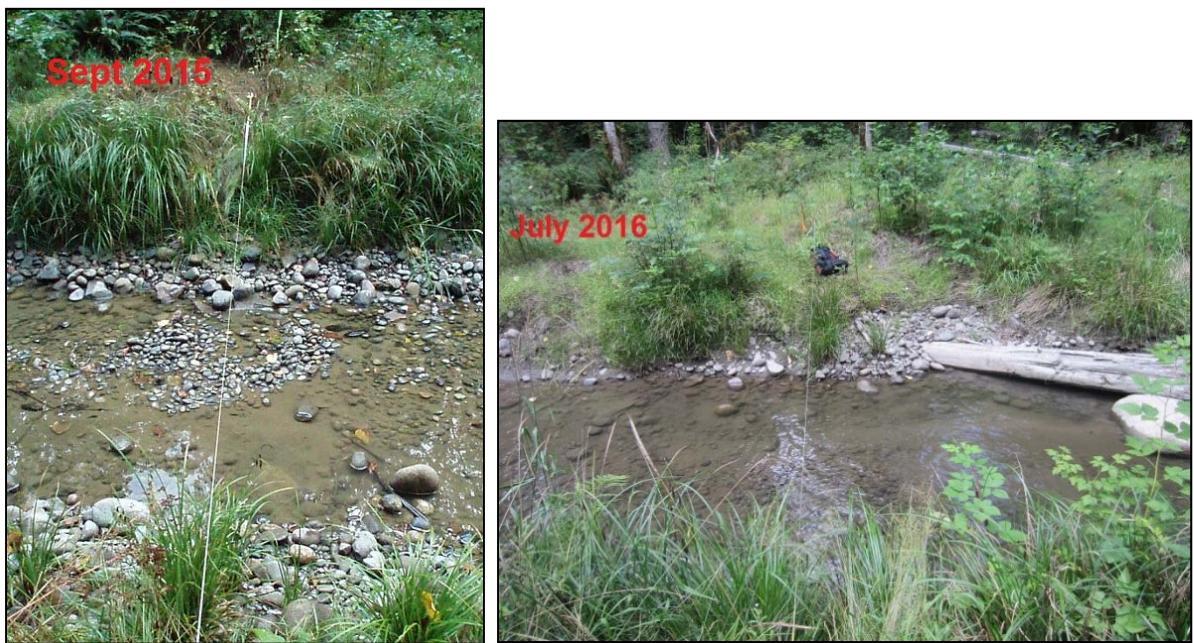
Photo Collection 10. SC1 Cross Section 8 near the upstream end of the New Outlet.

Cross Section 8 is located within the New Outlet a short distance downstream of the Old/New outlet split, near where surface flow ceased during the 2015 survey at 215 cfs. Little adjustment of the cross section is apparent between the September 2015 and July 2016 measurements (Figure 14, Photo Collection 10).

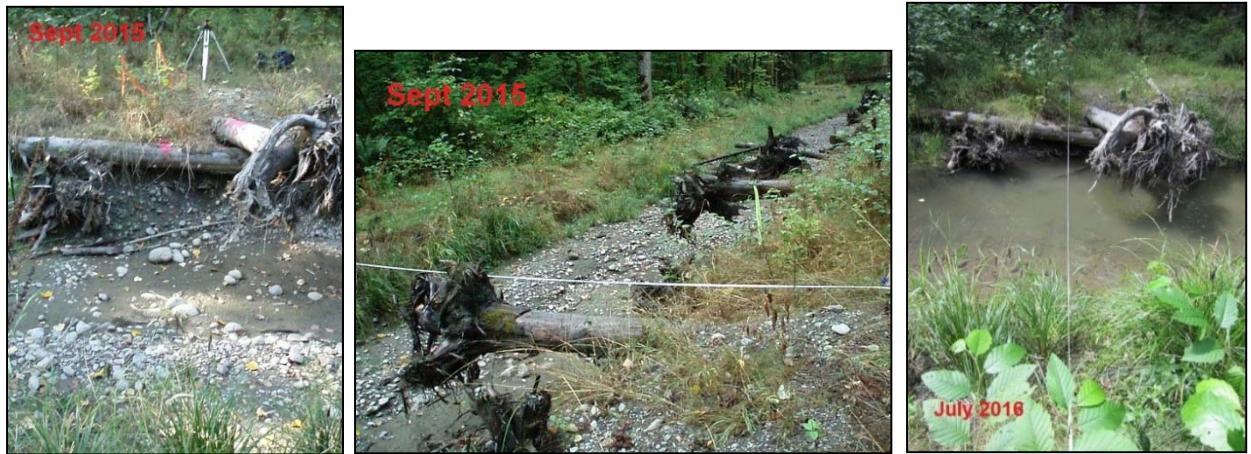
Photo Collection 11. SC1 Cross Section 9 near the upstream end of the New Outlet.

Cross Section 9 is located within the New Outlet a short distance downstream of the Old/New outlet split, where the channel was dry during the 2015 survey at 215 cfs. Little adjustment of the cross section is apparent between the September 2015 and July 2016 measurements (Figure 15, Photo Collection 11).

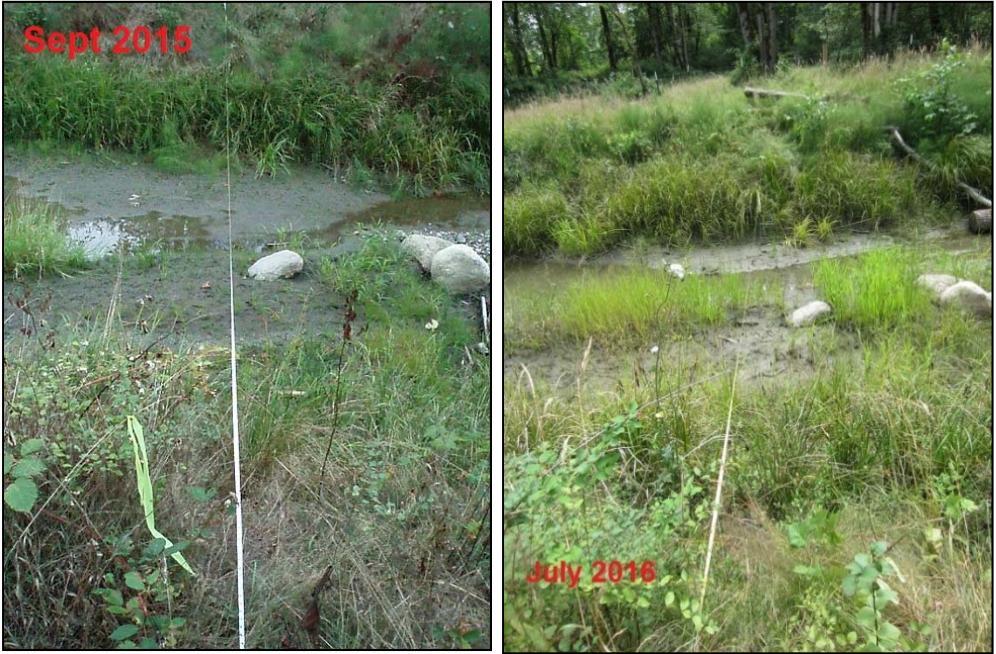
Photo Collection 12. SC1 Cross Section 10 within the New Outlet.

Cross Section 10 is located within the New Outlet where surface flow was intermittent during the 2015 survey at 215 cfs. Little adjustment of the cross section is apparent between the September 2015 and July 2016 measurements (Figure 16, Photo Collection 12).

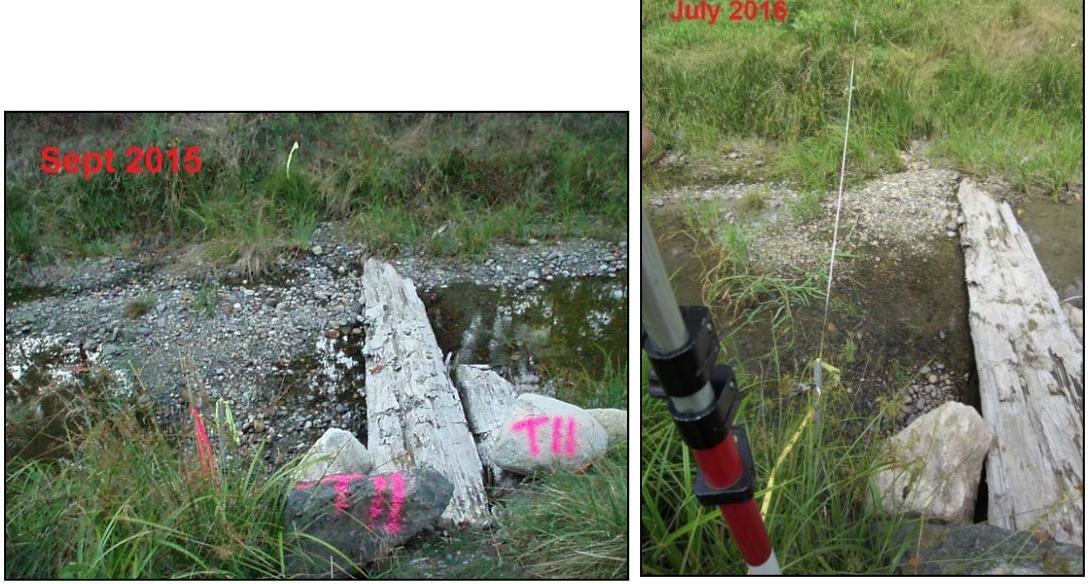
Photo Collection 13. SC1 Cross Section 11 within the New Outlet.

Cross Section 11 is located within the New Outlet where surface flow was intermittent during the 2015 survey at 215 cfs. Little adjustment of the cross section is apparent between the September 2015 and July 2016 measurements (Figure 17, Photo Collection 13).

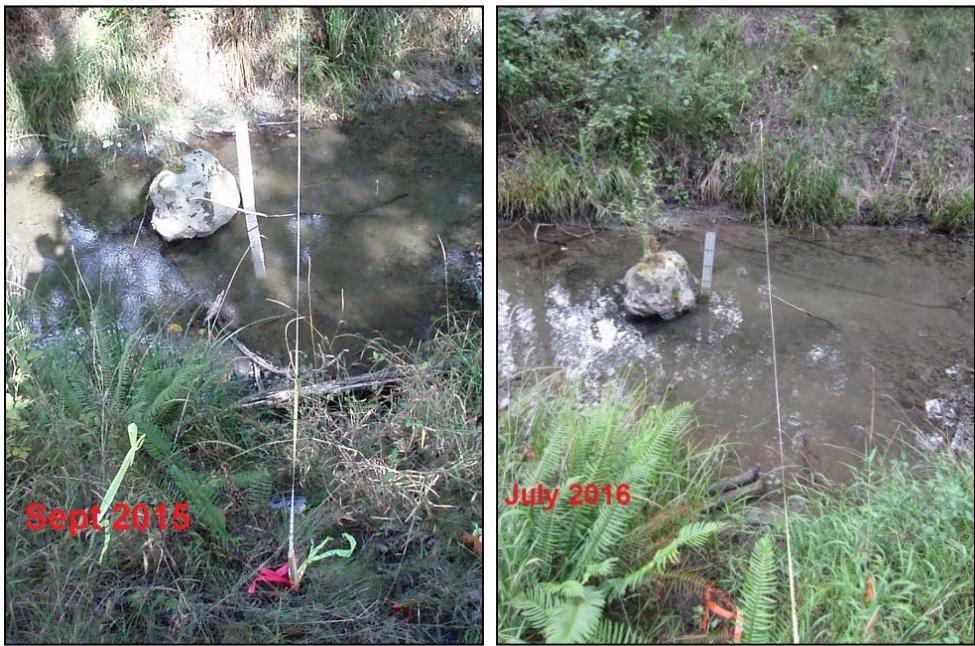
Photo Collection 14. SC1 Cross Section 12 near the downstream end of the New Outlet.

Cross Section 12 is located within the New Outlet where surface flow was continuous to the Sultan River confluence during the 2015 survey at 215 cfs, and is also located at the District's previously established staff gage monitoring site. Little adjustment of the cross section is apparent between the September 2015 and July 2016 measurements (Figure 18, Photo Collection 14).

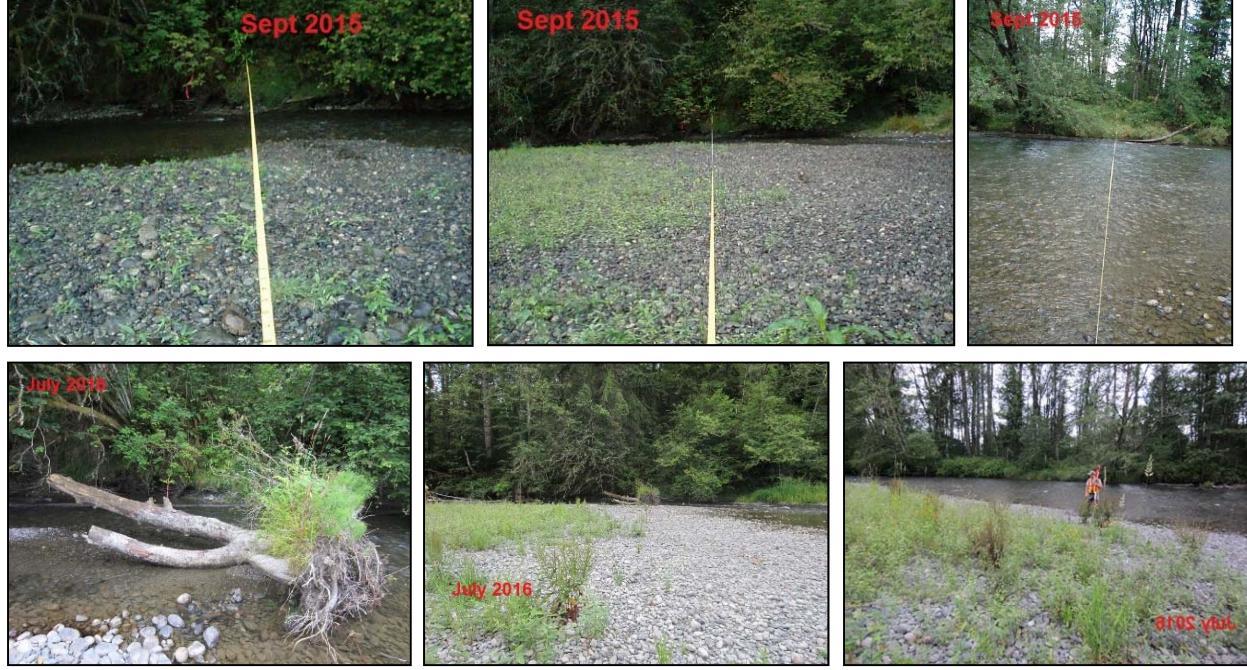
Photo Collection 15. SC4 Cross Section 13 at the upstream end of the Upper Inlet and the Sultan River.

Cross Section 13 is located at the upstream end of SC4 and extends across the SC4 Upper Inlet as well as the mainstem Sultan River channel. Some adjustment of the Sultan River cross section and upstream end of the SC4 inlet is apparent between September 2015 and July 2016 measurements (Figure 19). Adjustments observed included some scouring of the gravel bar along the SC4 Inlet and deposition of a log/rootwad (Photo Collection 15).

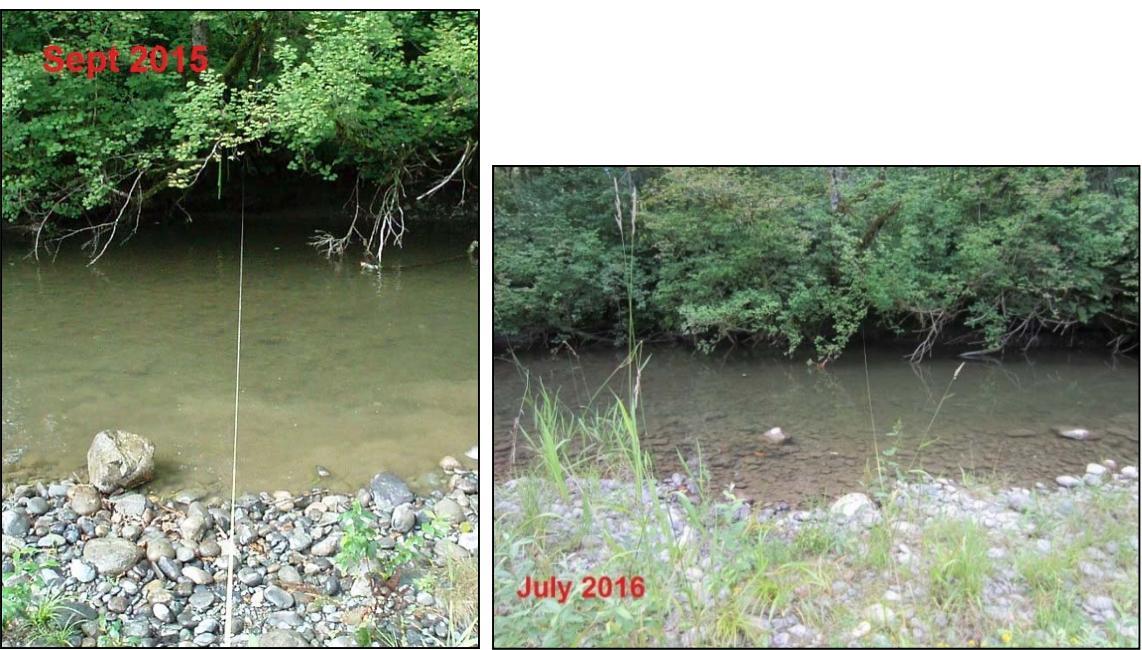
Photo Collection 16. SC4 Cross Section 14 within the Upper Inlet.

Cross Section 14 is located within the Upper Inlet of SC4; some adjustment of this cross section is apparent between September 2015 and July 2016 measurements (Figure 20, Photo Collection 16).

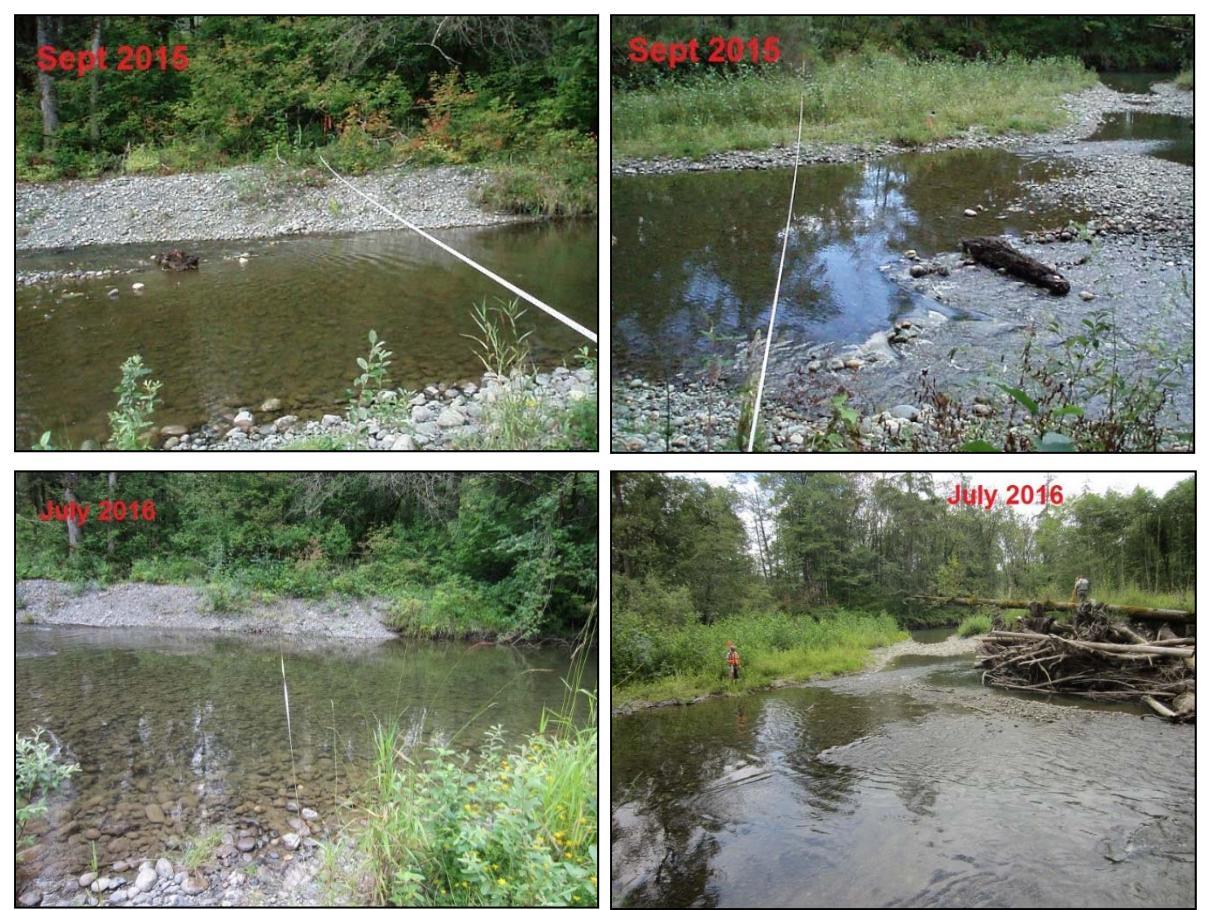
Photo Collection 17. SC4 Cross Section 15 at the downstream end of the Upper Inlet.

Cross Section 15 is located within the Upper Inlet of SC4 just upstream of where the Upper Outlet channel connects to the Sultan River. Some adjustment of this cross section is apparent between September 2015 and July 2016 measurements (Figure 21, Photo Collection 17).

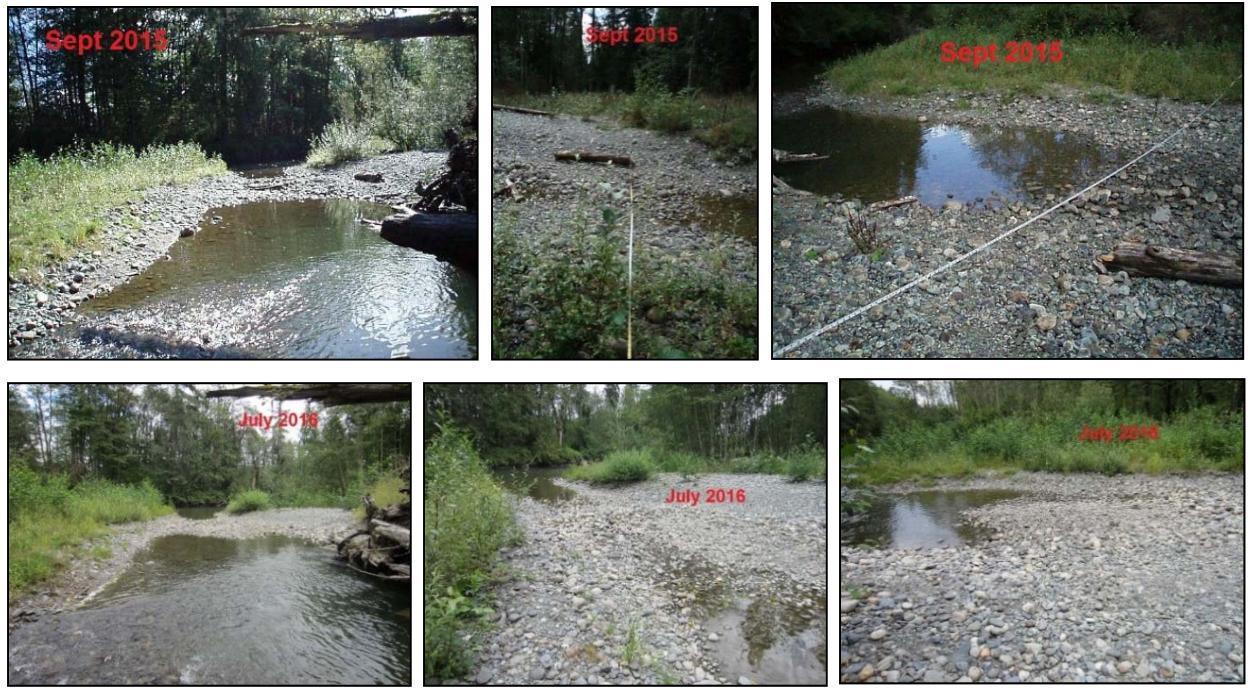
Photo Collection 18. SC4 Cross Section 16 within the Upper Outlet.

Cross Section 16 is located within the short Upper Outlet channel of SC4. This channel was dry during the 2015 measurement and barely flowing during the 2016 measurement. Some adjustment of this cross section is apparent between September 2015 and July 2016 measurements (Figure 22, Photo Collection 18).

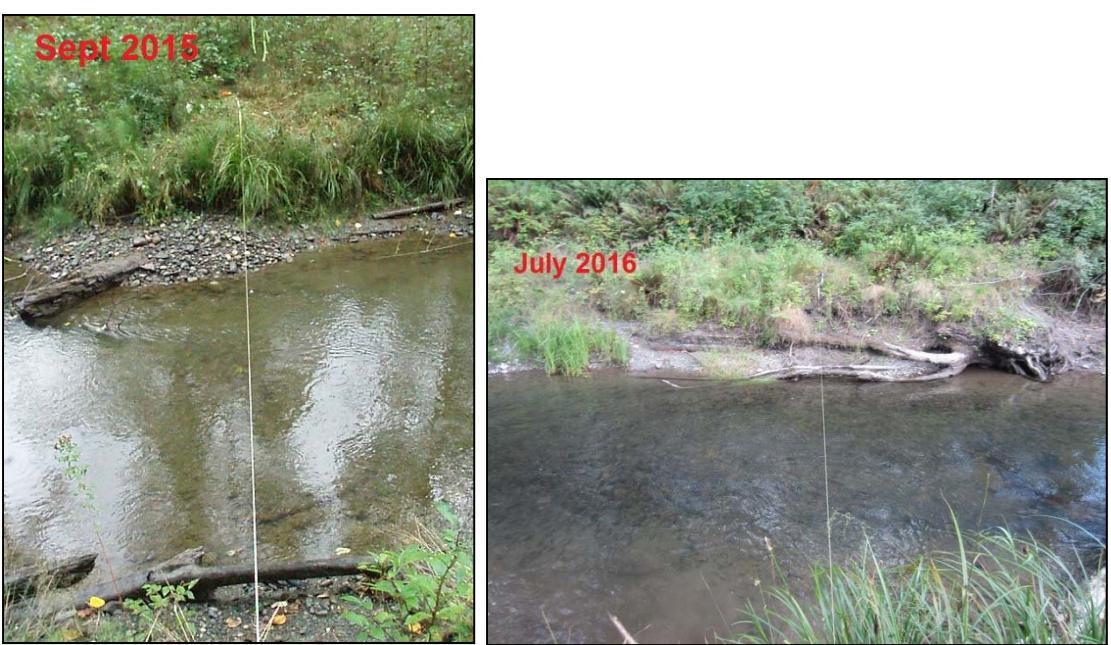
Photo Collection 19. SC4 Cross Section 17 within the Mainstem.

Cross Section 17 is located within the SC4 mainstem downstream of the Upper Outlet. Little adjustment of this cross section is apparent between September 2015 and July 2016 measurements (Figure 23, Photo Collection 19).

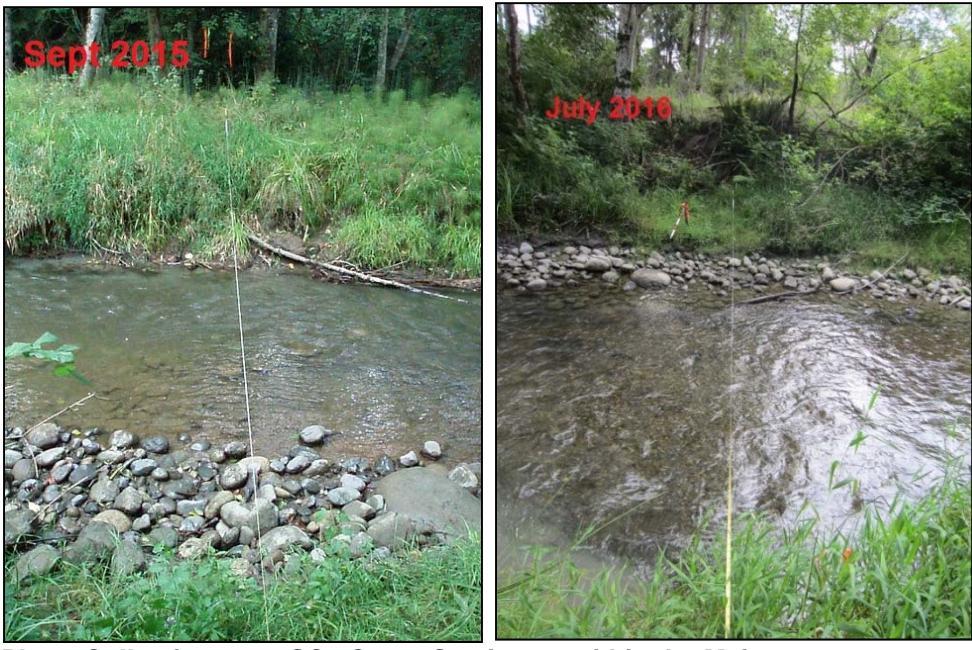
Photo Collection 21. SC4 Cross Section 19 within the Mainstem.

Photo Collection 20. SC4 Cross Section 18 within the Mainstem.
Cross Section 19 is located within the SC4 mainstem. Some adjustment of this cross section is apparent between September 2015 and July 2016 measurements (Figure 25 Photo Collection 21).

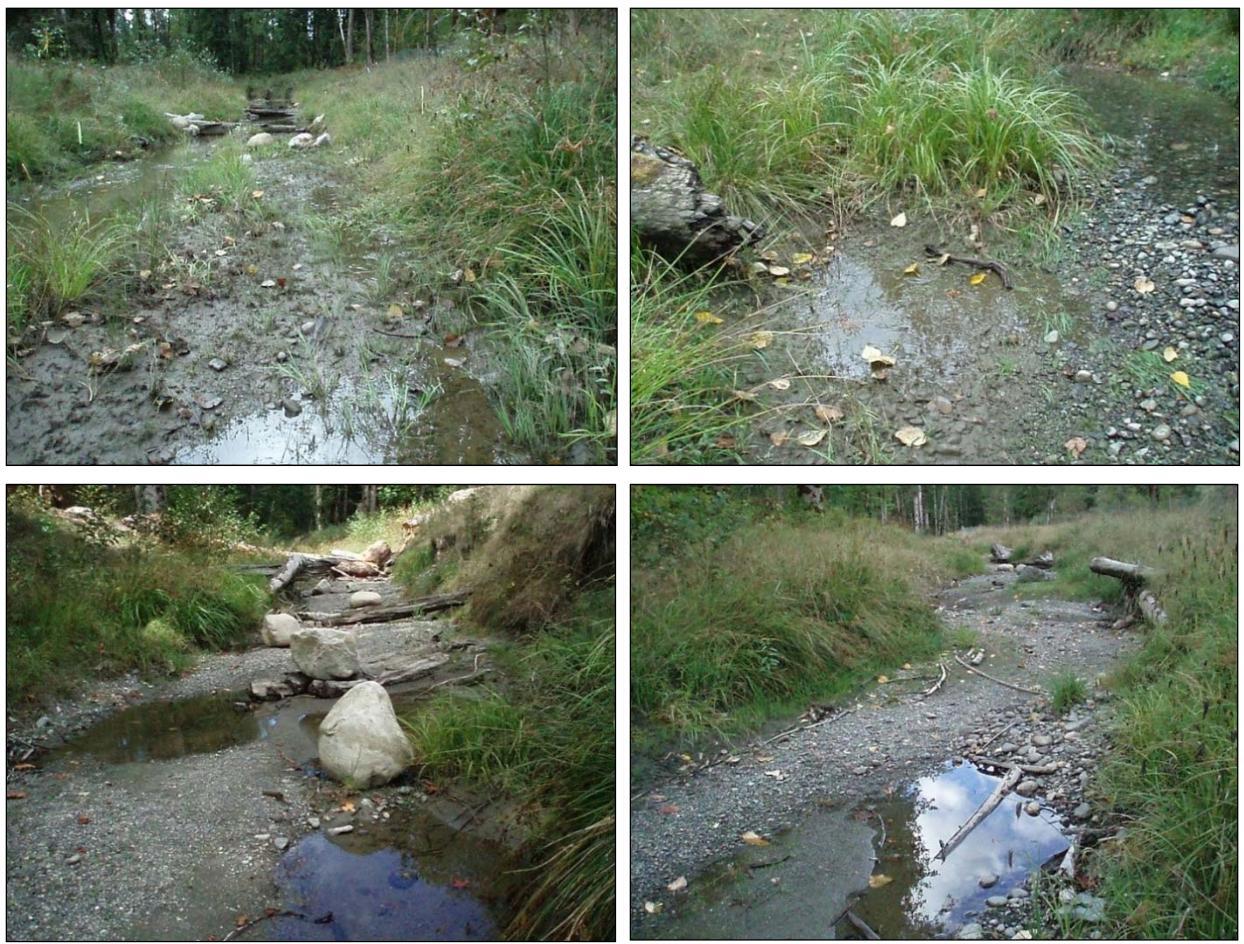
Following the downramping event, a team of biologists walked the entirety of SC1 and SC4 looking carefully for stranded fish and estimating the area of potential fish stranding habitat. In general, potential stranding habitat is most prevalent in the SC1 New Outlet as a portion of the channel becomes dewatered near 300 cfs (Table 1, Photo Collection 23), whereas the majority of the other portions of SC1 and SC4 remain wetted at 300 cfs. Only one stranded fish was found; a juvenile lamprey which was trapped in a small pocket of water within the portion of the SC1 New Outlet that goes dry below 300 cfs (Table 1, Photo Collection 24). Of note is that as soon as the flow was raised on September 12, many adult pink salmon entered the previously dry segment of the SC1 New Outlet. Adult pink salmon were observed migrating through the SC1 New Outlet during the downramping test, yet none were observed beached or trapped in isolated pools during the fish stranding study on September 13.

Photo Collection 23. Typical SC1 New Outlet potential fish stranding habitat.

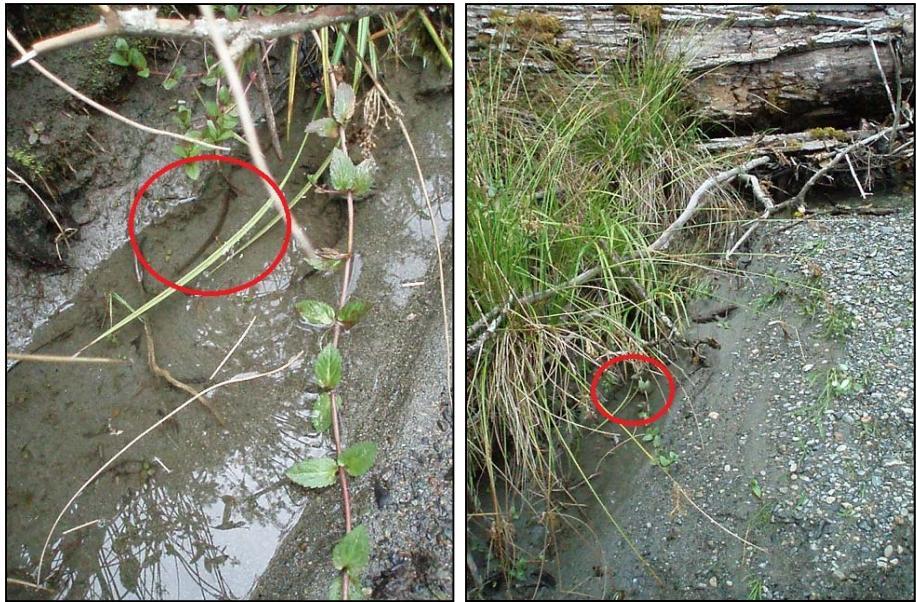
Photo Collection 24. Stranded juvenile lamprey trapped in isolated puddle within the SC1 New Outlet.
