#### Re: Jackson Hydroelectric Project, FERC No. 2157 Fish Habitat Enhancement Plan 2017 Annual Report License Appendix G A-LA 12

# Henry M. Jackson Hydroelectric Project (FERC No. 2157)

# Fish Habitat Enhancement Plan: 2017 Annual Report (A-LA 12)

# Lower Skykomish River Fish Habitat Enhancement Project 2016 Final Report

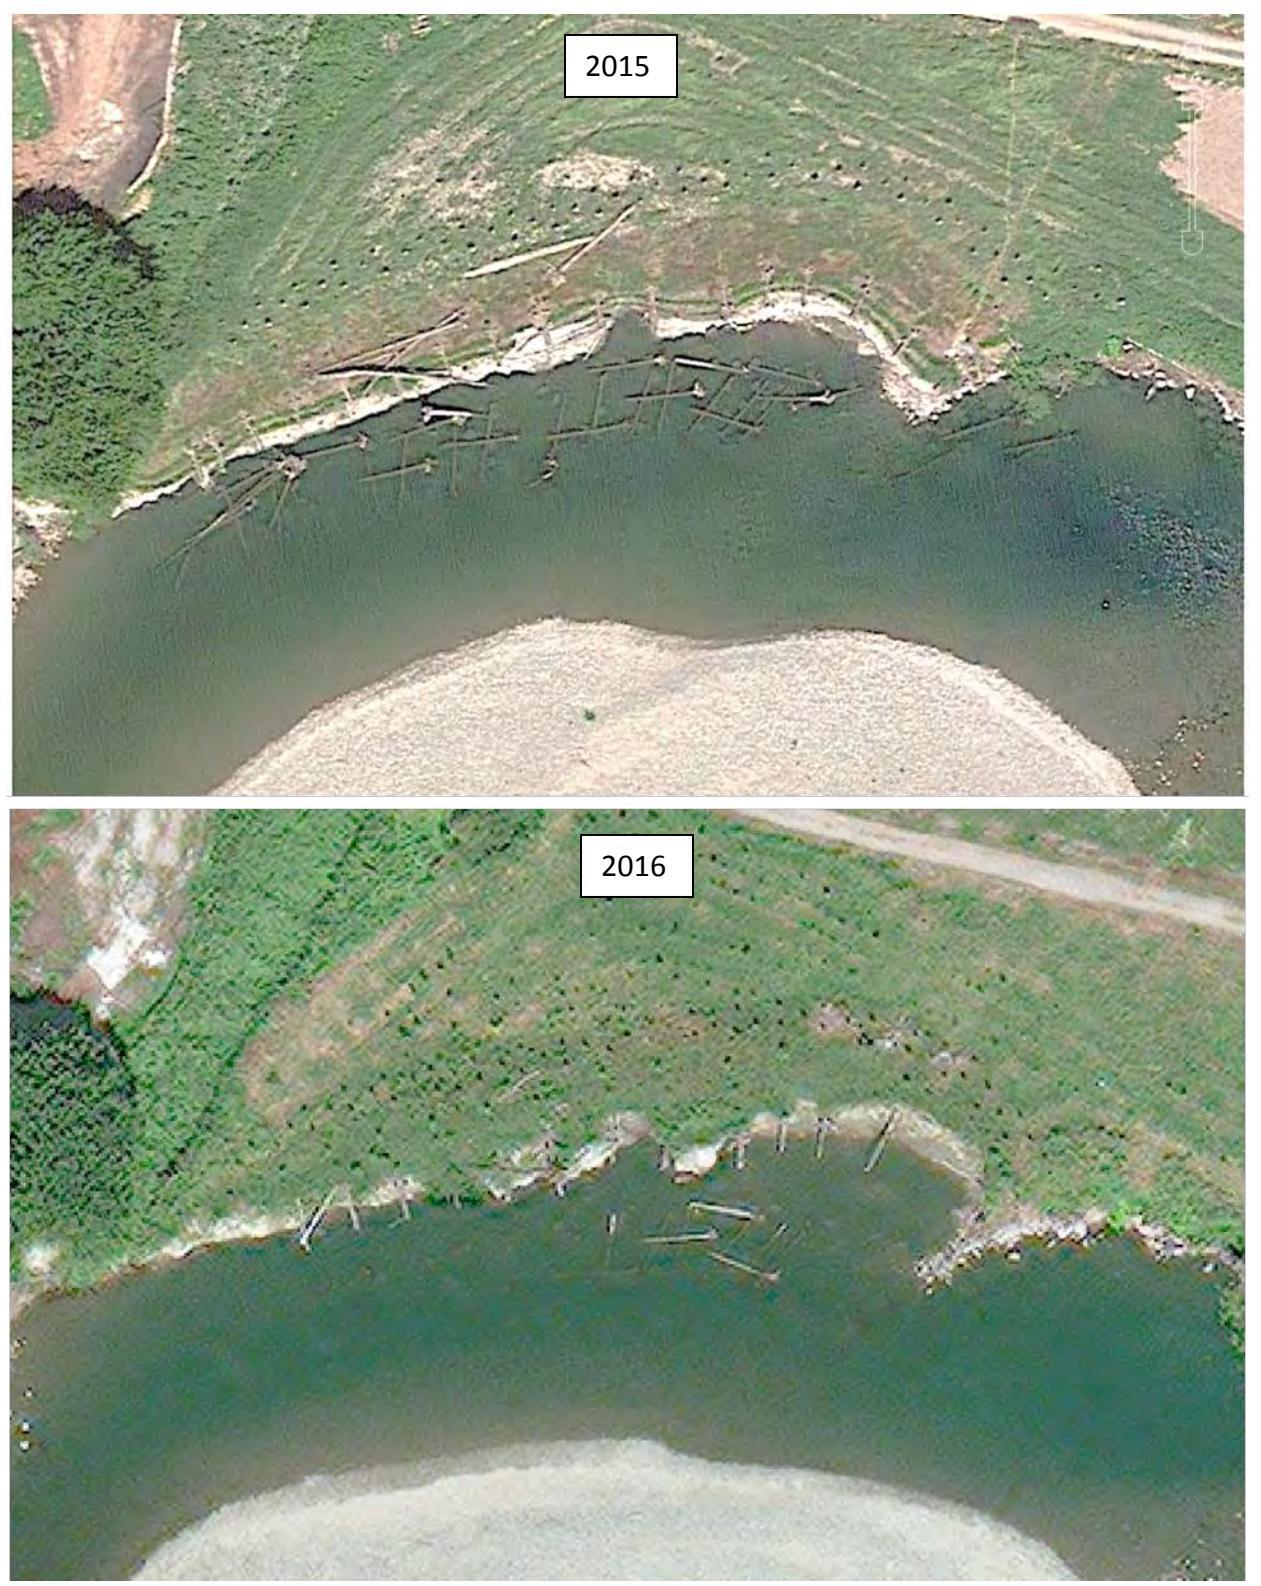
On the outside meander bank there were 36 ballasted logs placed on the channel bottom in an interlaced pattern, at the right bank toe extending out into the pool center. During summer low flow 2015 RM 10.5 habitat inventory, 33 ballasted logs were identified as well as 3 naturally recruited pieces. In 2016 a count was made during the summer low flow and only 10 placed ballasted logs were present. The boulders used for ballast remained in place. Figure 1 shows the aerial view of the RM 10.5 project bank structures in the summer of 2015 and 2016. The vertical eroding bank was back-sloped and 19 habitat structures were embedded in the bank extending out into the channel. The inventory in 2015 identified 18 originally installed structures remained as well as 7 naturally recruited logs. After the flood season of 2015-2016, 13 of the 19 structures remained. Ballasted logs at RM 11.5 were surveyed in the as-built report and have shifted but have not been re-surveyed as the water has

deepened and survey is difficult at that location. The habitat inventory in 2015 accounted for the all of the placed pieces within the backwater habitat.

Figure 1. Google Earth aerial photos, June 2015 and 2016 of the RM 10.5 bank rehabilitation project.Snohomish County Surface Water Mgmt.Page |7FHE Funded Project Final Report, 2016Page |7

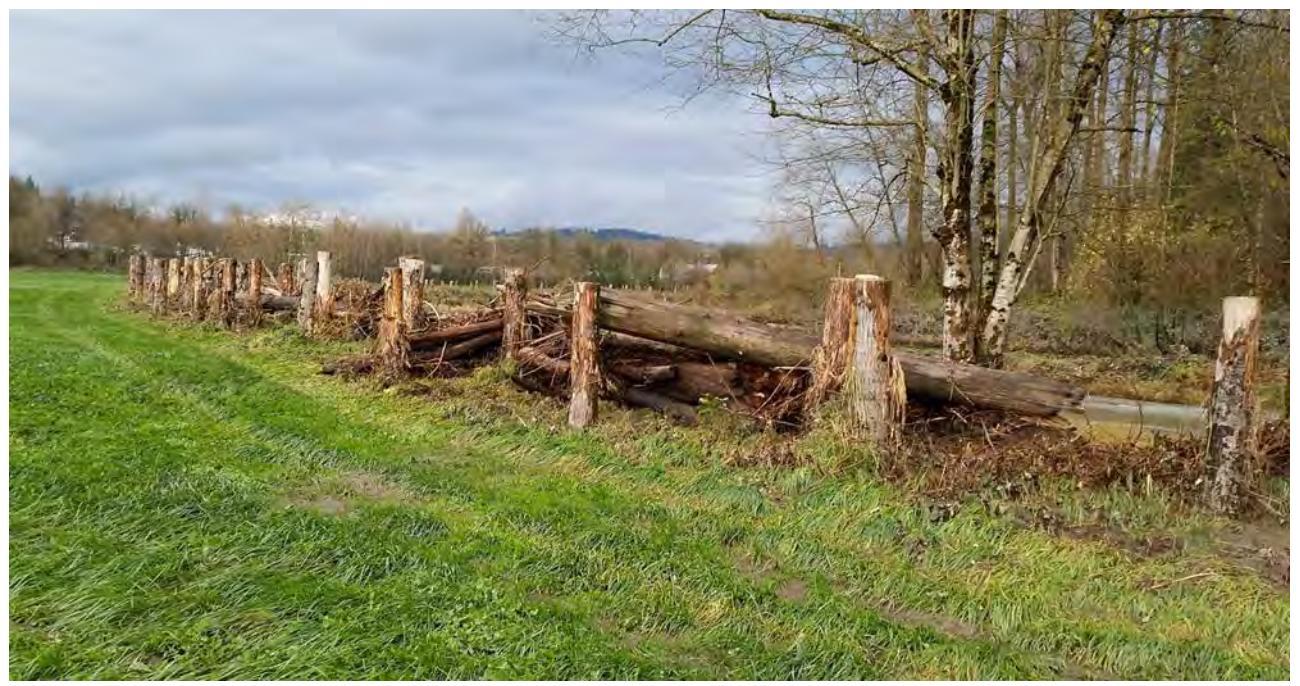
Over the 6000 lineal feet of floodplain flood fencing, a section ~100 feet in length was lost due to channel migration. The estimated 12 lost cottonwood boles were at the RM 11.5 project site in a location where installation was narrowed due to landowner constraints. The RM 12.5 site flood fencing accumulated natural wood at a bend in the side channel (Figure 2).

Figure 2. Accumulated natural wood on floodplain flood fencing, RM 12.5.

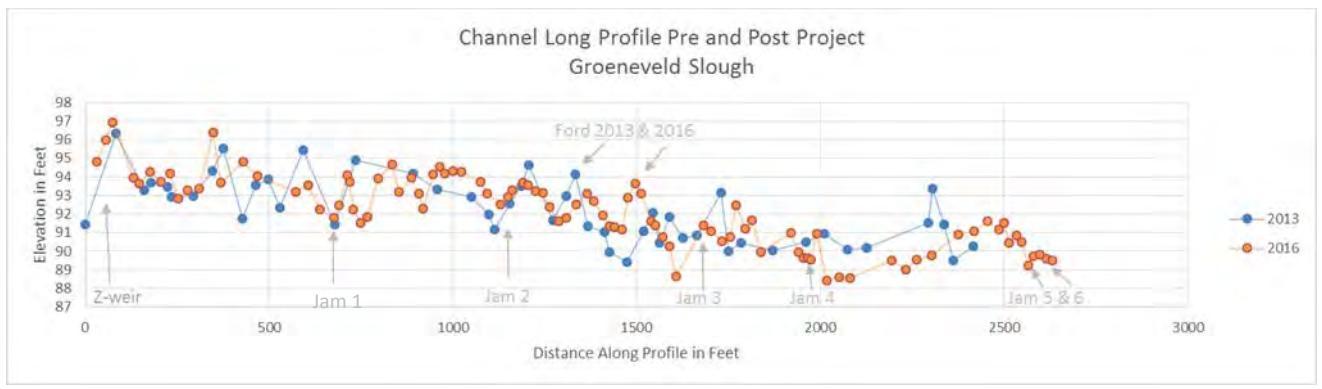
A longitudinal profile of the RM 12.5 channel thalweg was collected prior to the project construction and repeated in 2016 after the flood season. Figure 6 shows the longitudinal comparison by year through the structure treatment reach of the side channel. The channel increased in thalweg length by 194 feet, as seen by the resultant shift in the ford along the thalweg (Figure 6). The channel gained the most length between the Z arrays and the first jam, and again just after the first jam as the channel migrated to the left bank (south) and then the right bank (north). The natural bank erosion within the RM 12.5 surveyed reach was 17% in 2016, but not recorded in the 2005 survey. A change of note was the absence of a large beaver dam between jam 4 and 5, and the deepening of the pool upstream as indicated in the 2016 survey (Figure 6).

Figure 6. Longitudinal profile of RM 12.5 side channel pre and post project.

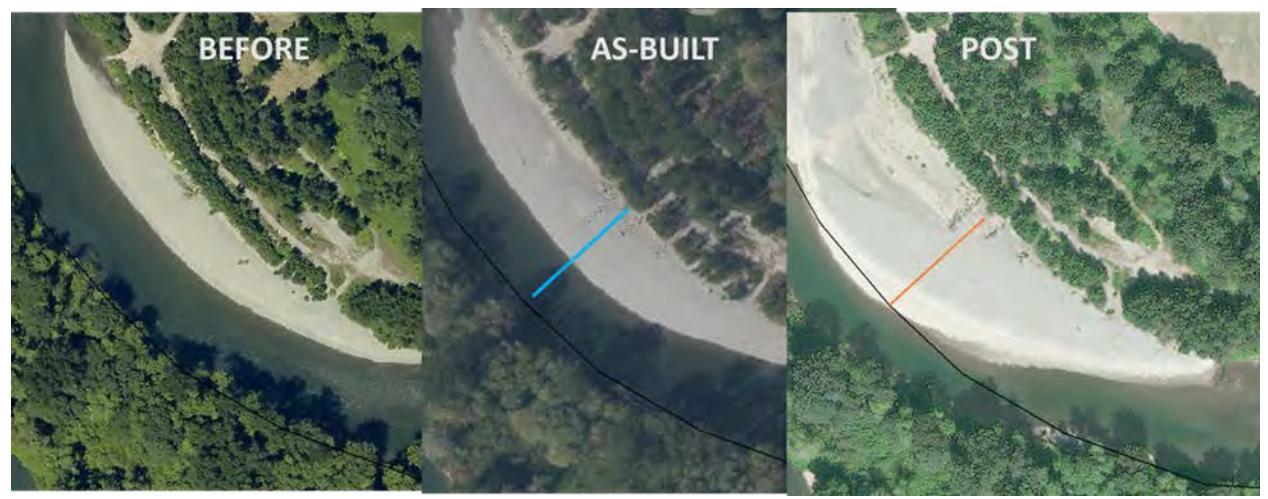
The channel length monitoring for the RM 10.5 channel was accomplished by comparing changes to the length of the left (island inner) bank. Bank edge data was collected at areas of erosion using Trimble<sup>®</sup> RTK equipment and aerial images were used to measure total bank lengths between years. Figure 7 shows the bank adjustment as the channel migrates away from the sediment deposition. Erosion distance measurements are taken at the location of maximum change and only represent the rate at that location for comparison purposes. The left bank length increased in the 2 years post project installation by ~35 meters. The channel length, increase rate pre project was 0.31% per year average. The channel length post-project after the following 2 years was an average increase of 1.14%. The increase in meander length and associated increase in edge habitat adjacent the bar flood fencing is ~25 meters along the meander bend.

Figure 7. Aerial images pre, as-built and post RM 10.5 meander bar vertical array construction.

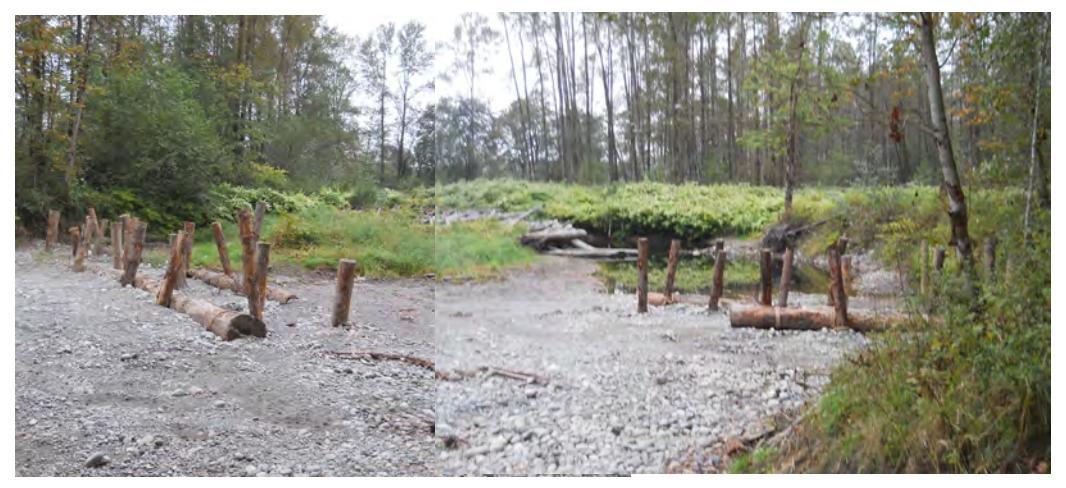
Figure 1. Composite photograph of the completed in-channel flood fences at the Groeneveld site. Flow direction is toward the photographer.

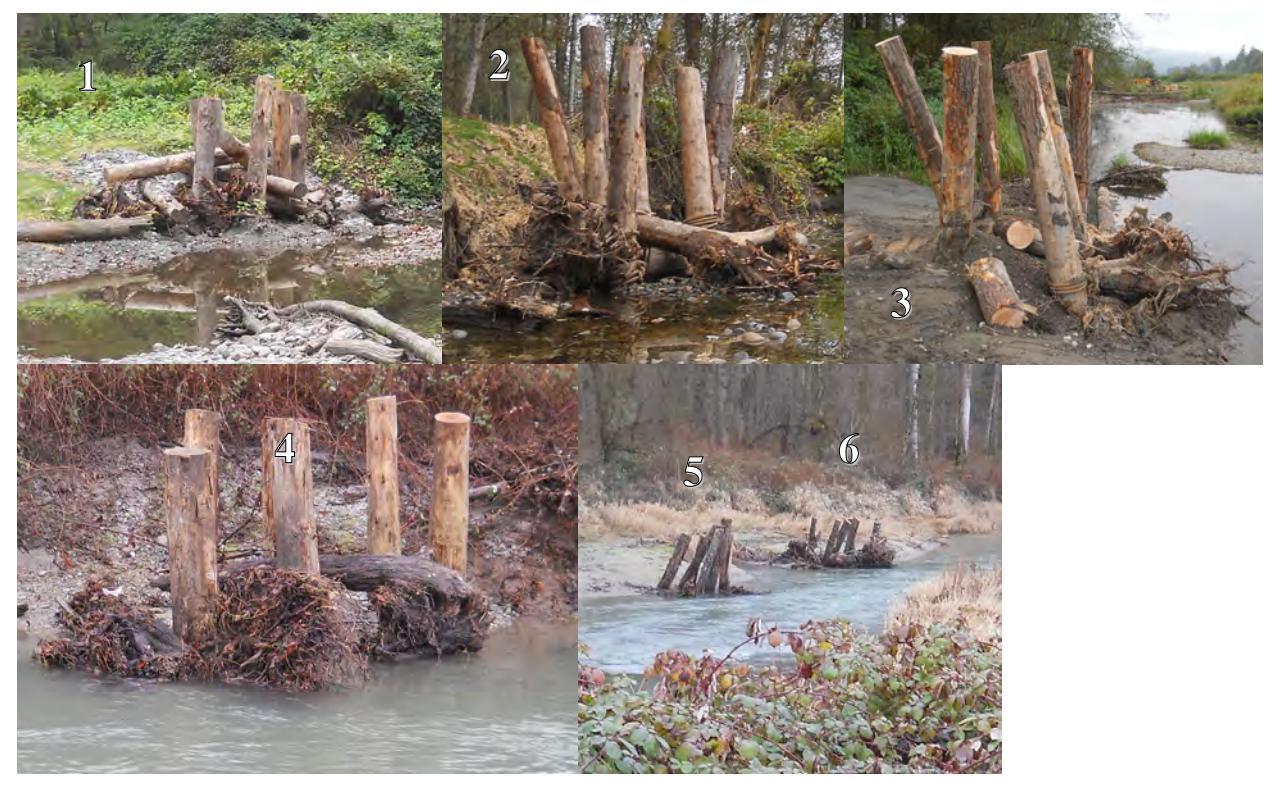
Figure 2. Photographs of the six completed modular log jam structures at the Groeneveld site. Structures are numbered consecutively moving in downstream direction.

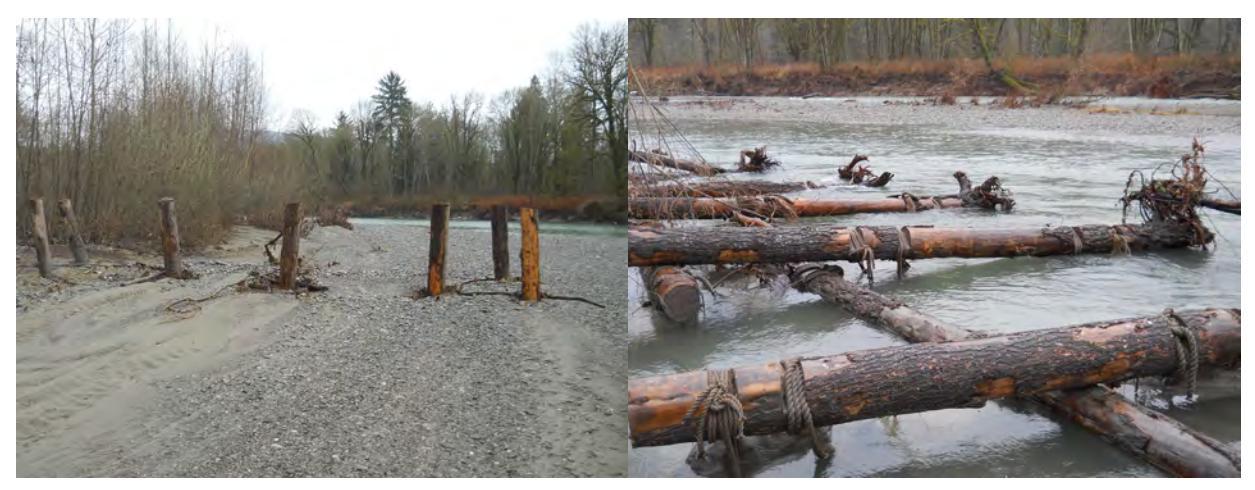
At the upstream site, ten (10) boulder-ballasted logs with rootwads were placed at a location overlapping the downstream portion of the design location, reflecting access constraints posed by trees (the County attempted to minimize cutting of riparian trees). Five (5) flood fence arrays were installed as planned, although their location was upstream of that depicted in the design which reflected a constraint presented by the landowner who wanted to avoid placing the northernmost array in an open grassy area; the array was placed at the upstream side of the area, and the configuration of the accompanying other four arrays was rotated upstream to be consistent with the design goal of forming the flood fences in-line. A visit to the site after the November 2014 flood indicated that all structures and arrays were functioning as intended, where deposition and grain sorting was noted at the flood fences and habitat complexity formation seen at the ballasted logs (Figure 3).

Figure 3. In-channel flood fences and ballasted logs in the upstream site, Labish sub-project.

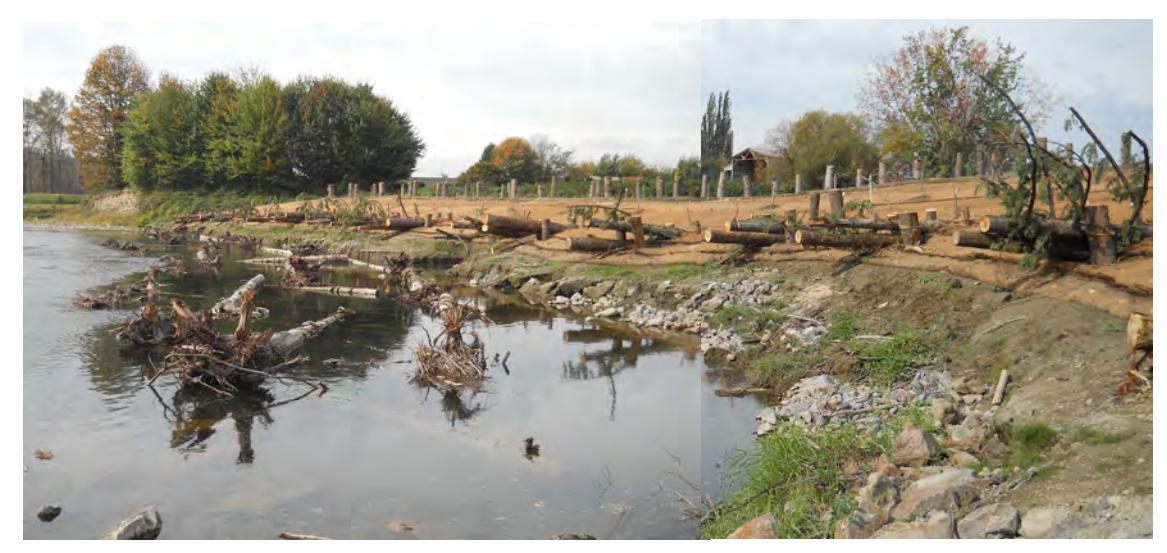
All project elements specified in the design were constructed at the downstream site where the bank was laid back. However, because of erosion subsequent to surveying for the design, the actual locations of placed edge complexity logs and floodplain flood fence were shorewards of the design location. The boulder ballasted logs were accordingly also placed shoreward of their planned location. Nonetheless, all logs were placed according to the numbers specified. The flood fence boles were installed over the general length of bank required. Figure 4 depicts the constructed site with ballasted logs, edge complexity logs, flood fence, and geotextile fabric in place.

Figure 4. Constructed laid back bank and log elements at the downstream site, Labish Sub-Project.
