**Re: Jackson Hydroelectric Project, FERC No. 2157
Side Channel Enhancement Ramp Rate Evaluation Report
License Article 405**

Jackson Hydroelectric Project
(FERC No. 2157)

**Side Channel Enhancement
Ramp Rate Evaluation Report
(License Article 405)**

October 2013

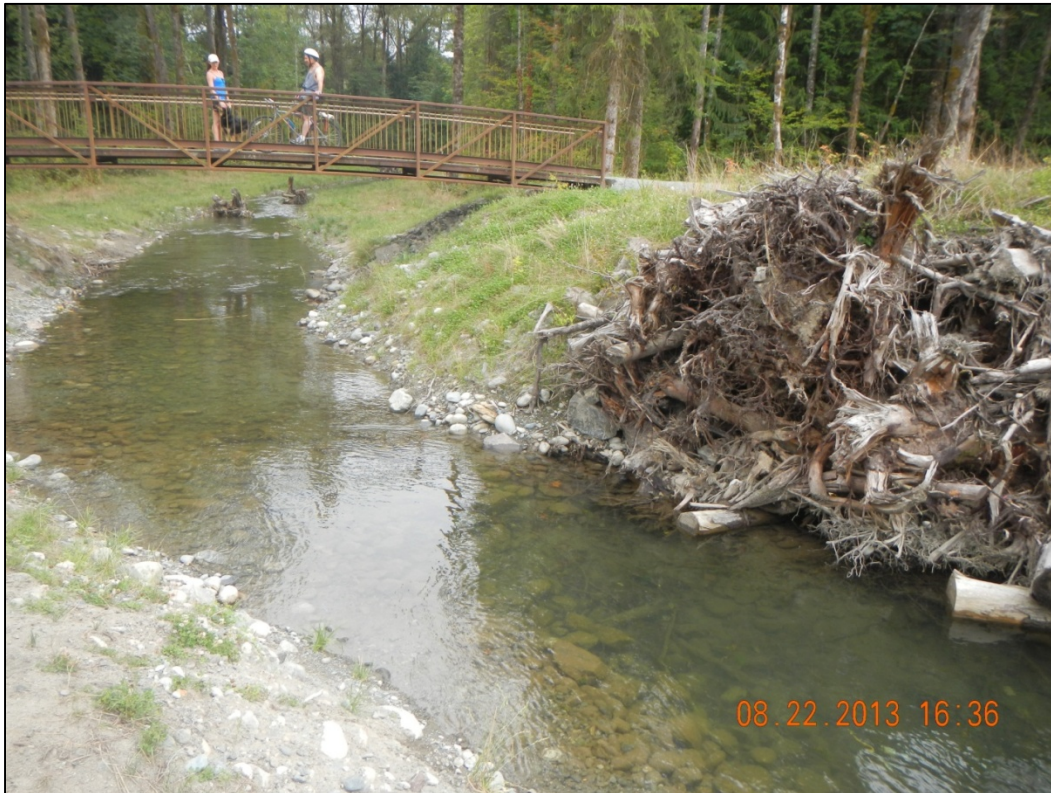
As previously stated, SC1 is unique among the Sultan River side channels in that it has two inlets and two outlets. The constructed, redundant inlet (Figure 4-1) works in concert with the historic inlet (Figure 4-2) to ensure the adequate delivery of sufficient flow volumes throughout the side channel network. Downstream, streamflow is split and routed down one of two pathways: 1) down the historic channel to its outlet (Figure 4-3), or 2) down the constructed extension to SC1 to its outlet (Figure 4-4). Management of the flow split for proper flow routing is a focal point of ongoing monitoring. Racking of woody debris and evolution of the split under high flows will be closely observed.

Figure 4-1. Redundant inlet to SC 1, looking downstream with Engineered Log Jam (ELJ) 4 on the right, mainstem discharge of 581 cfs.

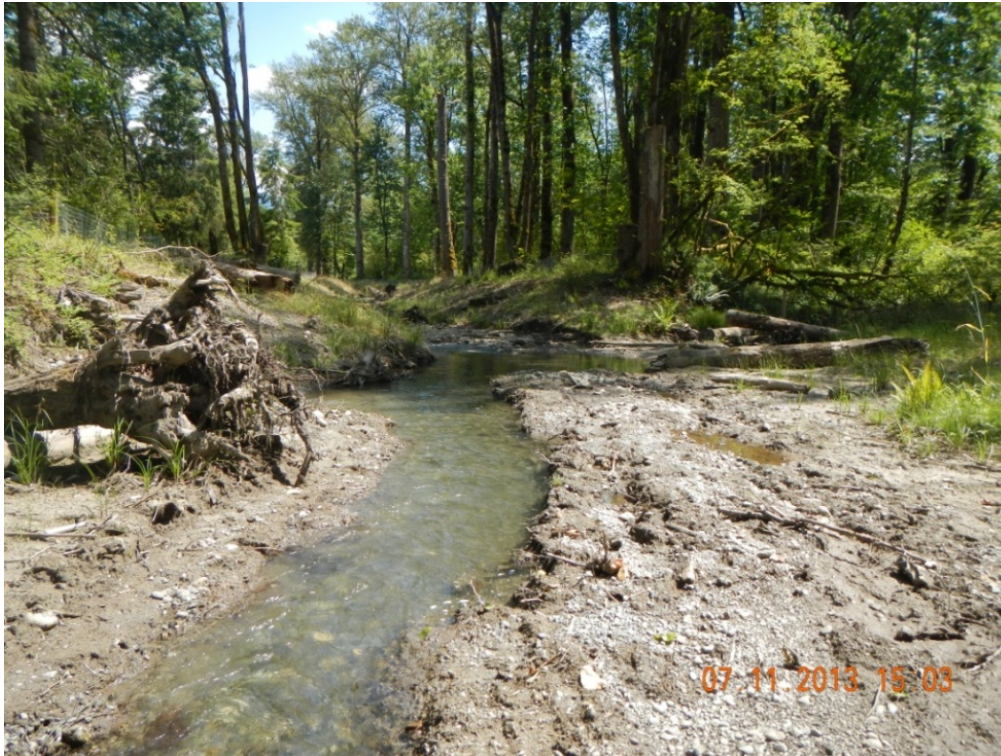
Figure 4-12. Deposition within SC1 Extension near wetland crossing.

measured at each station ranged from 0.3 to 2.8 feet (Figure 4-13). Shallow water depths were observed in the lower 175 feet of the channel between Stations 24+00 and 25+75. Substrate in this area is comprised predominantly of sand and silt. Deposition in this area may be exacerbated by backwatering from the main river channel under conditions of high flow and transport. This area will also be an area of focused evaluation under ongoing monitoring efforts. Under low flow conditions, the average depth of measured cross sections in the extension ranged between 0.1 and 1.9 feet, with a mean of 0.6 feet.

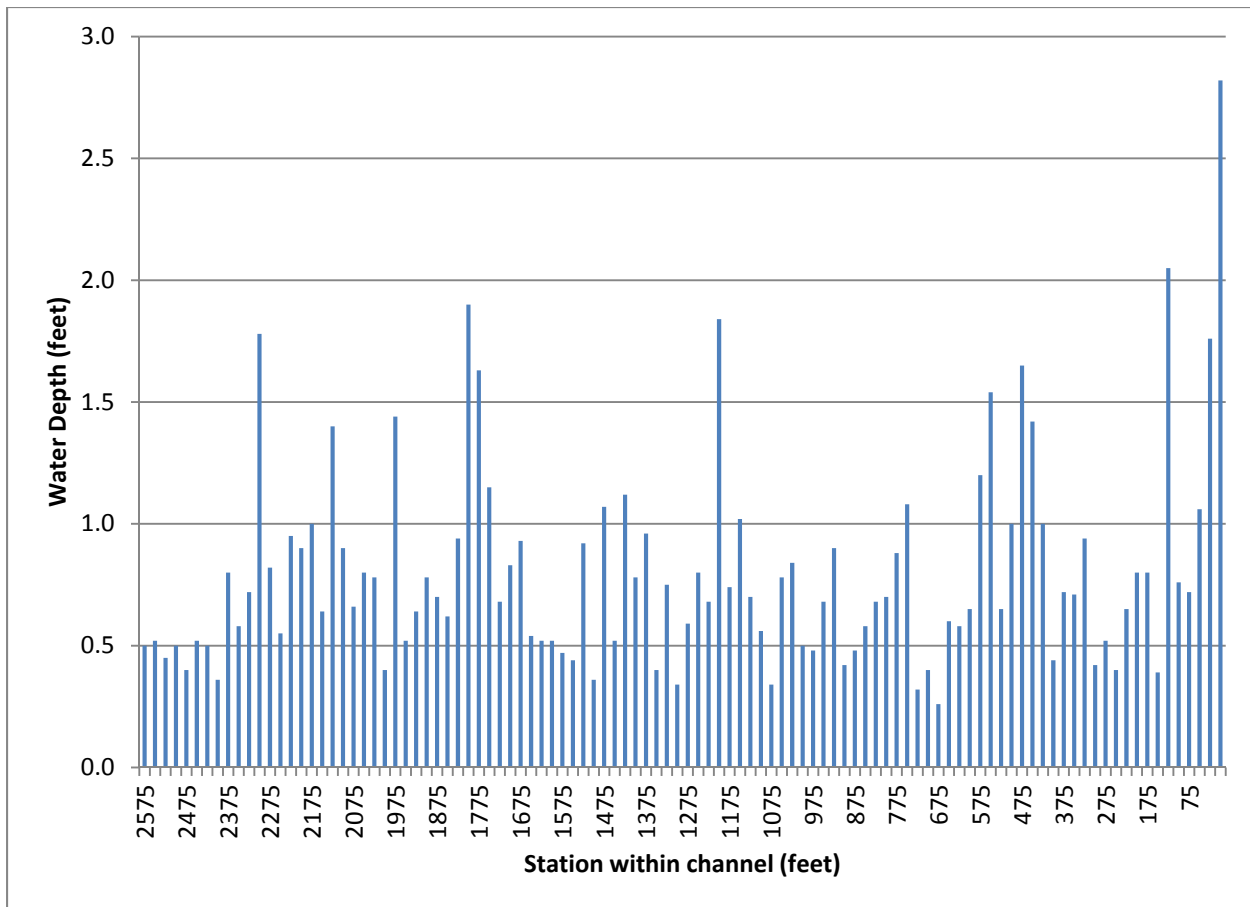
Figure 4-13. Thalweg profile, Side Channel 1 Extension.

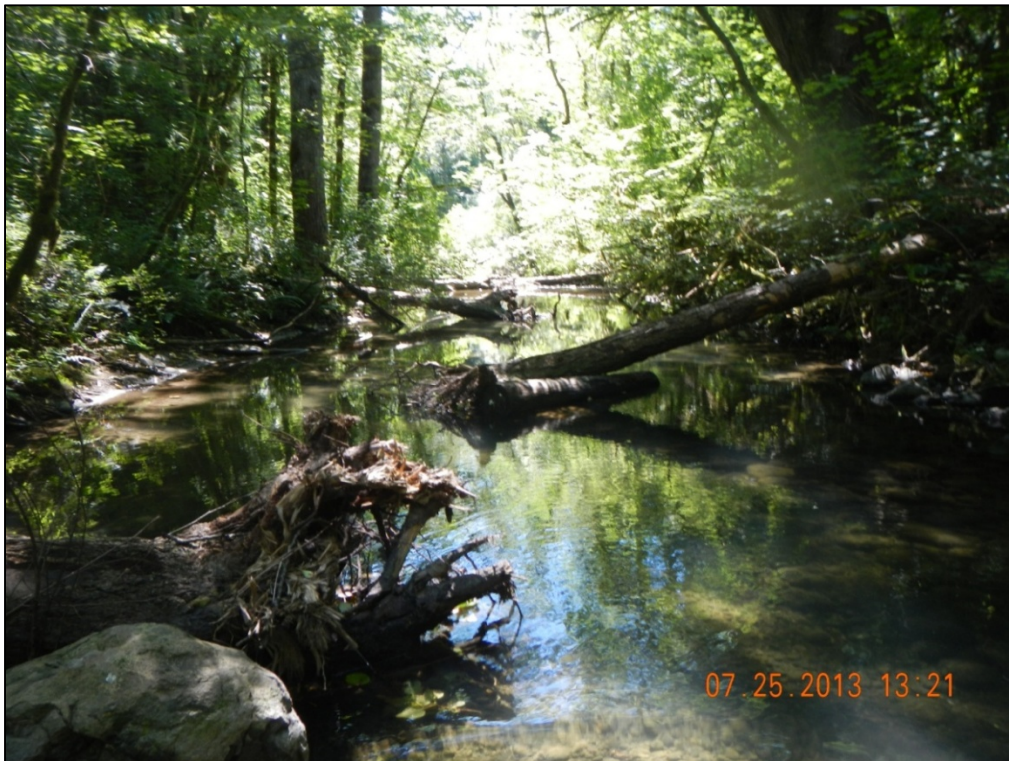
Figure 4-15. SC2 with wood treatments installed during summer 2012, mainstem discharge of 369 cfs.

Substrate within SC2 was predominantly cobble and gravel (coarse and fine) providing for ideal spawning conditions. LWD was well distributed with the inclusion of wood placed during the 2012 restoration work. As before the restoration work, the riparian community was well established with mature canopy providing a heavily shaded environment (Appendix 1).

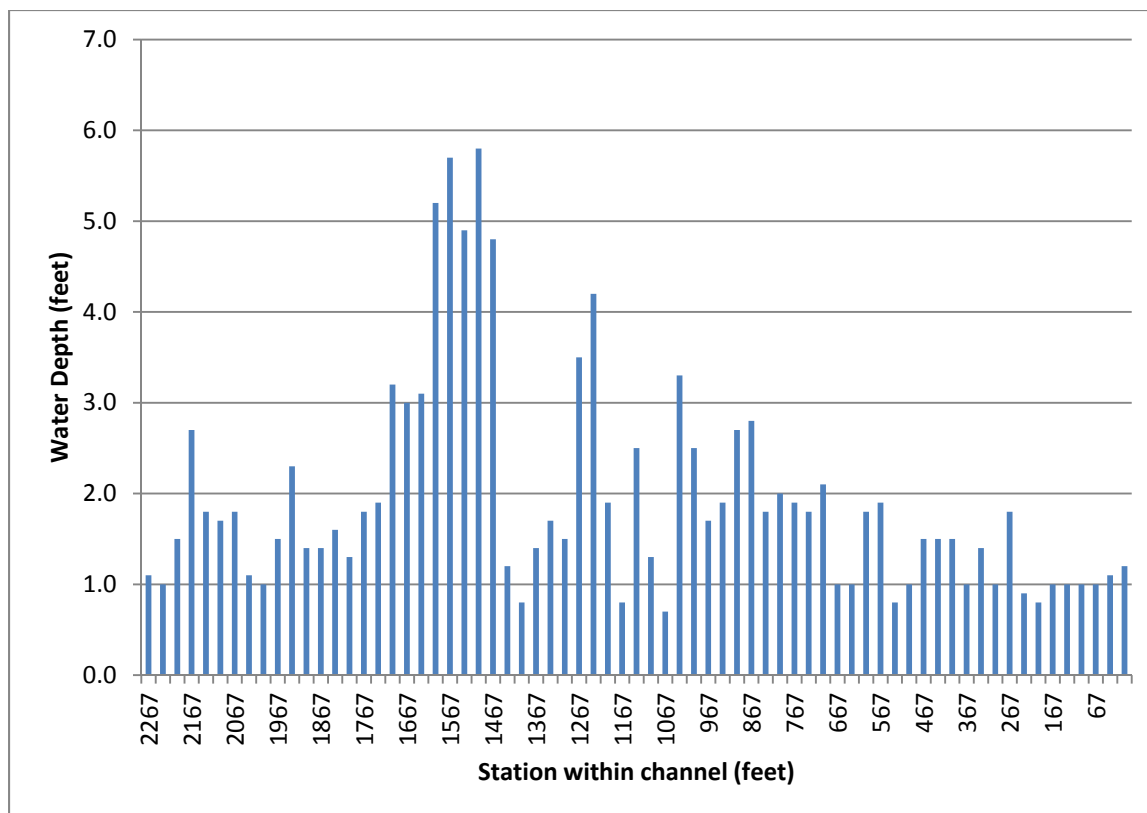
In contrast to other side channels, the substrates within SC3 were larger and predominantly rubble and boulder. LWD was more sparsely distributed in SC3 compared to other side channels. The riparian community was well established particularly along the lower portion of the channel. The upper portion of the channel was wider with a less developed riparian community resulting in greater exposure than observed in other side channels.

**Figure 4-21. Thalweg profile, Side Channel 3.**

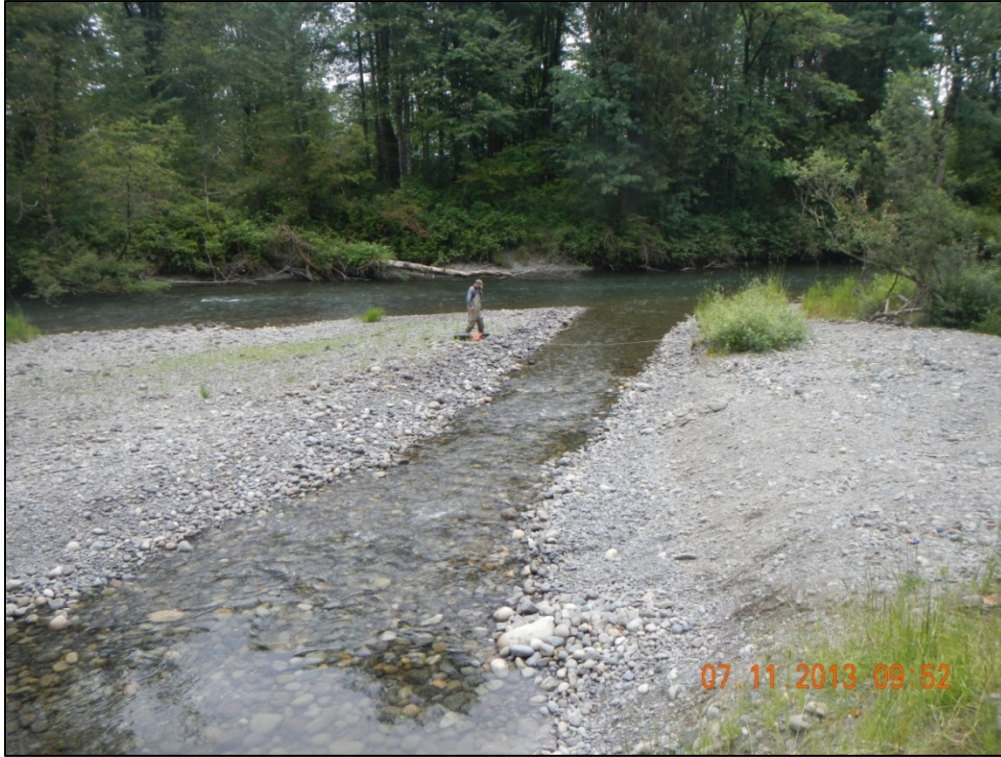
Figure 4-25. SC4 secondary channel / return route to river (picture taken from top of ELJ 1, mainstem discharge of 357 cfs).

Channel width in the secondary channel of SC4 ranged between 11 and 24 feet with a mean measured width of 14.6 feet (Table 4-9). Under low flow conditions, the average depth of measured cross sections ranged between 0.9 and 2.6 feet, with a mean of 1.4 feet (Table 4-9). The substrate conditions within this secondary channel were predominately larger sized substrates (cobble and rubble). LWD was absent as this channel traverses a gravel bar that is routinely subjected to active and dynamic sediment transport.

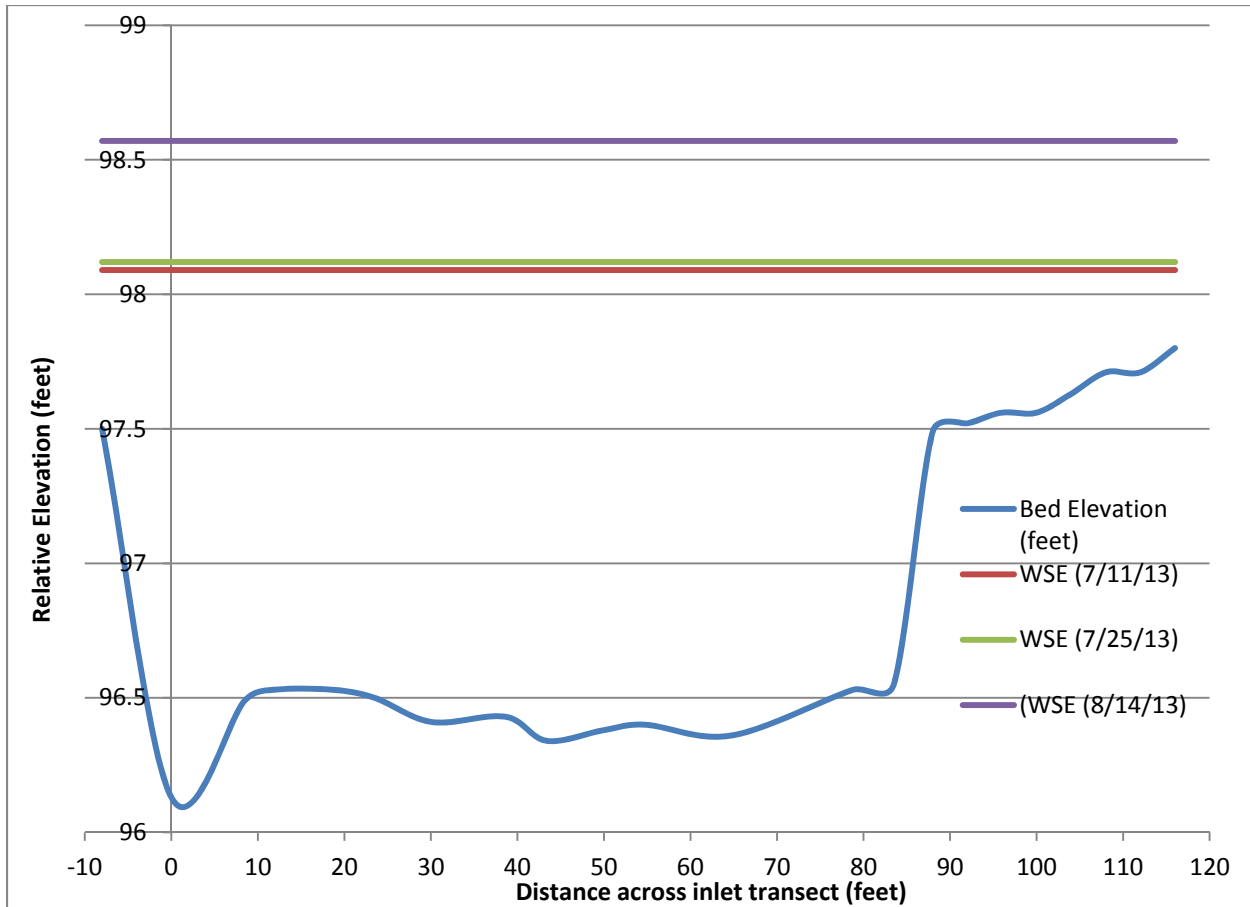
SC4 was surveyed on three occasions during summer 2013 (Figure 4-26). During these surveys, mainstem discharge, as measured at USGS Gaging Station No. 12138160, ranged between 338 and 657 cfs (Table 4-8). Total inflow to SC4 ranged between 61.3 and 130.7 cfs during the surveys. The portion of mainstem flow entering SC 4 averaged at approximately 20%. Measurements of total outflow were consistent with inflow. Distribution of outflow was variable between the primary and secondary outlet over the range of conditions due to backwatering by the presence of the ELJ. The presence of a significant amount of racking material at the ELJ enhances this backwatering effect and will likely lead to the continued evolution of this side channel. Human disturbance (damming) at the secondary outlet has also impacted flow routing, although temporary in nature.

Figure 4-26. Bed and water surface elevations, inlet to SC4, summer 2013.
