Henry M. Jackson Hydroelectric Project (FERC No. 2157)

Relicensing Study Plan No. 24

Feasibility of Marsh Creek Slide Modification to Improve Fish Passage

March 2009

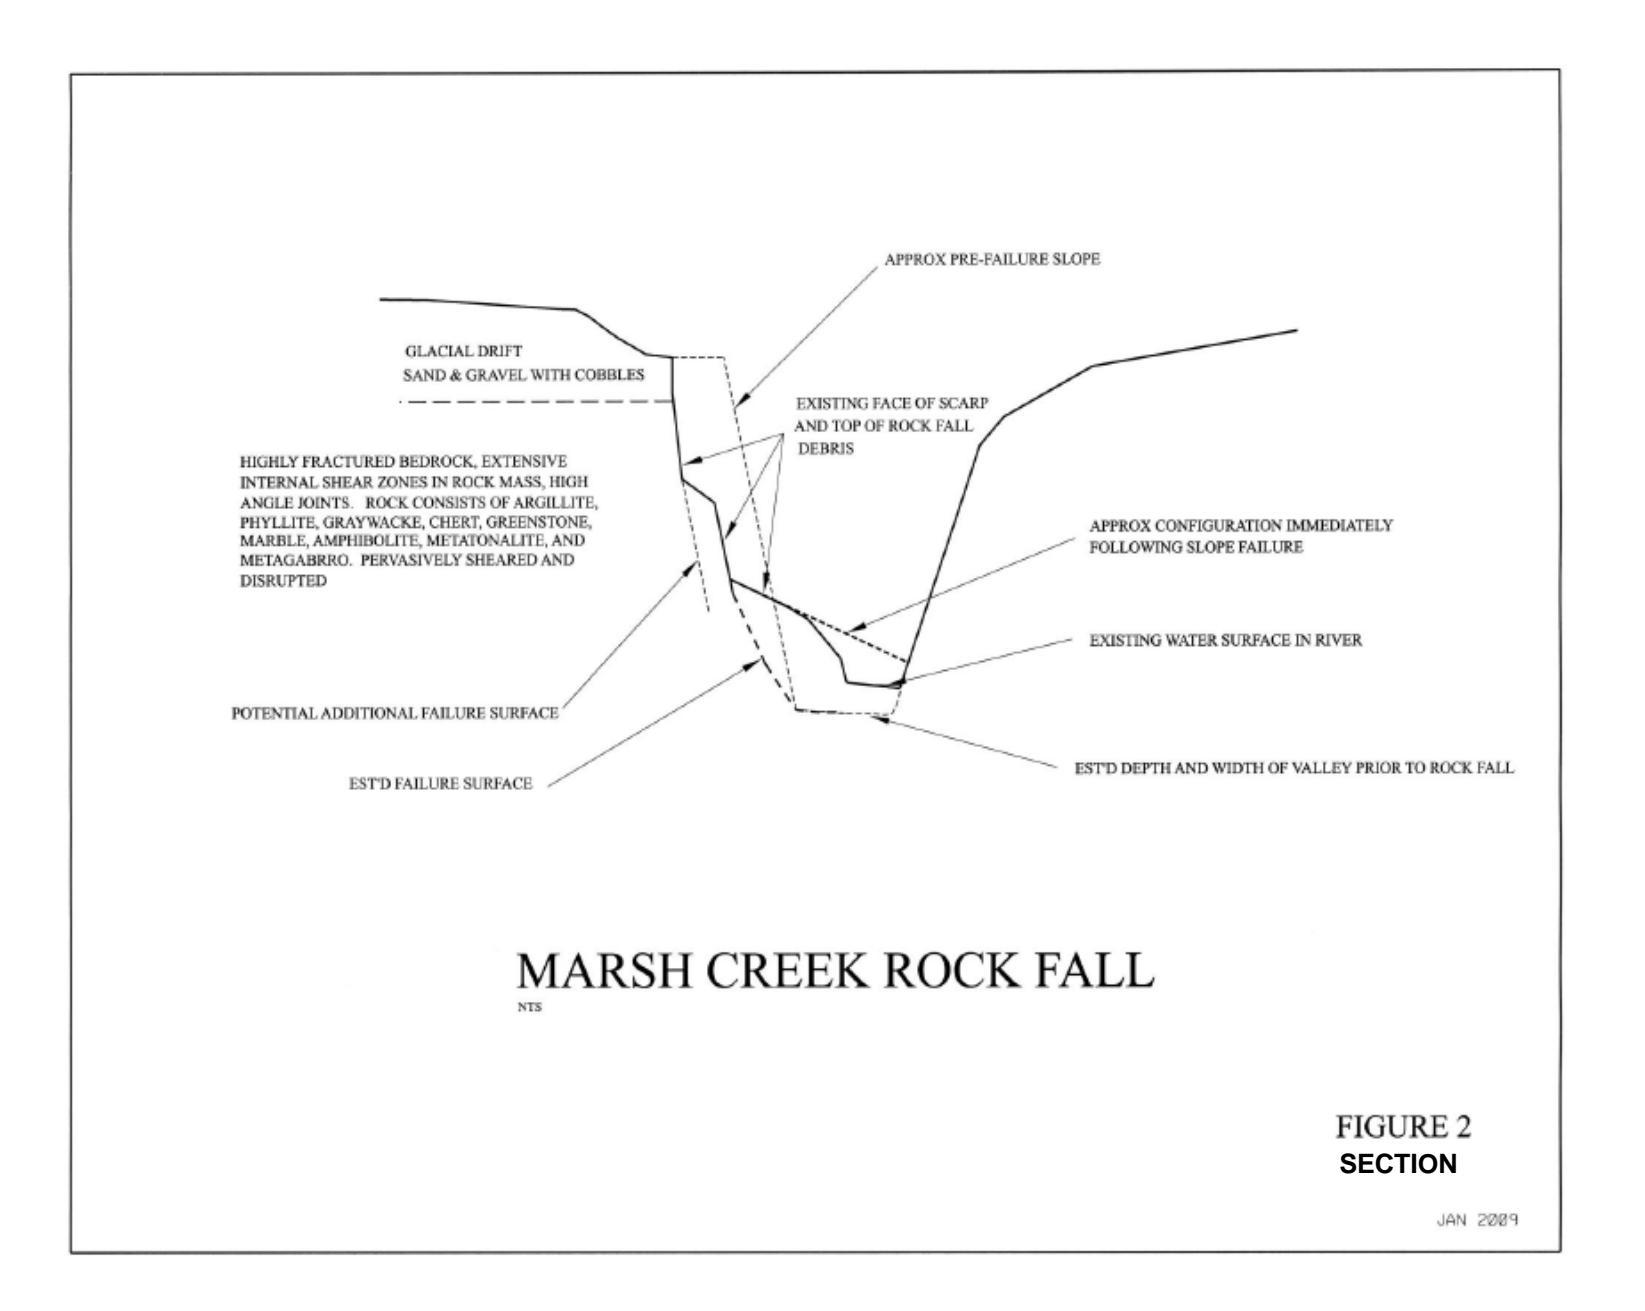
Figure 2 illustrates the approximate geometry of the slide area. The north rim of the canyon is at an elevation of approximately 600 ft and the river immediately downstream of the slide debris is at elevation 435 ft. The debris pile at the base of the rock fall rests against the rock hillside at a height of about 35 to 40 feet above the river.

Also shown in Figure 2 is the approximated configuration of the slope and river valley prior to the rock fall. It also shows the estimated current configuration and potential rock masses that may become unstable with additional unloading of the debris from the toe of the slide area. The figure also shows about where the slope debris was configured immediately after the slide. A portion of the lower slope has subsequently eroded away approximately as shown. This is further illustrated by Photo 4.

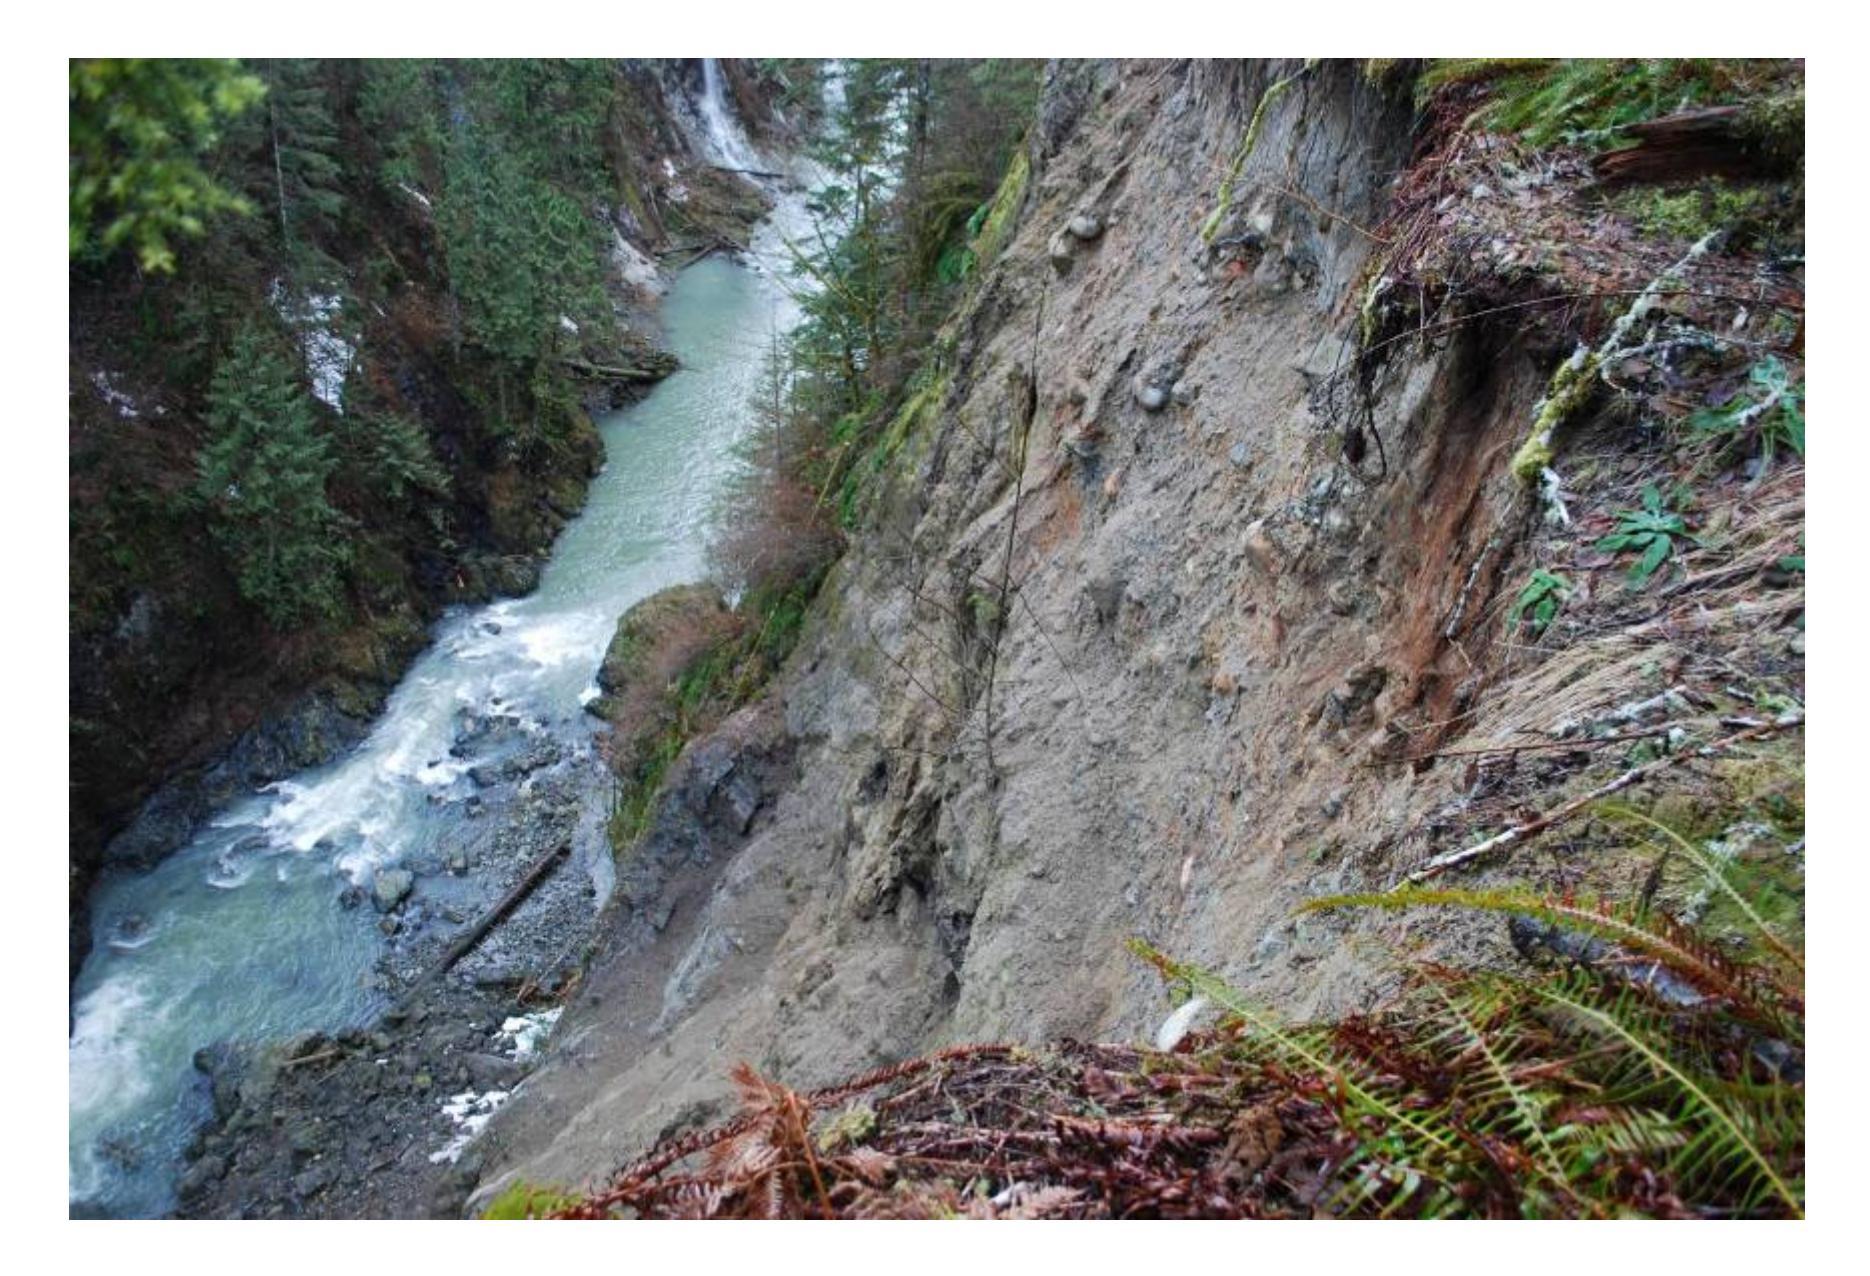
During the December 2004 rockslide, the upper portion of the scarp sheared at a near vertical slope, and the scarp appears to be at about the same configuration currently. Photos 1 and 2 show a top looking down and a bottom looking up perspective of the scarp. The downstream portion of the upper scarp appears to have been influenced by a near vertical shear zone that is more planar in surface shape than in other portions of the scarp. The shear planes appear to have been controlled by pre-existing fractures and jointing, and/or foliation in the rock. The upstream two thirds or more of the upper slide scarp is characterized by a very irregular shaped but near vertical fracture surface. The jointing/fracture system or foliated plane of weakness, which may have controlled the stability of the downstream portion of the upper slope, may also extend under a large

PHOTO 1. SOIL AND ROCK MATERIALS EXPOSED IN TOP OF ROCK FALL SCAR

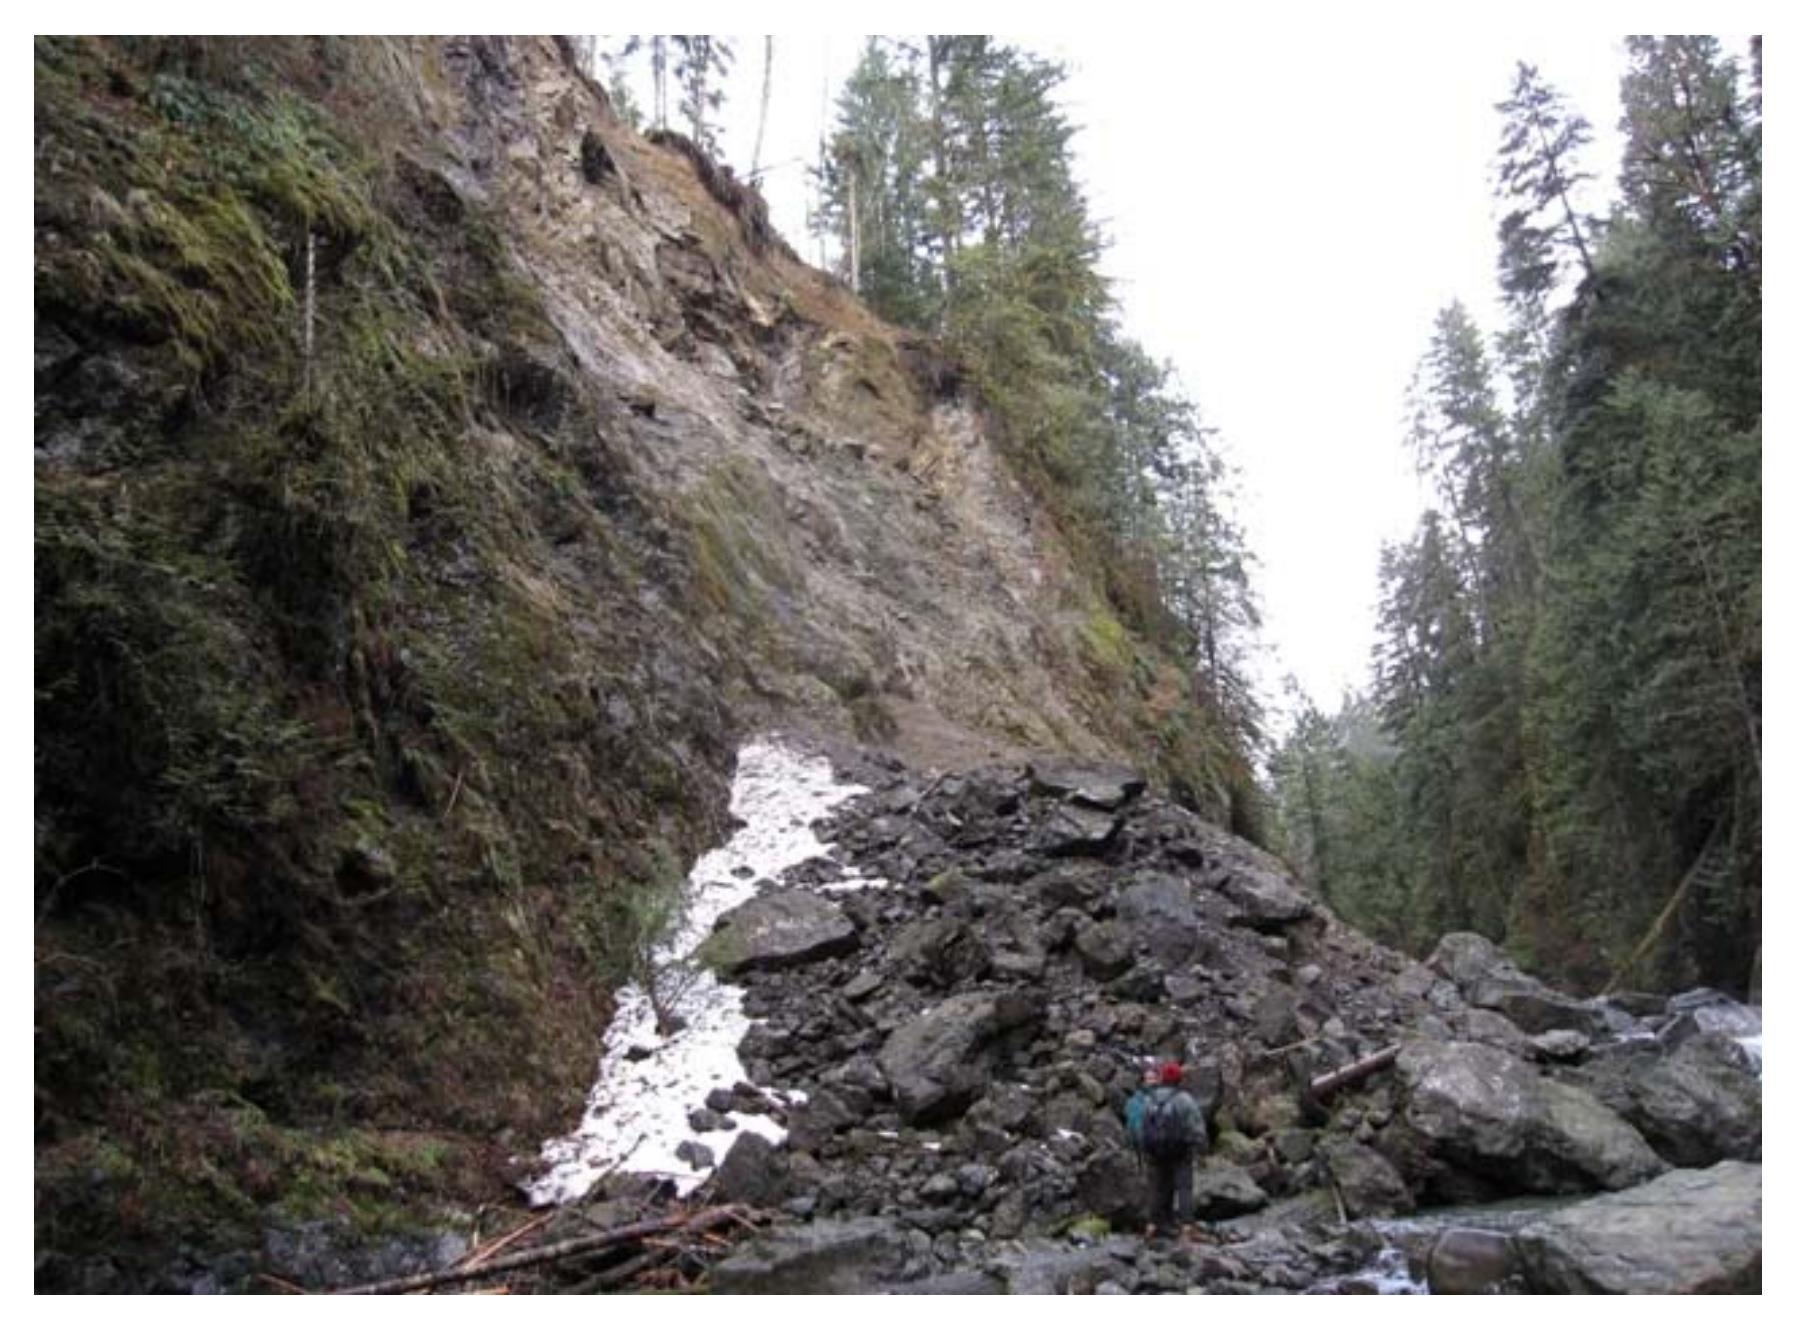
PHOTO 2. ROCK FALL SCARP AND DEBRIS FAN

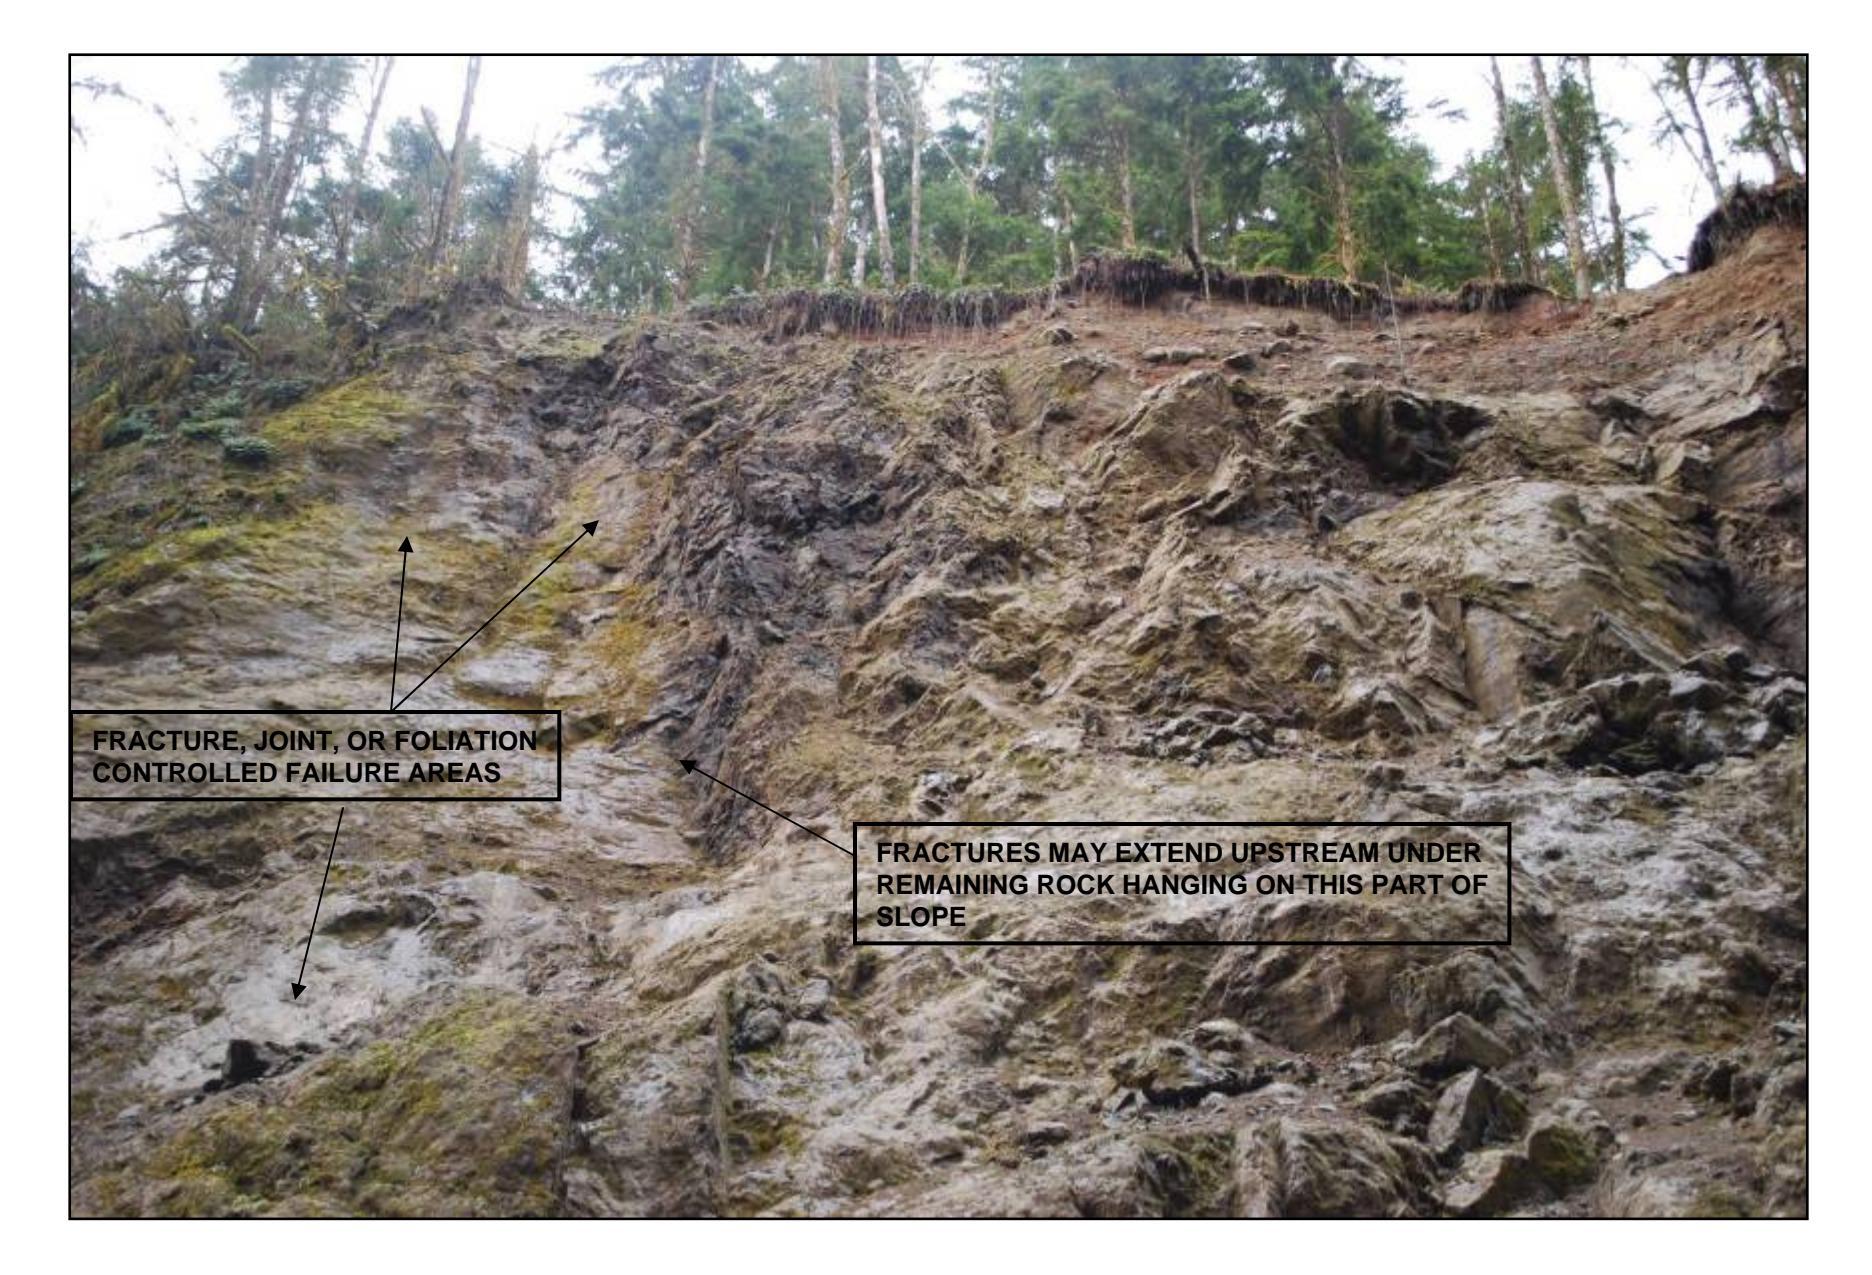
portion of the rock mass still hanging on the steep upstream portion of the slope. Photo 3 illustrates these conditions.

PHOTO 3. ROCK FALL SCARP

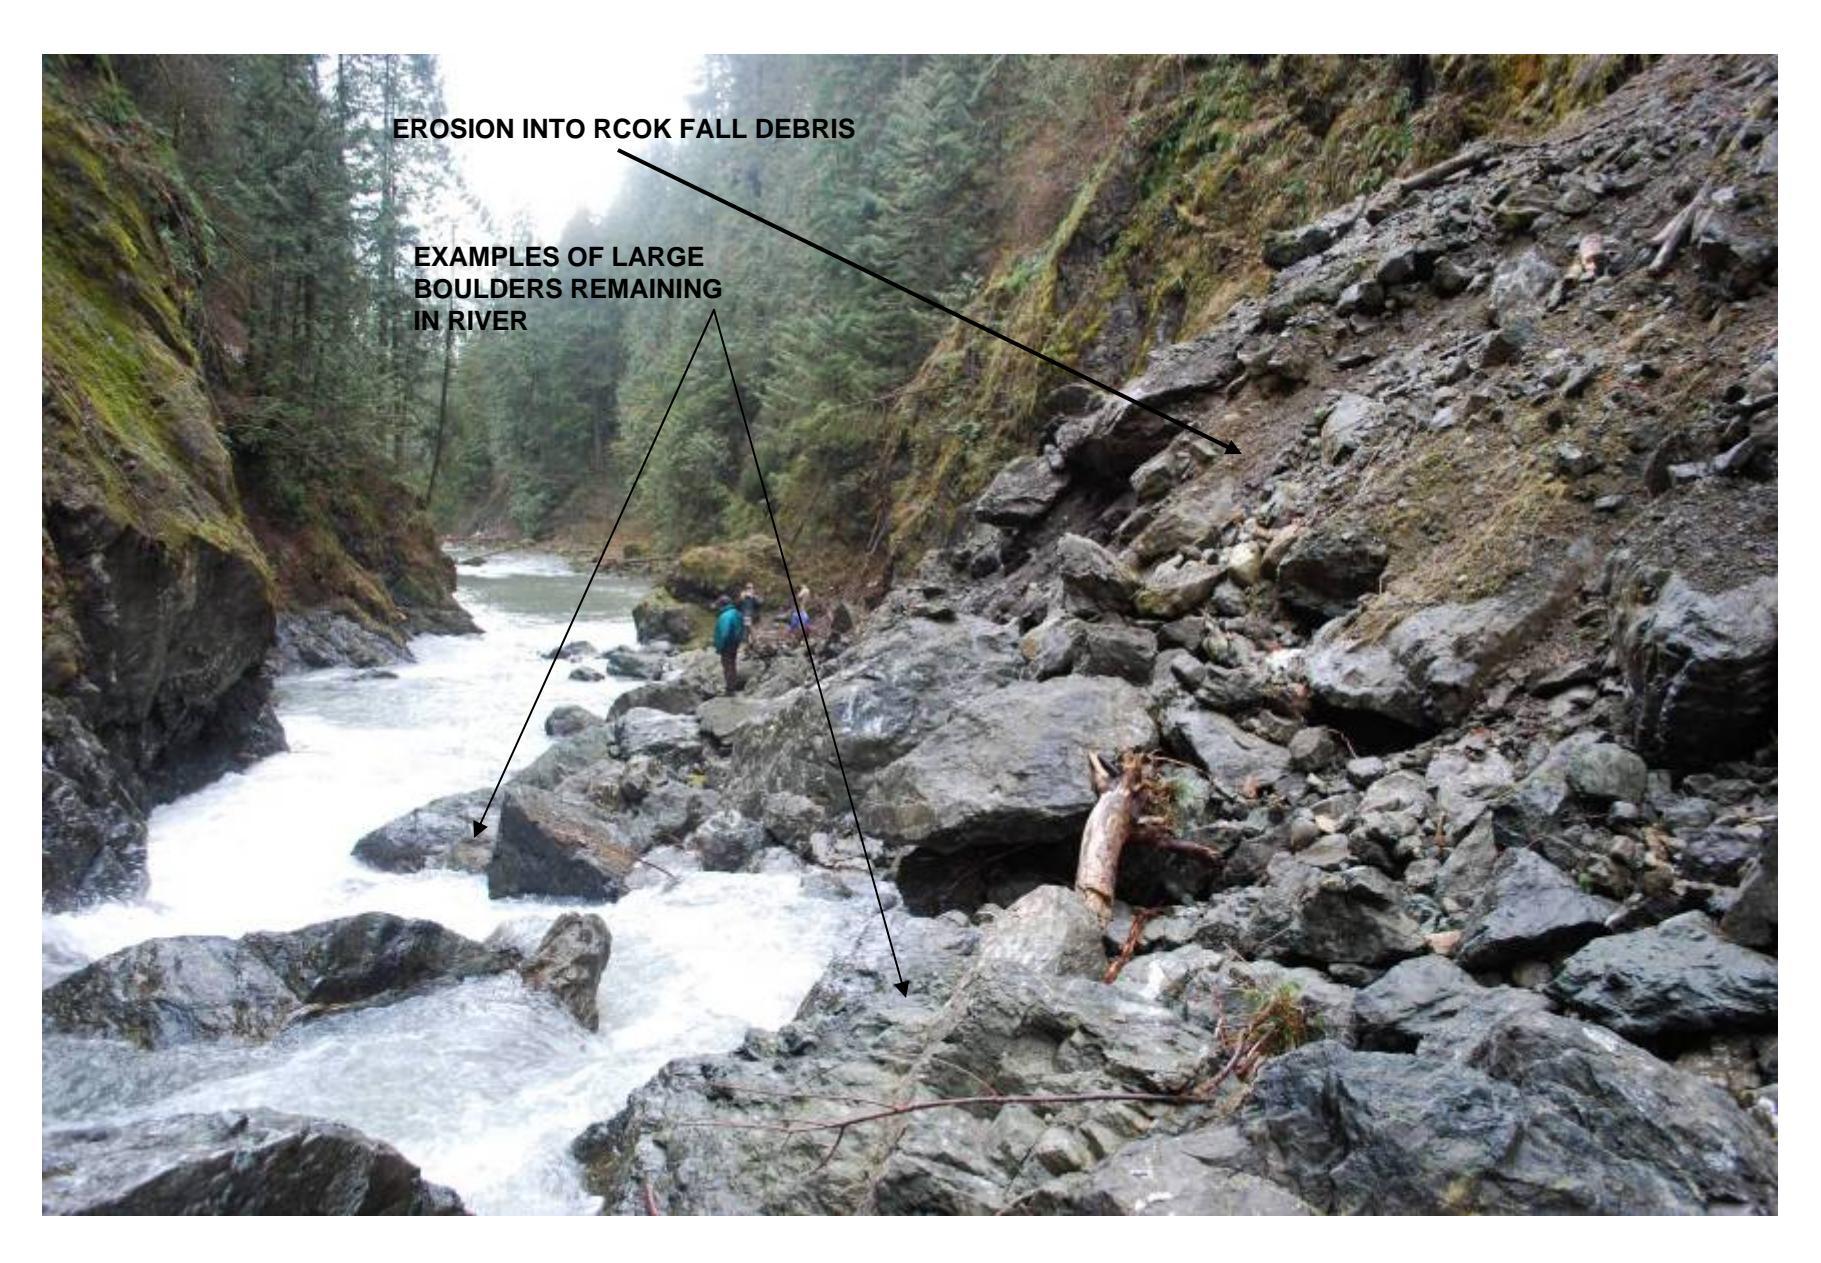
PHOTO 4. LOOKING DOWNSTREAM THROUGH CASCADE

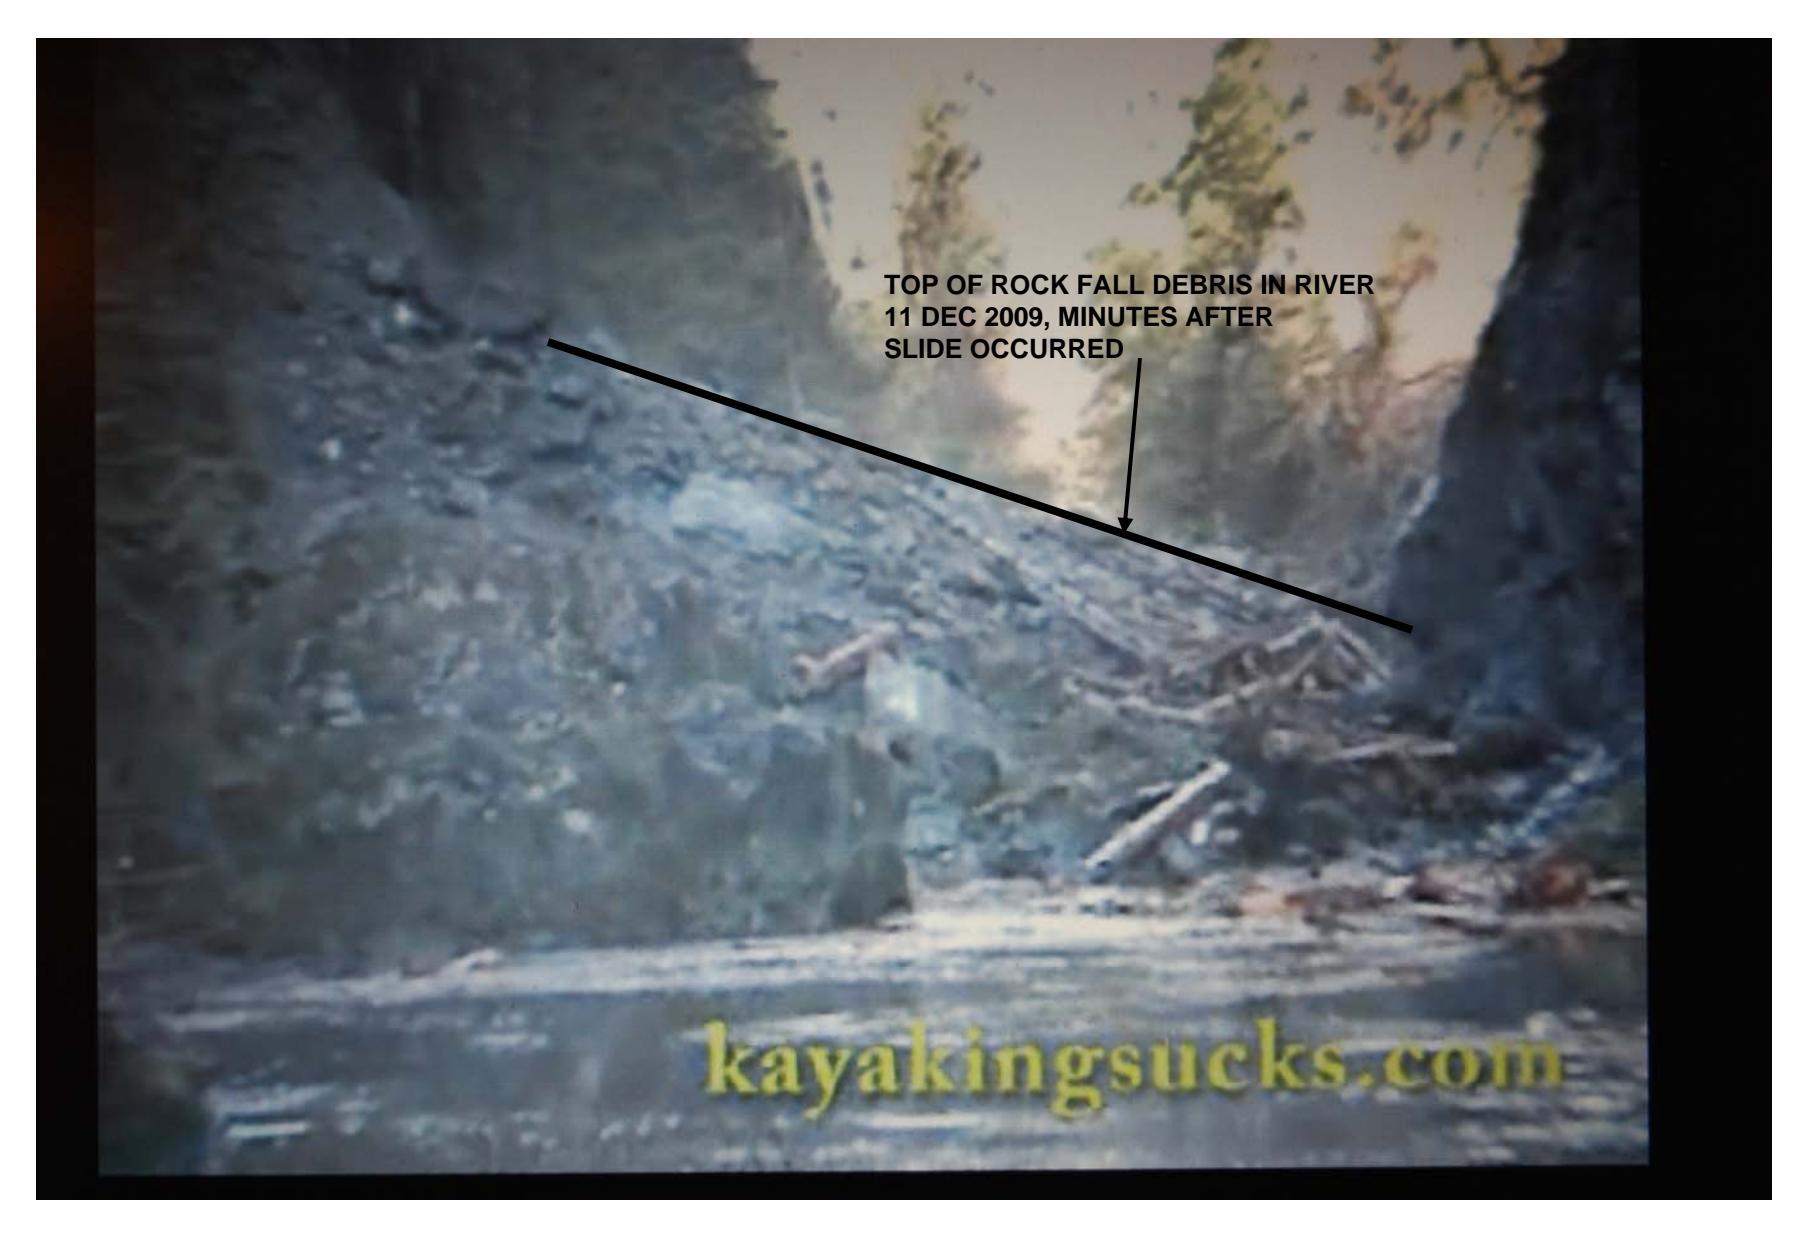
Photo 5 is an image taken from the landslide movie (kayakingsucks.com) that was captured a few minutes after the rockfall occurred. The photo shows the rock and debris pile as it came to rest against the rock hillside on the south side of the river. The river had not yet begun to flow over the debris pile. The slope of the debris pile is evident. A large boulder can be observed on the upper left side of the photo that also shows up in the recent Photo 6. A line has been added to this photo illustrating about where the original debris pile came to rest. This illustrates how much of the debris has eroded away naturally since December 11, 2004. The initial erosion removed much of the "finer" debris leaving the larger rocks that have become wedged and anchored in place.

PHOTO 5. ROCK FALL SHORTLY AFTER THE SLIDE OCCURRED

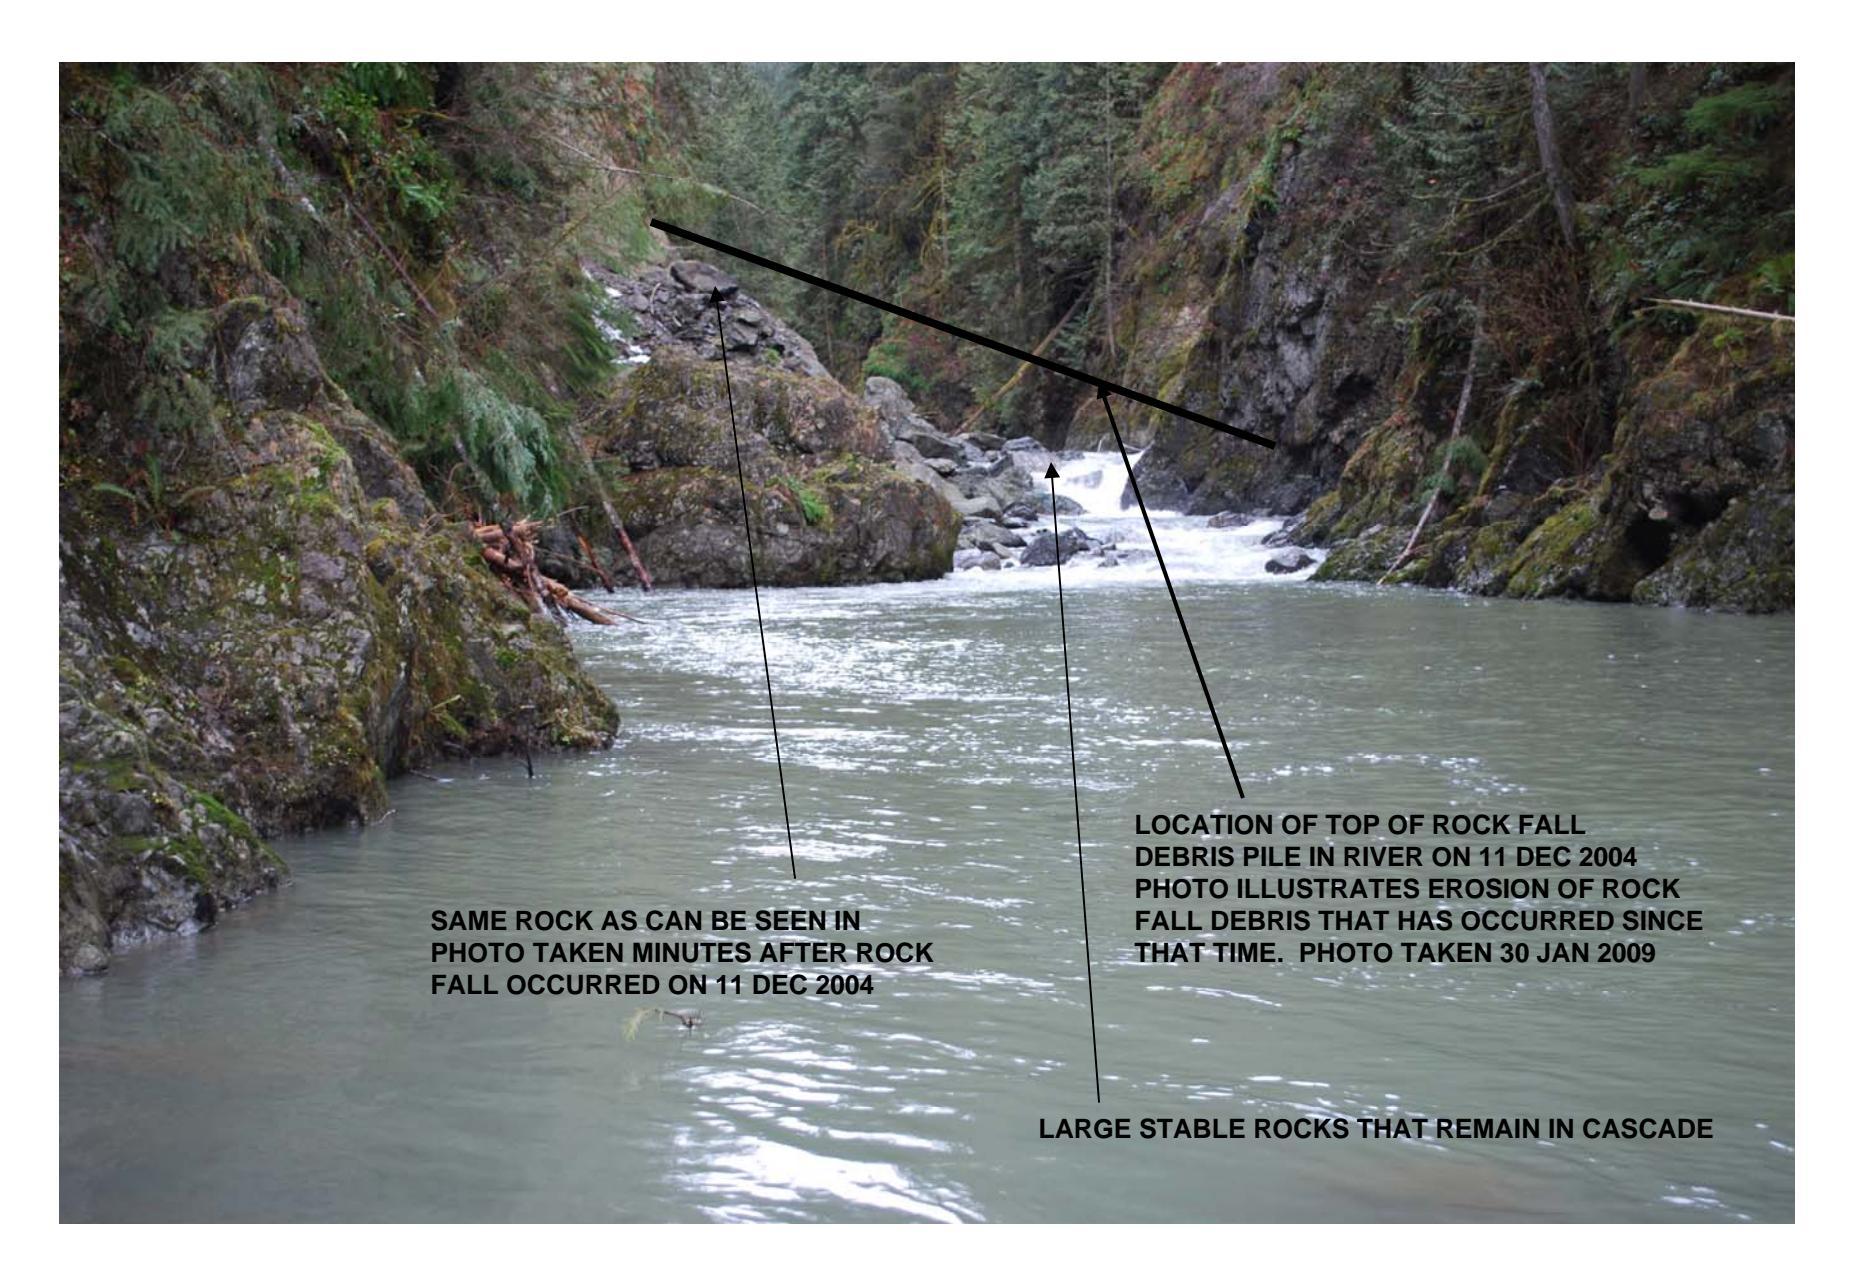
PHOTO 6. ROCK FALL DEBRIS AREA LOOKING UPSTREAM

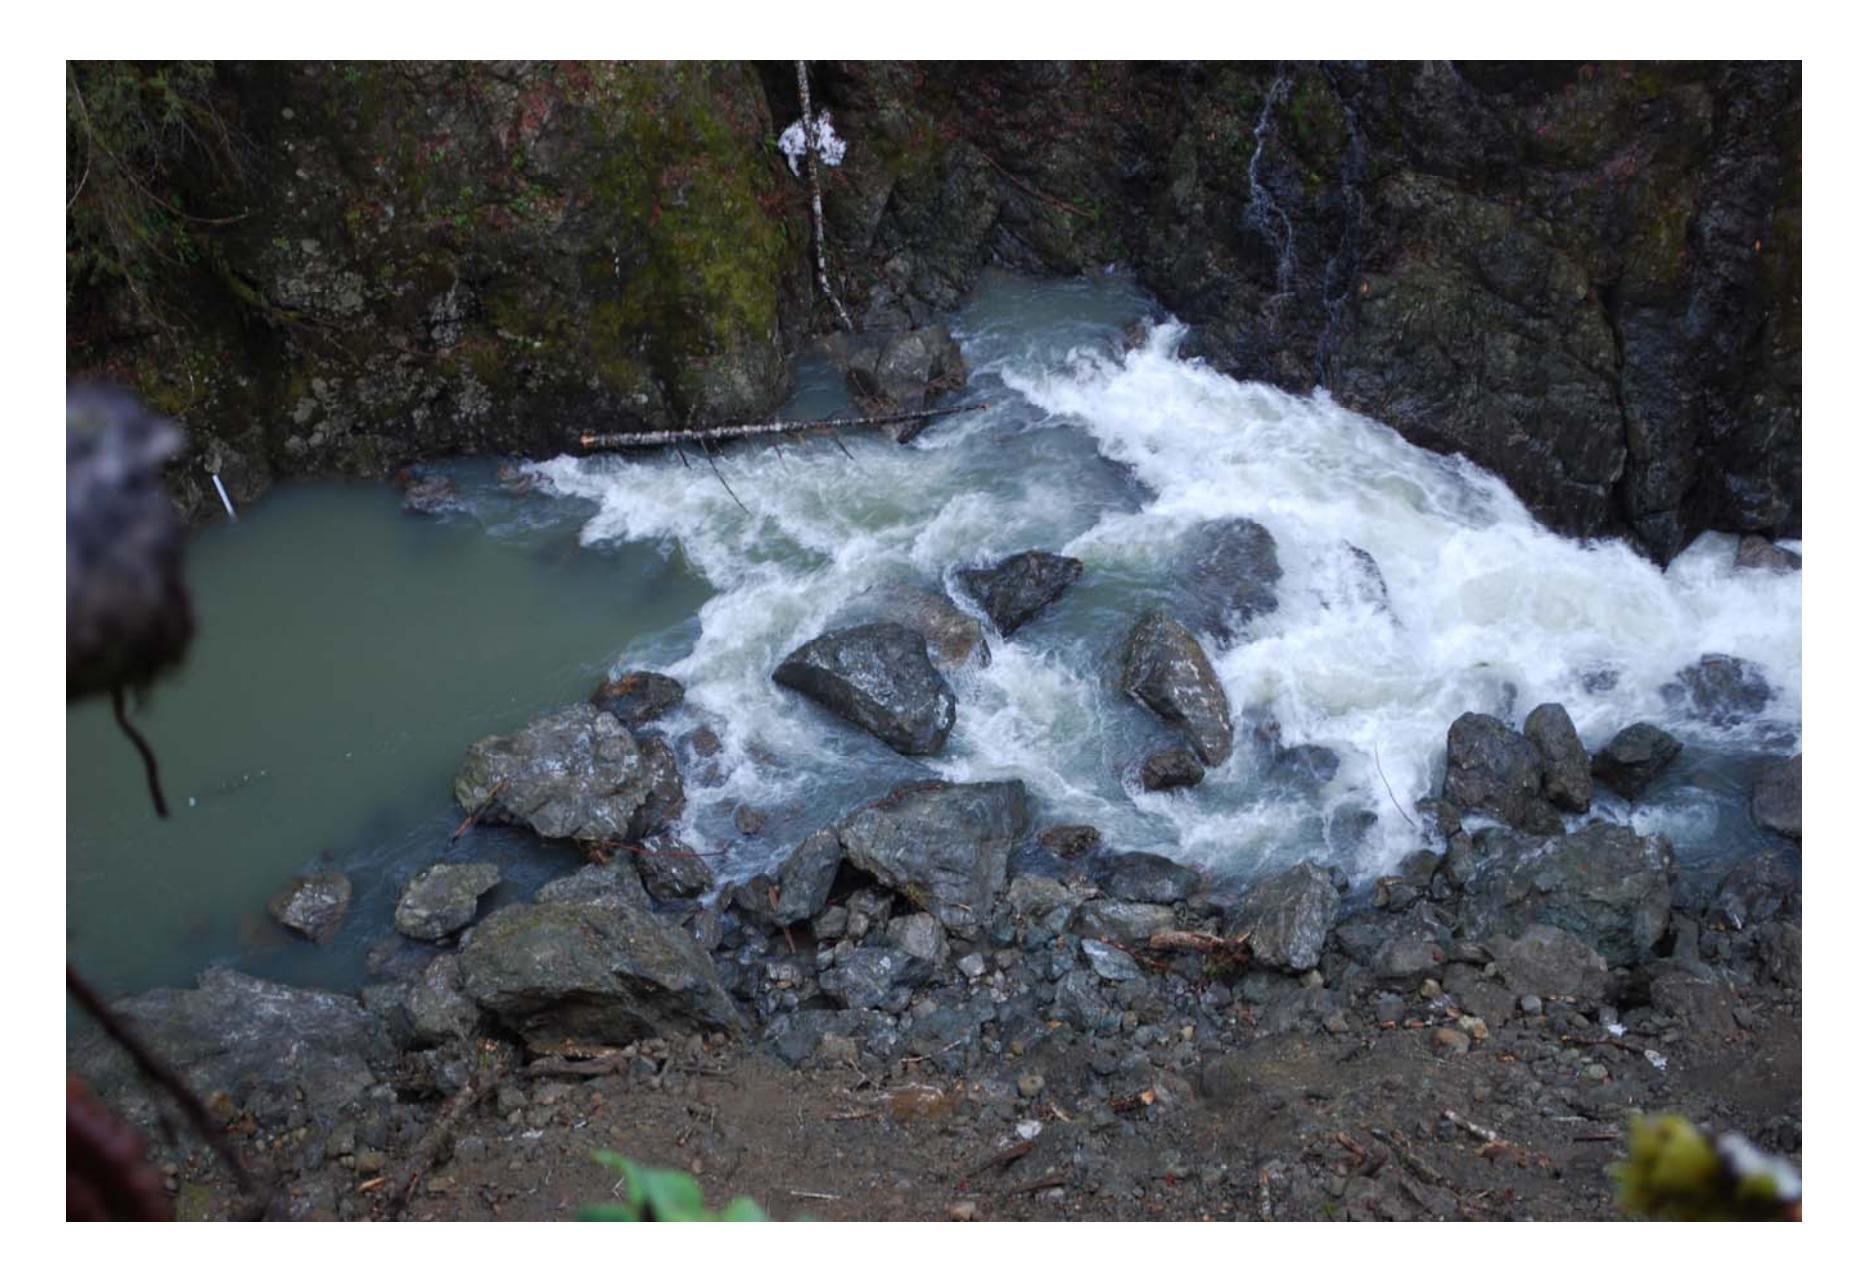
Photos 7 to 9 show the large boulders that remain in the new channel. The rocks commonly range in size from 3 to 25 feet or more. The erosion has resulted in an oversteepened slopes adjacent to the west side of the river with many large boulders "hanging"in the debris pile, ready to fall into the river with additional erosion or down cutting by the river.

PHOTO 7. TELEPHOTO VIEW OF UPSTREAM AREA OF CASCADE

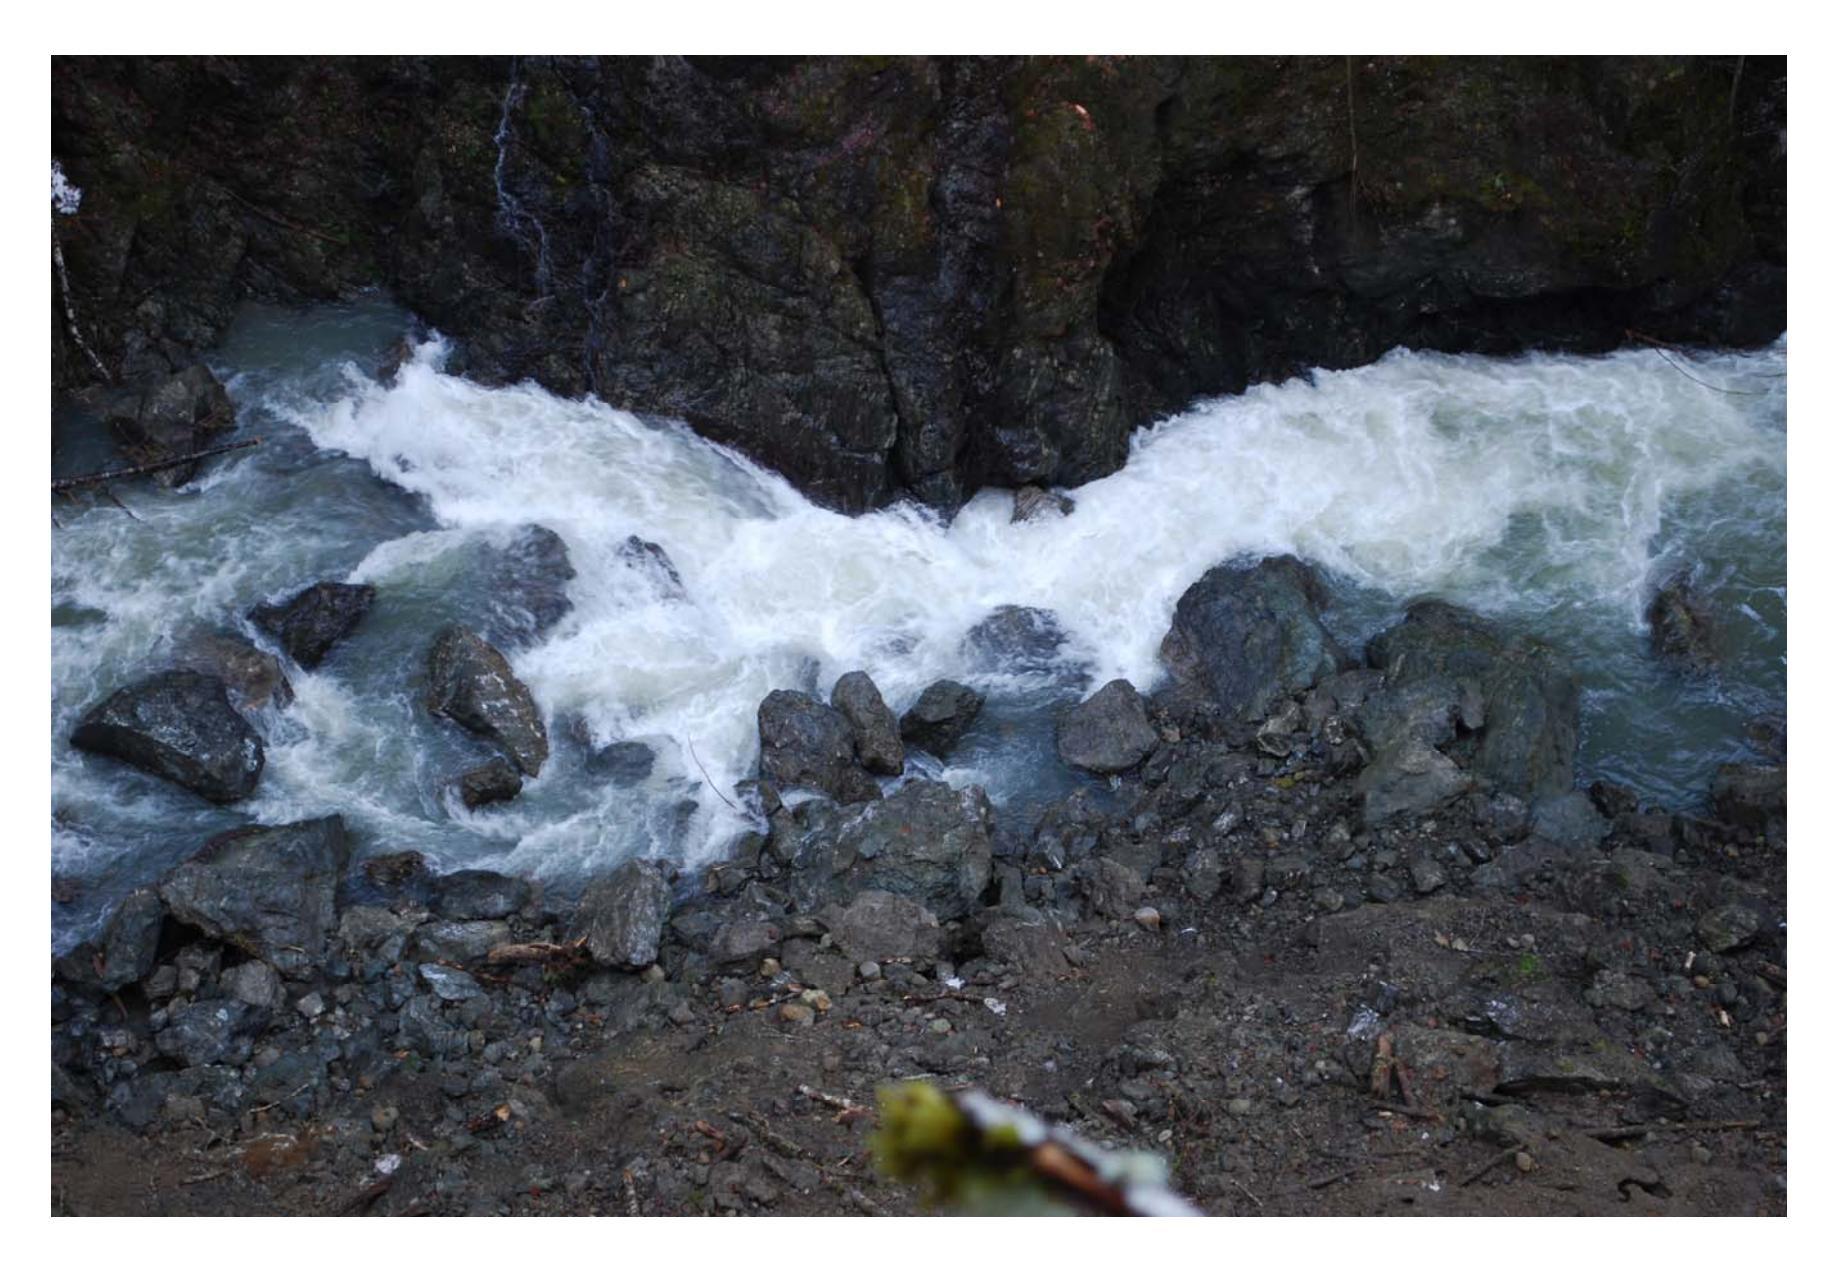
PHOTO 8. TELEPHOTO VIEW OF MIDDLE AREA OF CASCADE
