Henry M. Jackson Hydroelectric Project (FERC No. 2157)

Relicensing Study Plan No. 24

Feasibility of Marsh Creek Slide Modification to Improve Fish Passage

March 2009

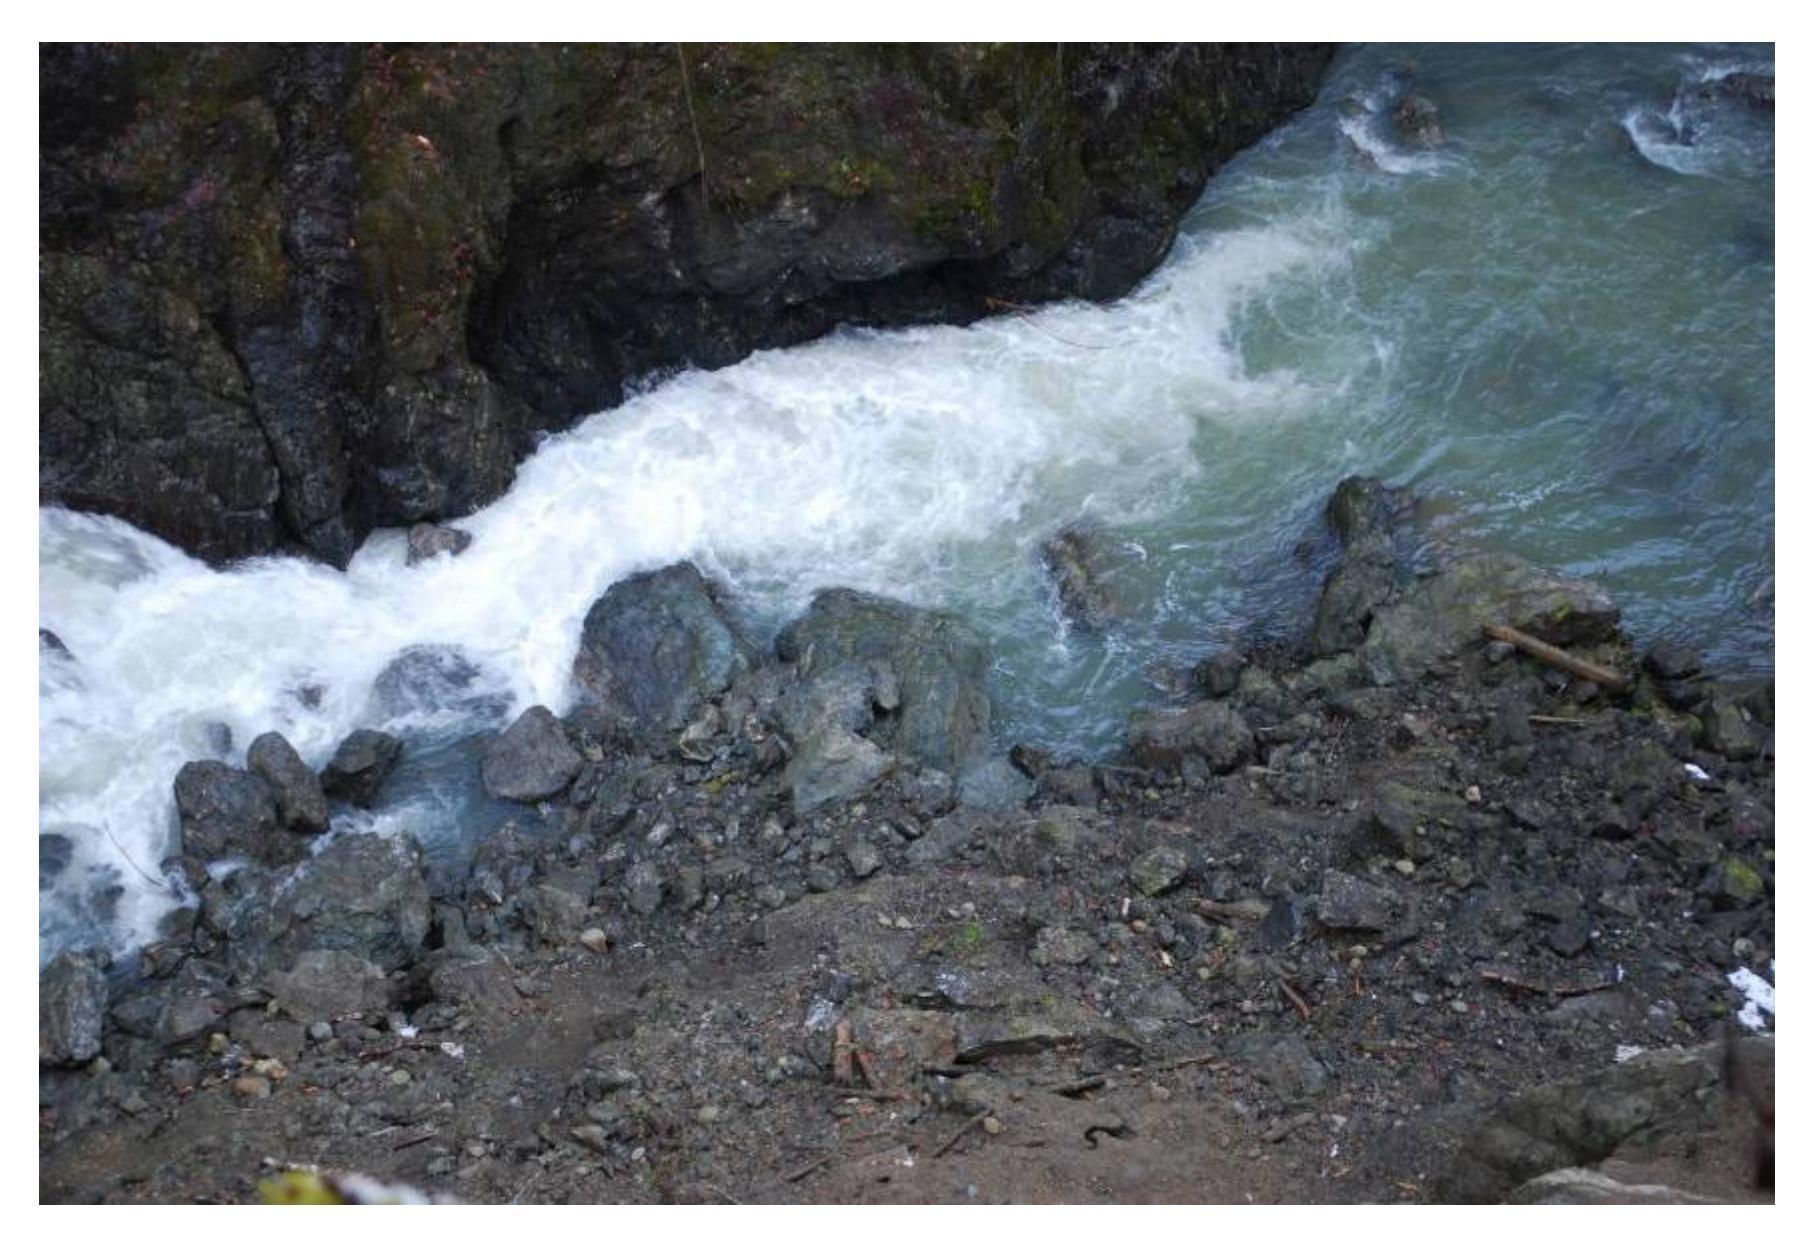
Photos 7 to 9 show the large boulders that remain in the new channel. The rocks commonly range in size from 3 to 25 feet or more. The erosion has resulted in an oversteepened slopes adjacent to the west side of the river with many large boulders "hanging"in the debris pile, ready to fall into the river with additional erosion or down cutting by the river.

PHOTO 9. TELEPHOTO VIEW OF DOWNSTREAM AREA OF CASCADE

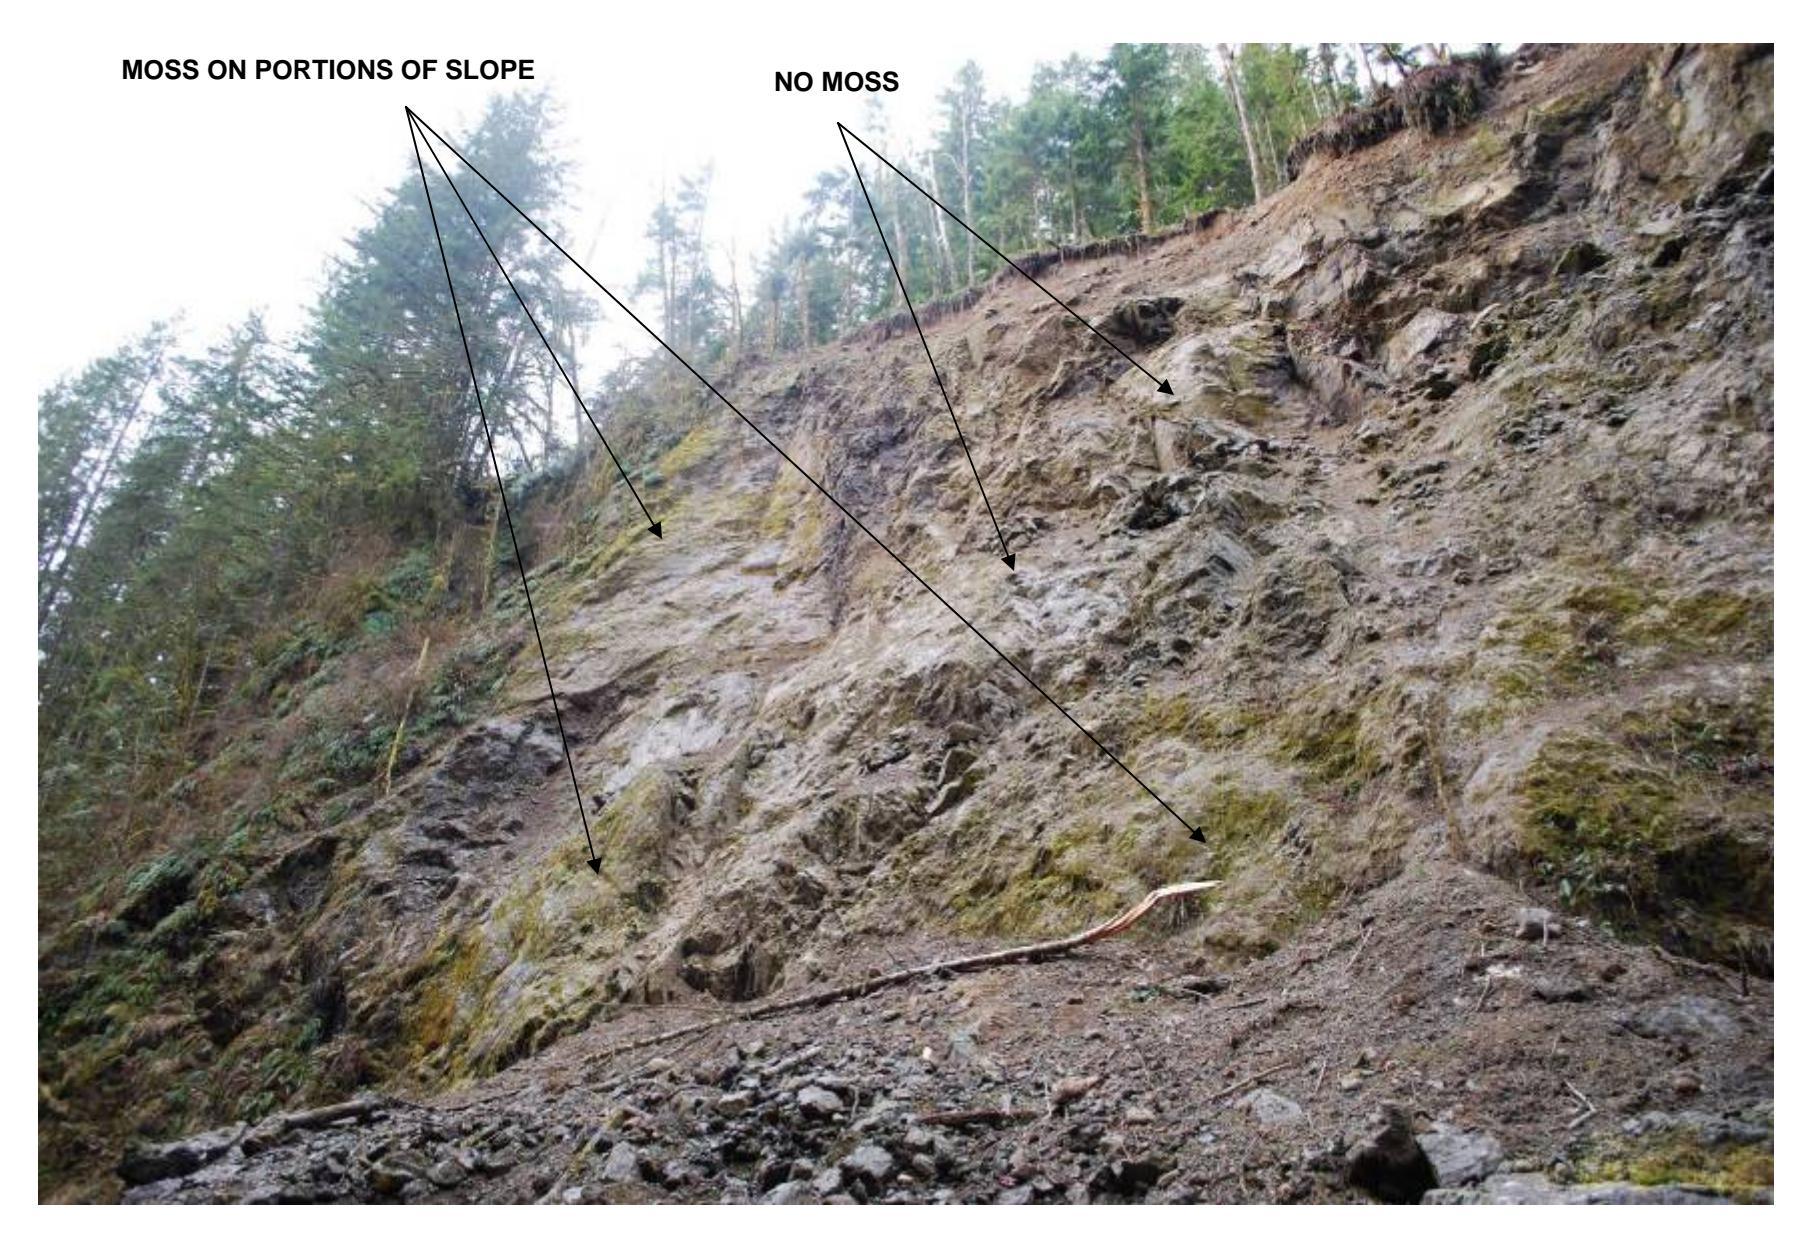
Photos 10 and 11 reveal that rock falls have continued to occur in some portions of the slide area since 2004. Although the entire slide scarp is characterized by a relatively fresh rock surface, a thin mantle of moss covers portions of the slopes. Because moss and small vegetation establishes within a year, the large areas of the scarp observed without moss indicate that substantial rock falls have continued since the original hillside failure in 2004.

PHOTO 10. SLIDE SCARP SHOWING STILL-ACTIVE ROCK FALL AREAS

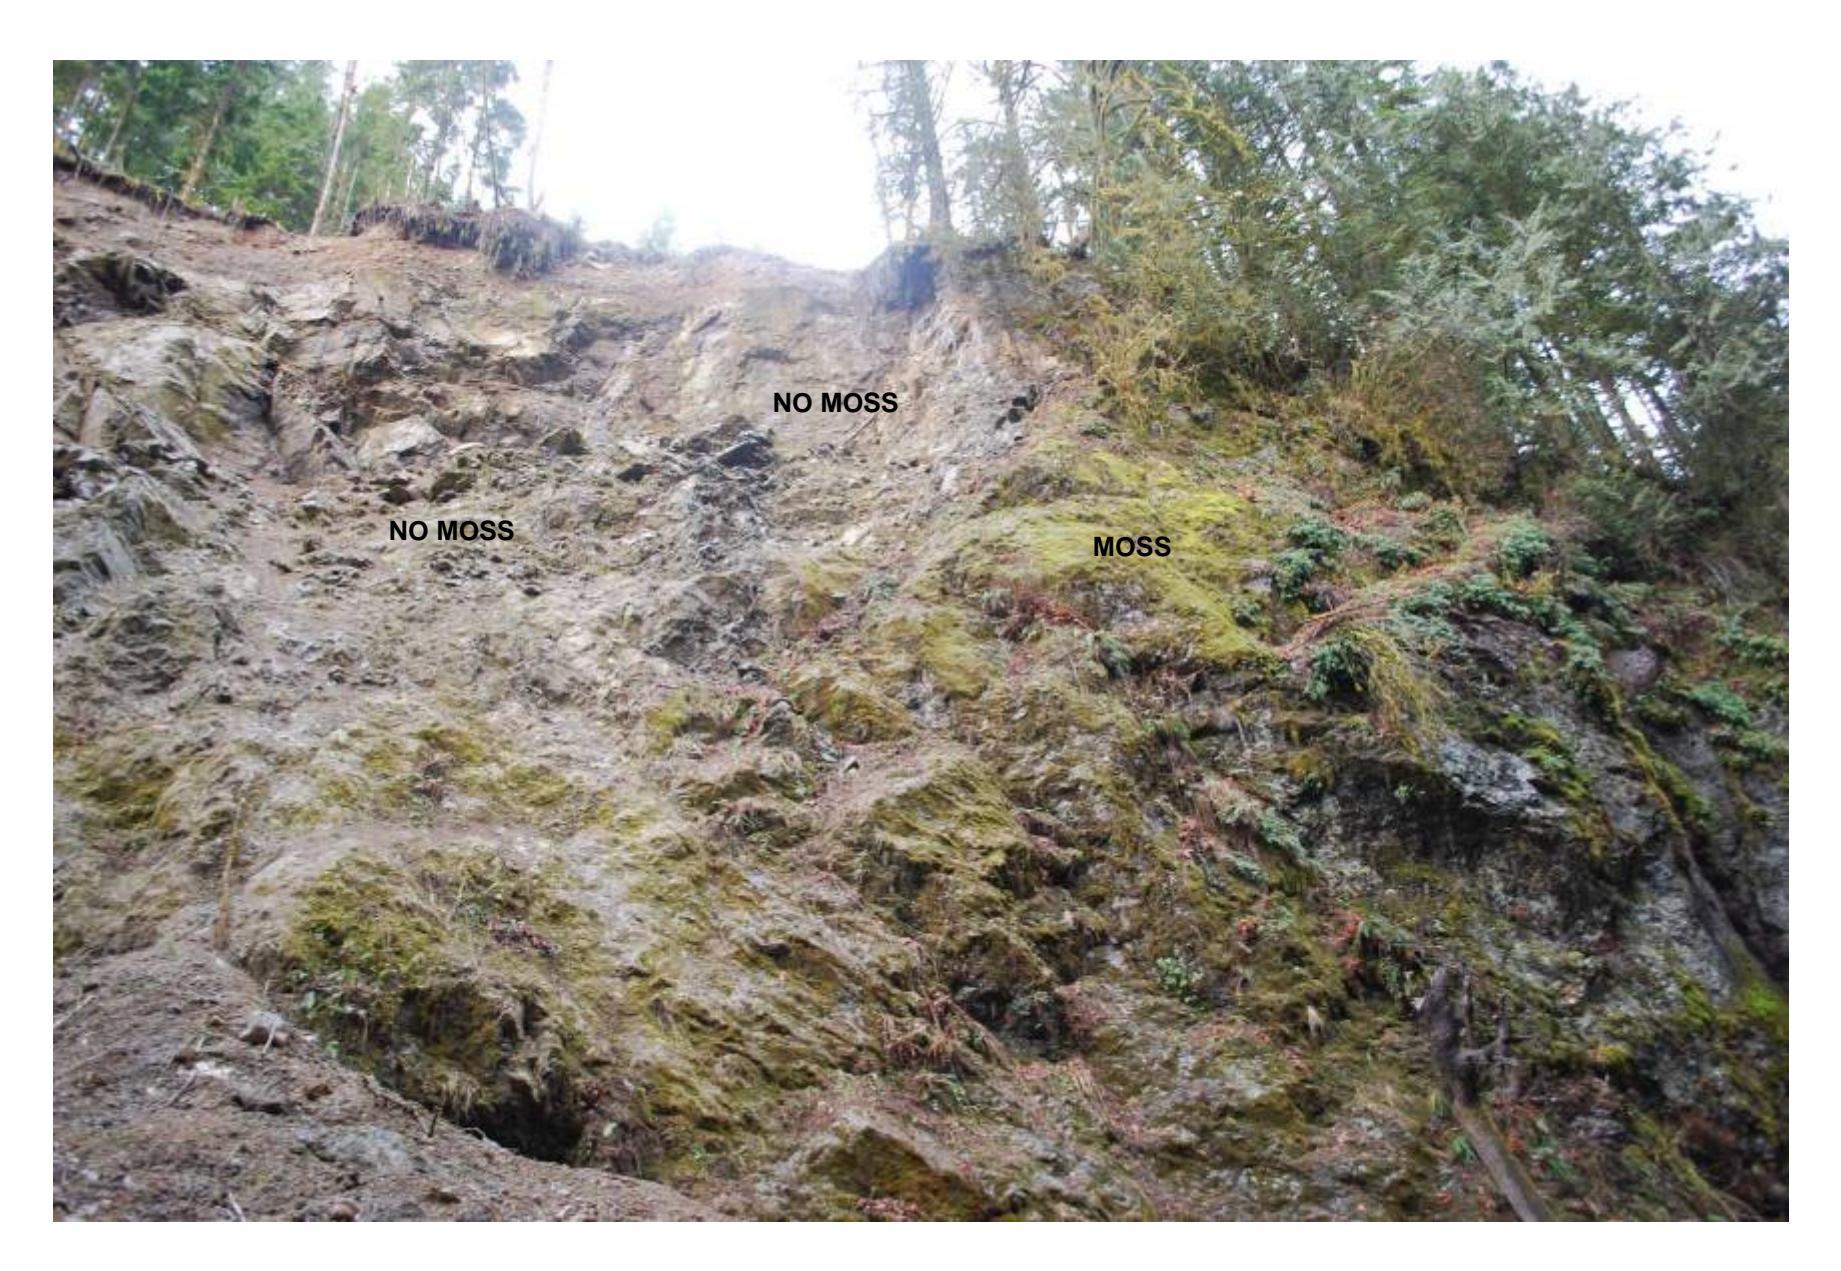
PHOTO 11. NOTE AREAS OF MOSS AND AREAS OF NO MOSS AREAS WITH LITTLE OR NO MOSS MAY REPRESENT AREAS THAT HAVE EXPERIENCED RECENT ROCK FALLS

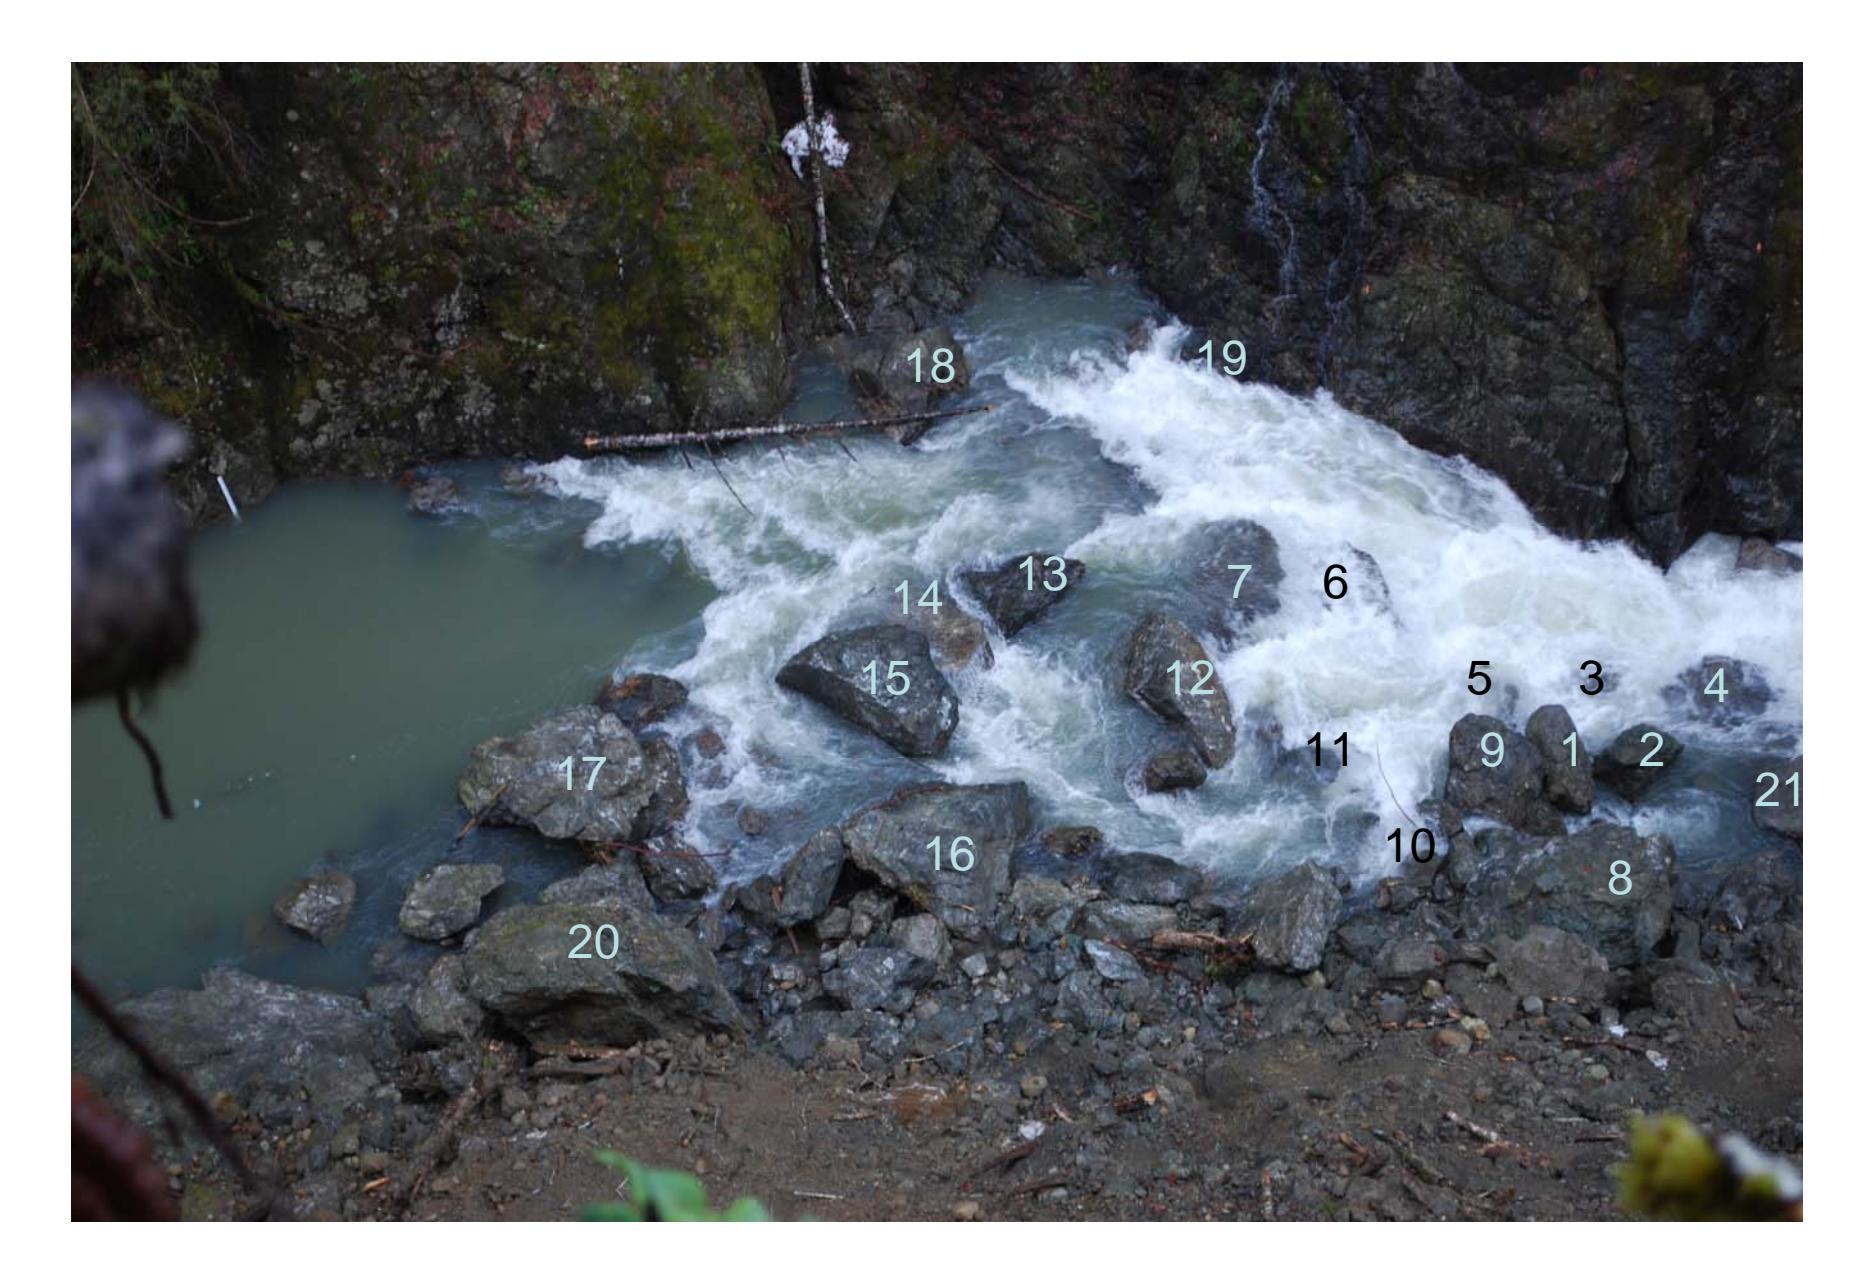
Rock sizes and numbers. All of the boulder removal options would require the reduction in size of most rocks prior to their moving or removal. Photos 12 and 13 show some of the more prominent boulders in the cascade reach. Each boulder is numbered and approximate dimensions were determined by measuring the size of the rocks in the field. The rock numbers and dimensions are shown in Table 1. This information was used to estimate the number of rocks that would result if the large boulders were to be broken into small pieces having the maximum rock sizes shown. The table illustrates that for the 22 surficial boulders selected for measuring, reduction in size would result in a range of 160 to 1120 boulders for the respective 14,000 and 2,000 maximum lifting weights.

PHOTO 12. NUMBERED ROCKS IN UPPER CASCADE CORRESPONDING TO TABLE 1

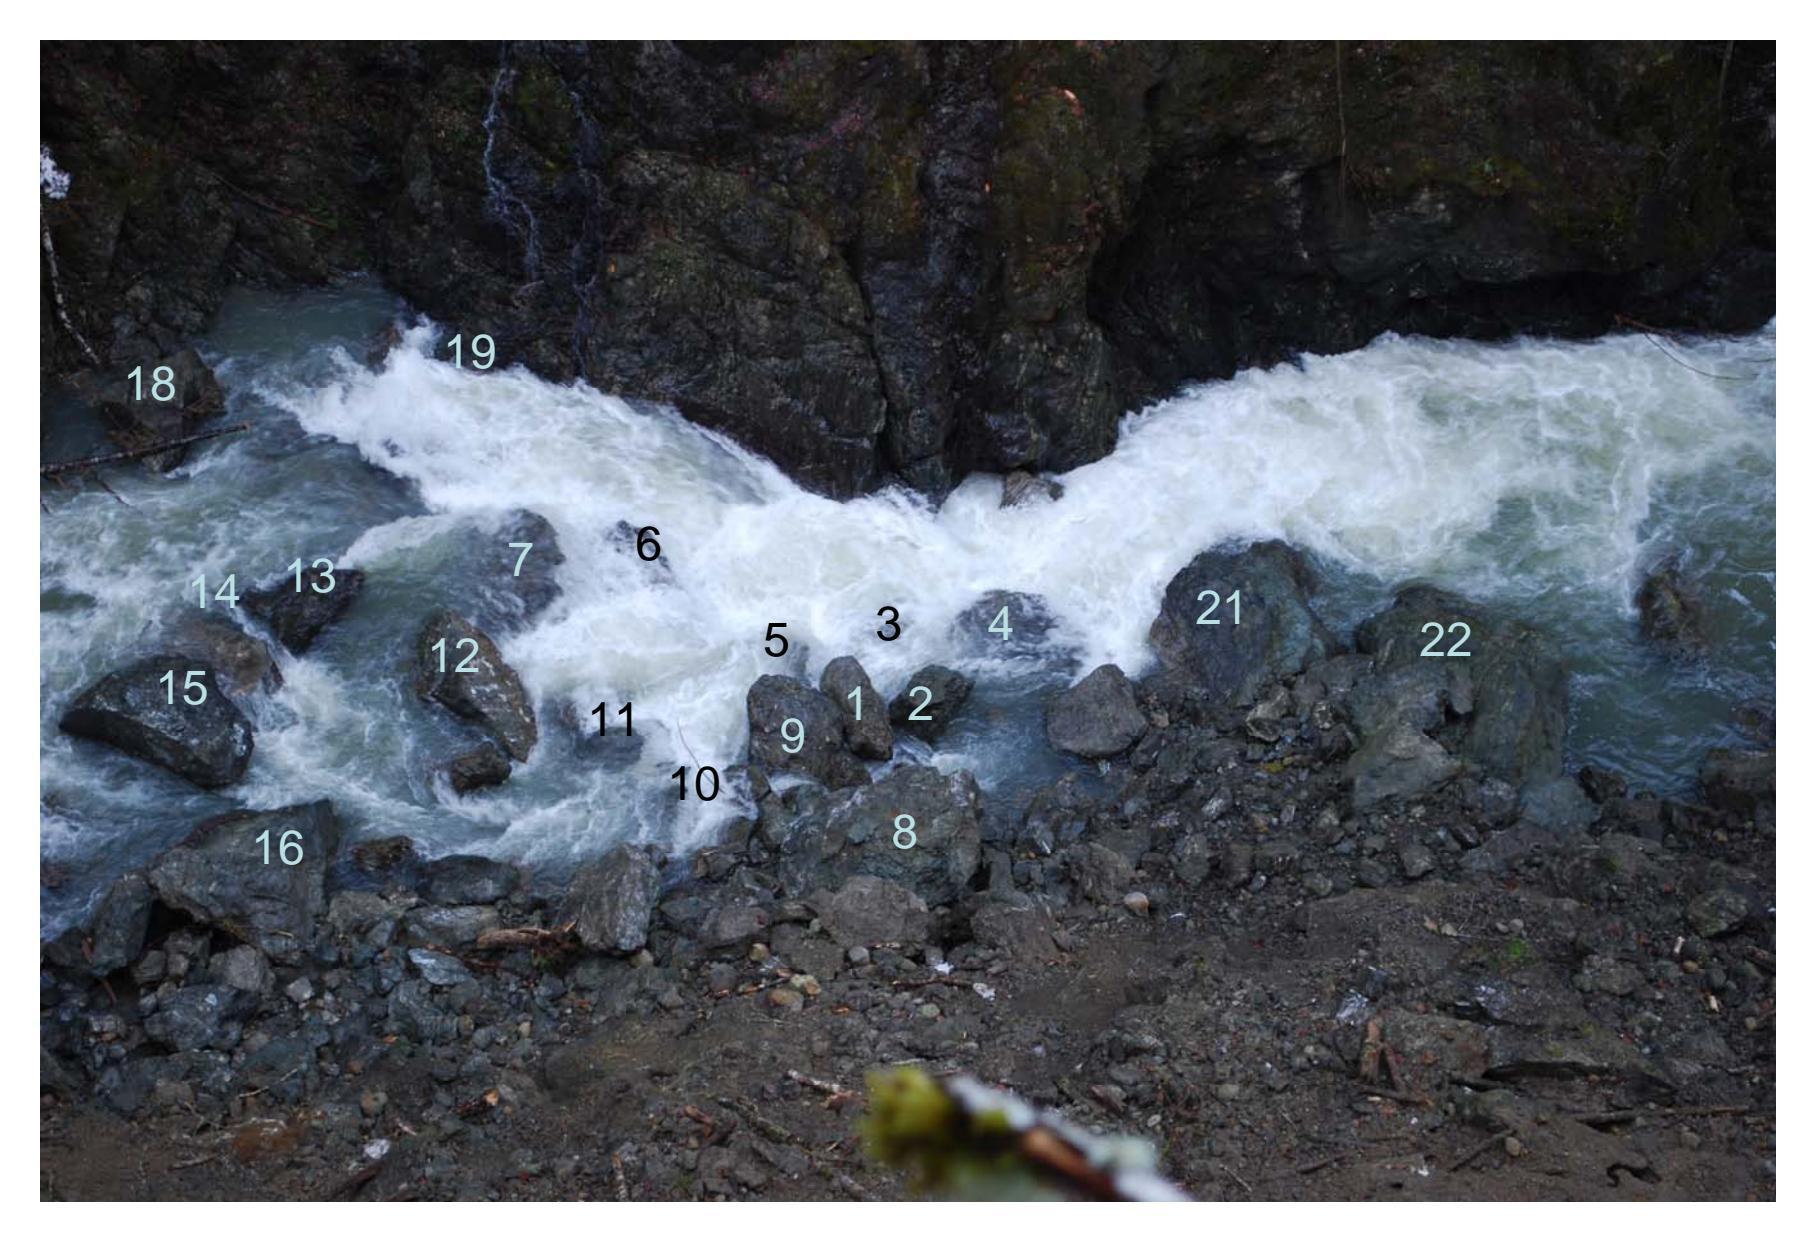
PHOTO 13. NUMBERED ROCKS IN LOWER CASCADE CORRESPONDING TO TABLE 1

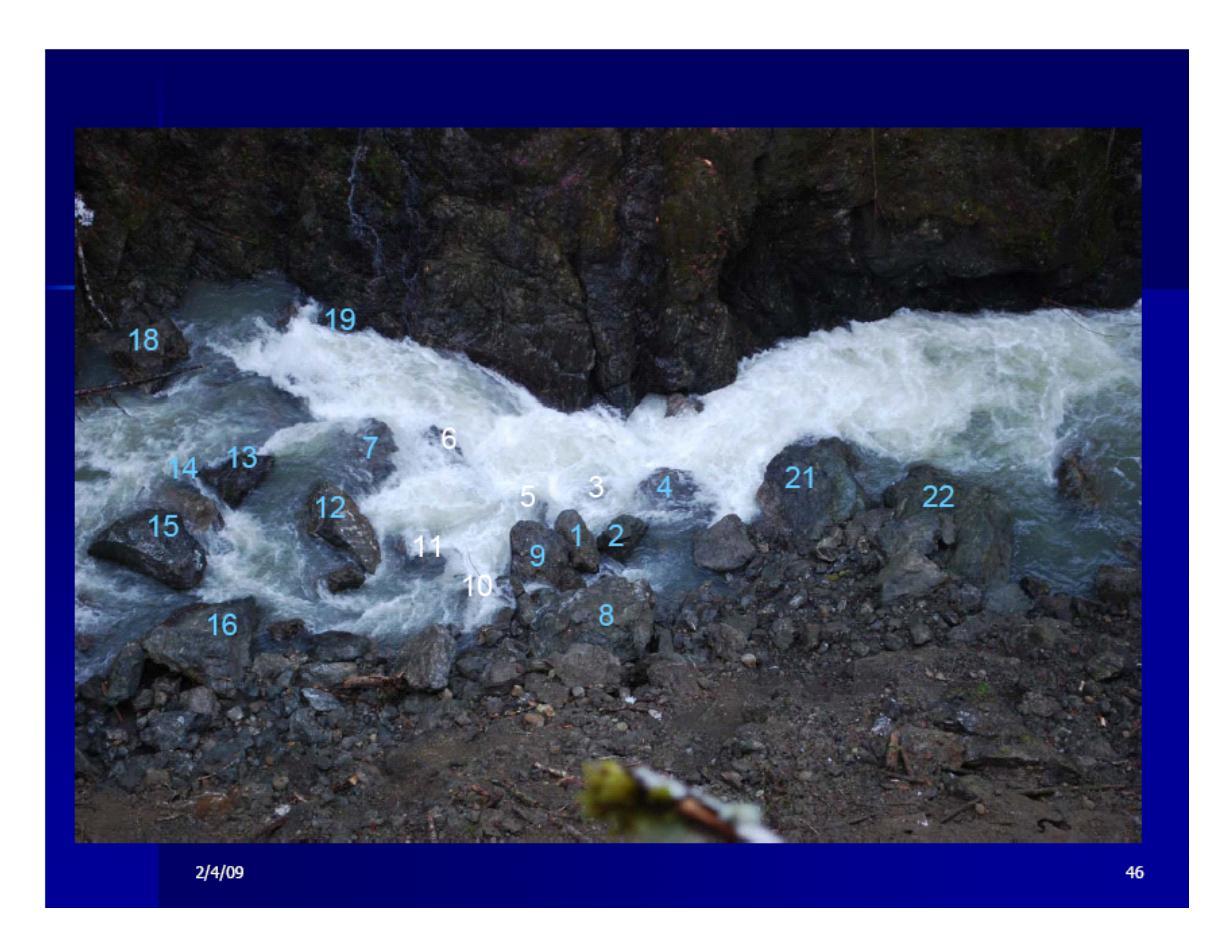
Figure 3. Background picture of slide area. Main passage impediments are found in channel between rocks #4 and #18
