**Youngs Creek Hydroelectric Project**  
**FERC No. P-10359**

**WILDLIFE HABITAT MITIGATION PLAN**  
License Article 403

**ANNUAL REPORT 2012**

January 2013

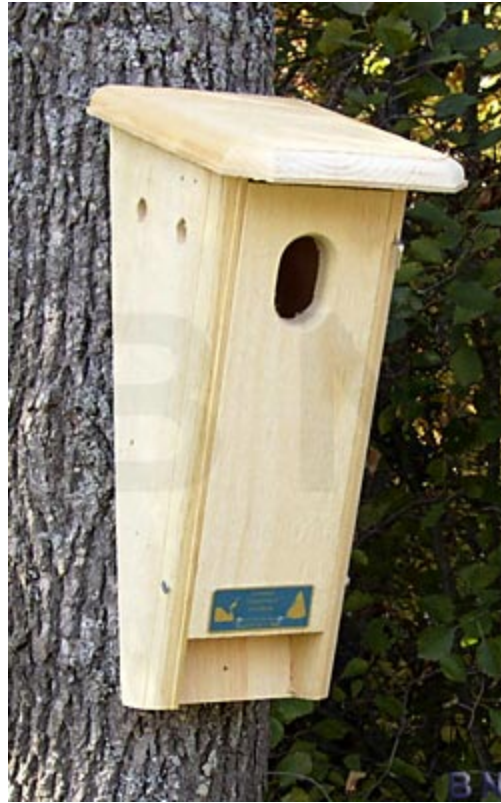
Photo 2. Coveside Slant Front Box

Box8	Coveside Slant front		4/4 – no use noted. 5/1 - yellow jacket nest removed 5/28 – no use noted 7/3 – adult incubating 1+ nestling RESULT: <u>Failed tree swallow nest. 1 dead egg, 1 dead chick, no shell fragments.</u>
Box9	Woodlink	Mounted on mature riparian tree	4/4 – no use noted. 5/1 - yellow jacket nest removed 5/28 – no use noted 7/3 – no use noted 8/28 – no use noted
Box10	Woodlink	Co -mounted on perch pole	4/4 – no use noted. 5/1 - yellow jacket nest removed 5/28 – no use noted 7/3 – no use noted 8/28 – no use noted
Box11	Coveside Slant front		4/4 – no use noted. 5/1 – no use noted 5/28 – no use noted 7/3 – no use noted 8/28 – no use noted
Box12	Coveside Slant front		4/4 – no use noted. 5/1 – yellow jacket nest removed 5/28 – yellow jacket nest removed 7/3 – no use noted 8/28 – no use noted

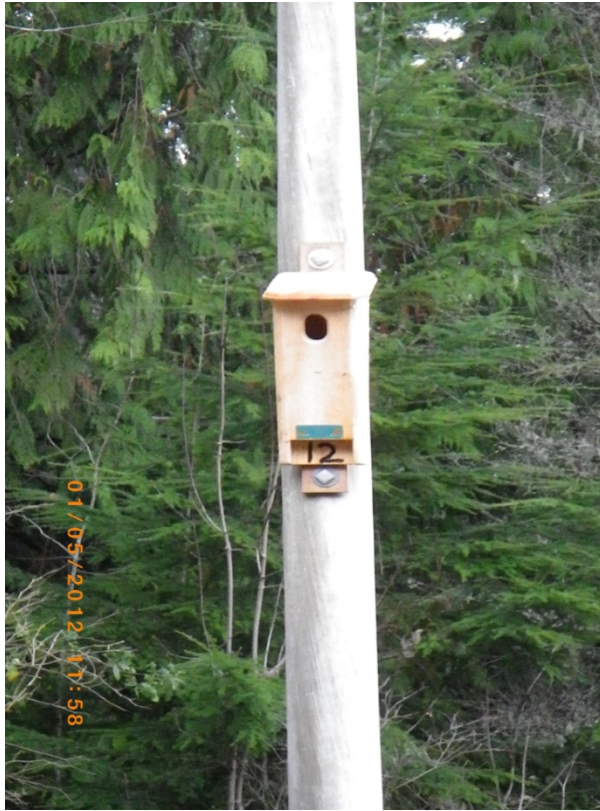
Photo 5. Typical nest box mounted on pole.

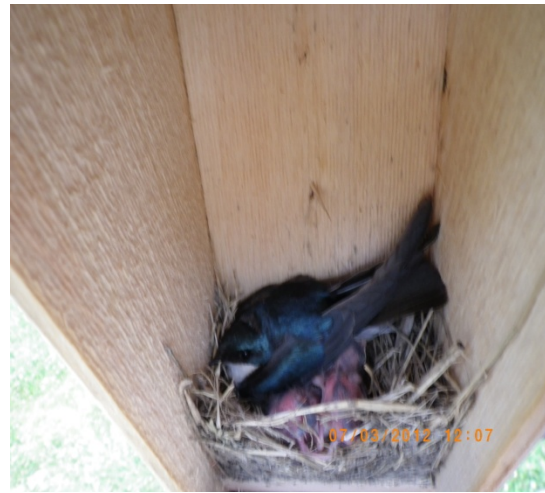
the pole-mounted nest boxes (see Photo 6 and Table 3), with only one nest successfully fledging young. When checked at the end of the nesting season, the second nest had one dead egg and one dead chick. Most nest box programs and their monitoring results do not support adding boxes until a threshold of 50 to 80 percent usage is reached, so no additional boxes are planned at this point.

Photo 6. Tree swallow with 2 nestlings.

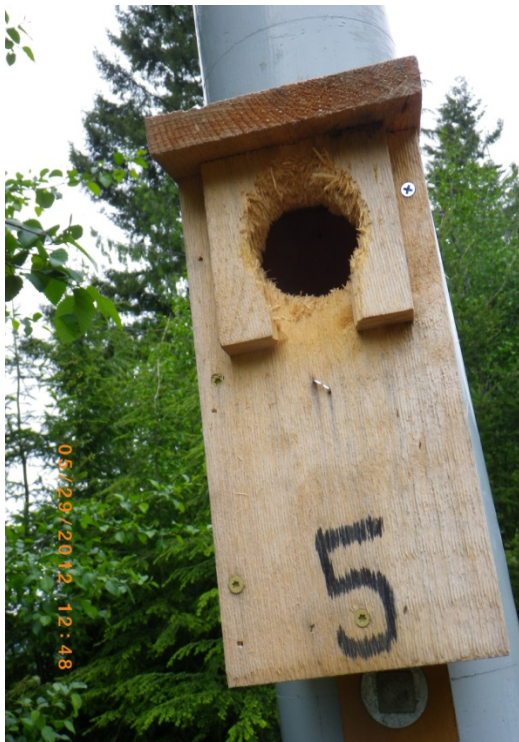
Box6	Bluebird Trailbox	Co -mounted on perch pole	4/4 – no use noted. 5/1 – single white egg (20.5 x 26mm); no nest material except chips from entrance hole enlarging; a few dark gray feathers. 5/28 – egg missing, no additional nesting material. 7/3 – more wood chips from entrance hole enlarging 8/28 – no use noted RESULT: <u>failed flicker nesting attempt</u>
Box7	Audubon		4/4 – no use noted 5/1 - no use noted 5/28 – no use noted 7/3 – no use noted 8/28 – no use noted

Photo 7. Enlarged entrance hole.

Nest boxes which have been damaged by woodpeckers will have a new faceplate installed to restrict the diameter of the opening to the original size. This work will be completed prior to the beginning of the 2013 nesting season.

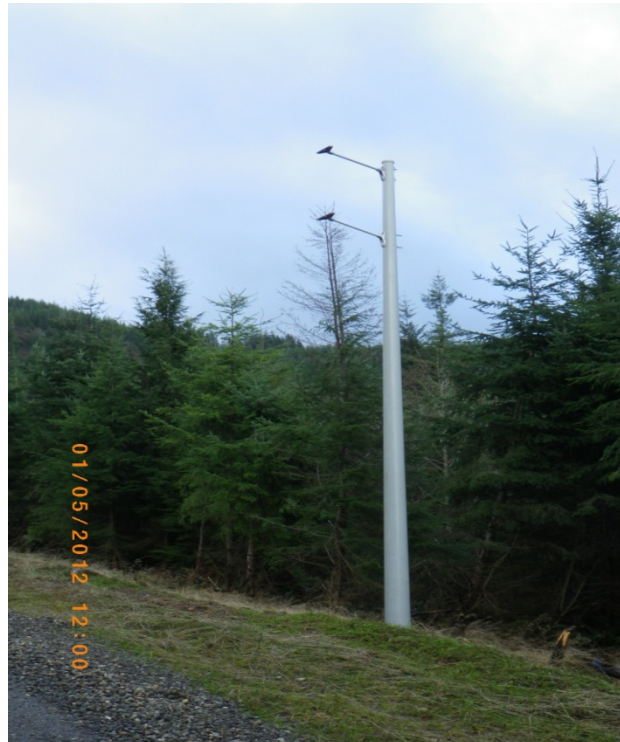
Photo 8. Raptor perch pole.

Seven raptor perch poles were installed at locations identified during the previously mentioned site visit to maximize line-of-sight hunting opportunities by raptors (see Figure 4 and Photo 8). These are typically 30-foot tall fiberglass light poles with two aluminum arms extending out over the ROW. Literature suggests that the upper arm may reduce harassment of raptors by small flocking birds while utilizing the perch. Perch poles are monitored concurrently with nest boxes. During site visits, the immediate vicinity of the perch poles was inspected for signs of raptor use, including whitewash or owl pellets, but none was noted (see Table 4).
