FINAL REPORT • FEBRUARY 2015

# Sultan River

## Riverine Habitat Monitoring

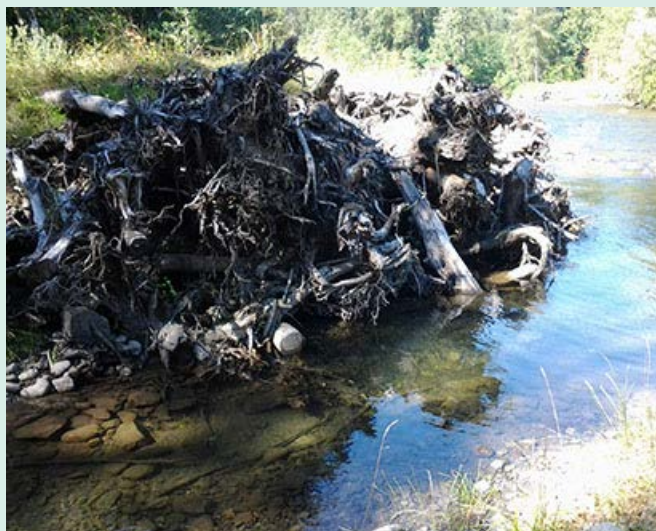
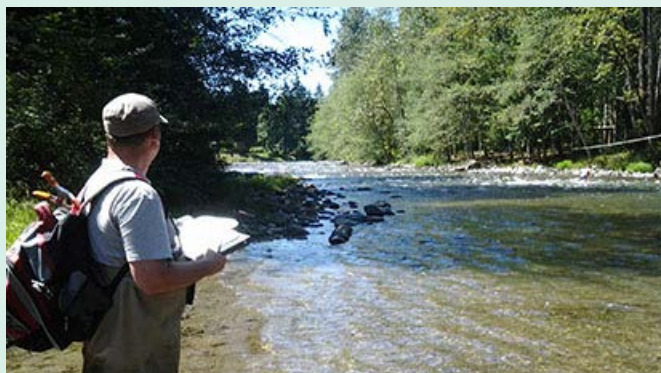
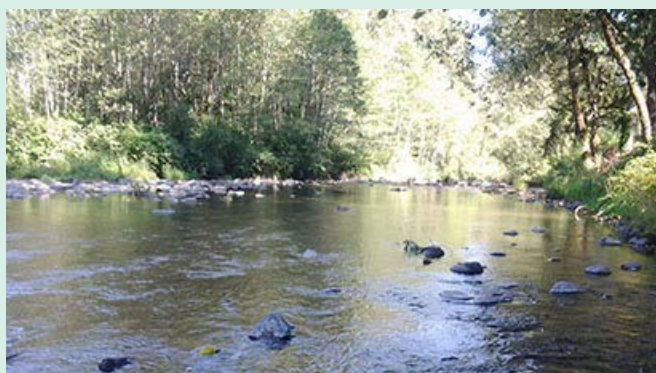
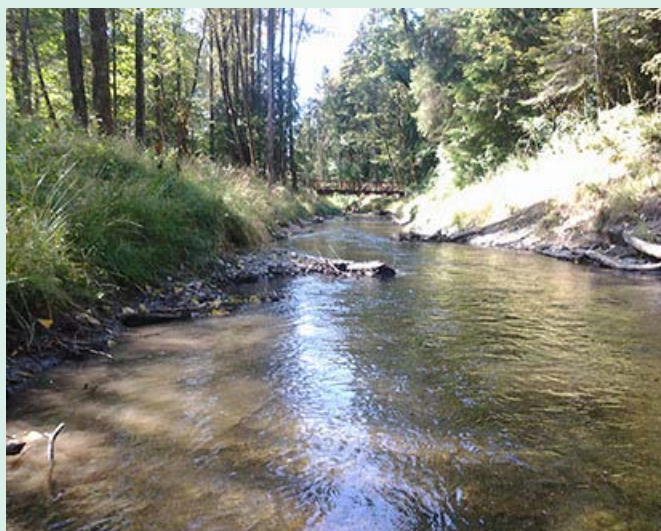
Cover photos: Clockwise from top left: Installed large wood in Side Channel 1; Stillwater staff surveying the main channel of the Sultan River; bridge on Side Channel 4; upper end of Side Channel 4.

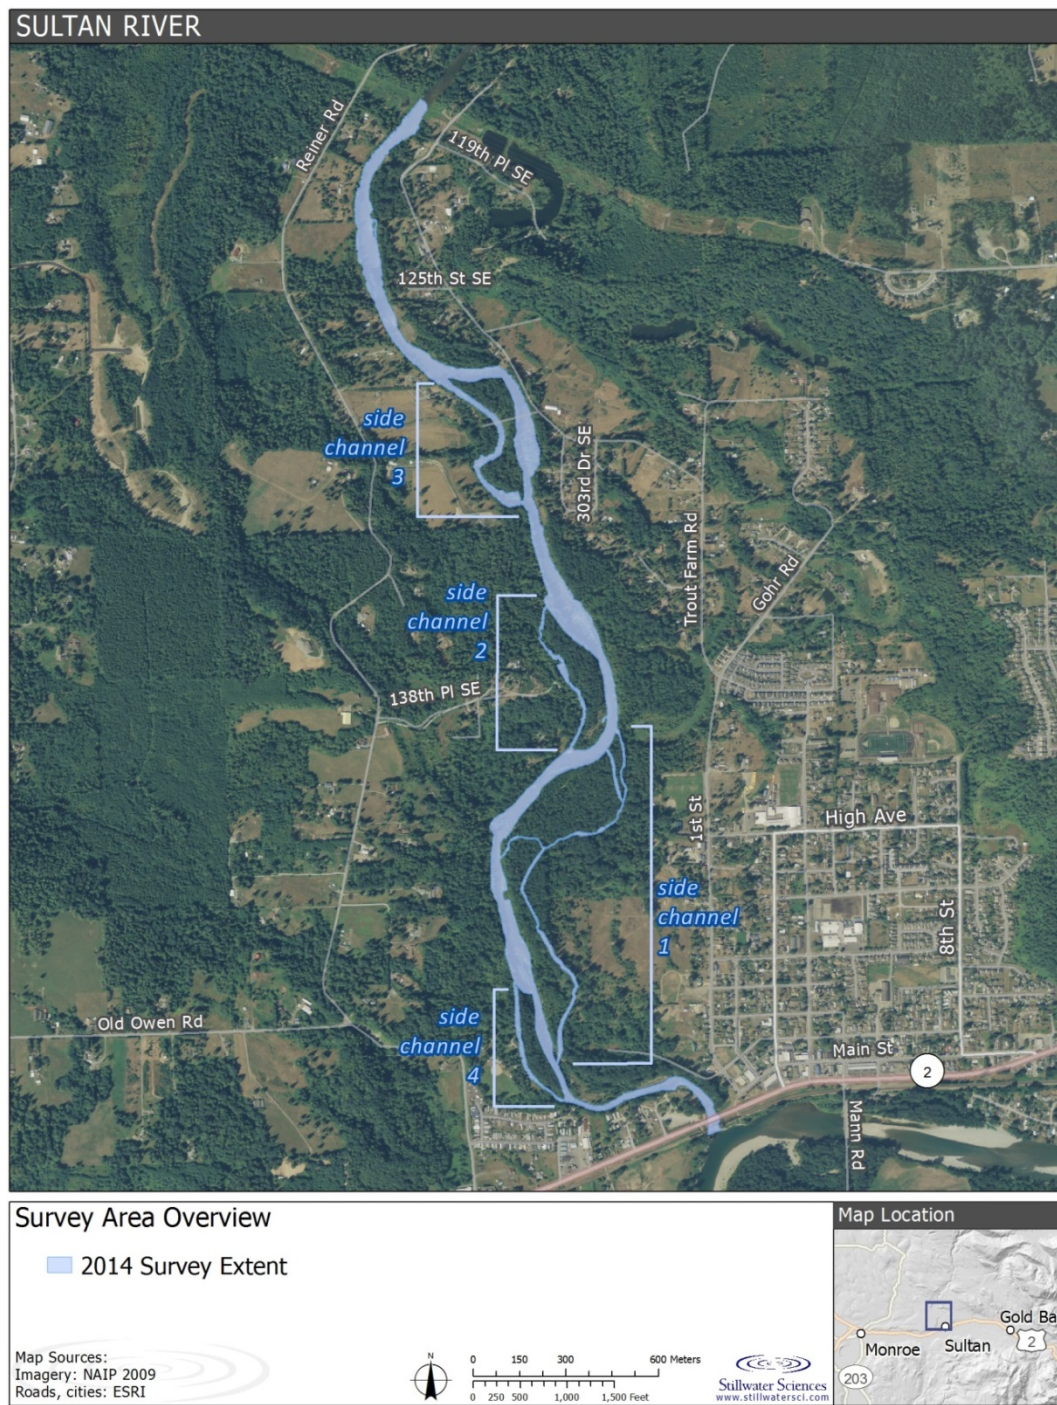
**Figure 1.** Overview map of Study Area, spanning the lowermost 2.7 miles of the Sultan River upstream of its confluence with the Skykomish River (bottom right portion of the image). The four side channels covered by this survey are highlighted.

The Sultan River below Culmback Dam is a highly confined, steep channel over 13 of its 16-mile length to its confluence with the Skykomish River. The canyon that confines the river creates a high-energy environment that significantly affects the nature of instream habitats found within it. At approximately river mile (RM) 3.3, however, the river transforms into a less confined, alluvial valley where the channel widens and gravels from upstream sources deposit and accumulate. This survey was conducted on the lowermost low- gradient alluvial portion of the watershed (Figure 1) below the power line crossing at RM 2.7.

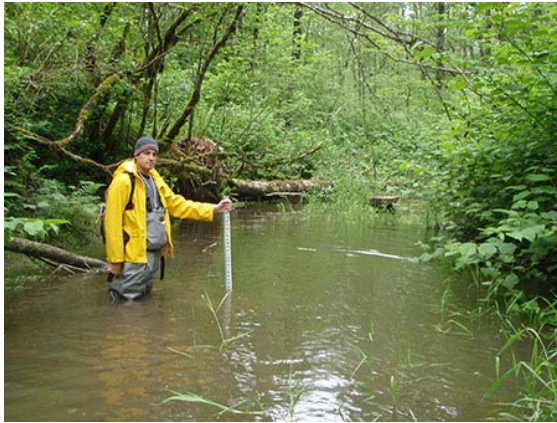
Figure 2. Photo of SC-1 in 2010.

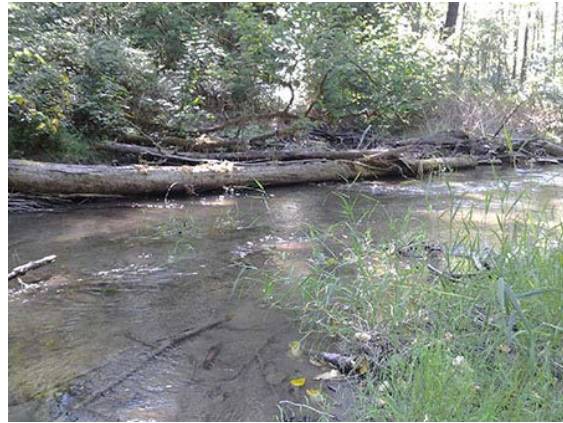
Figure 3. Photo of SC-1 in 2014.

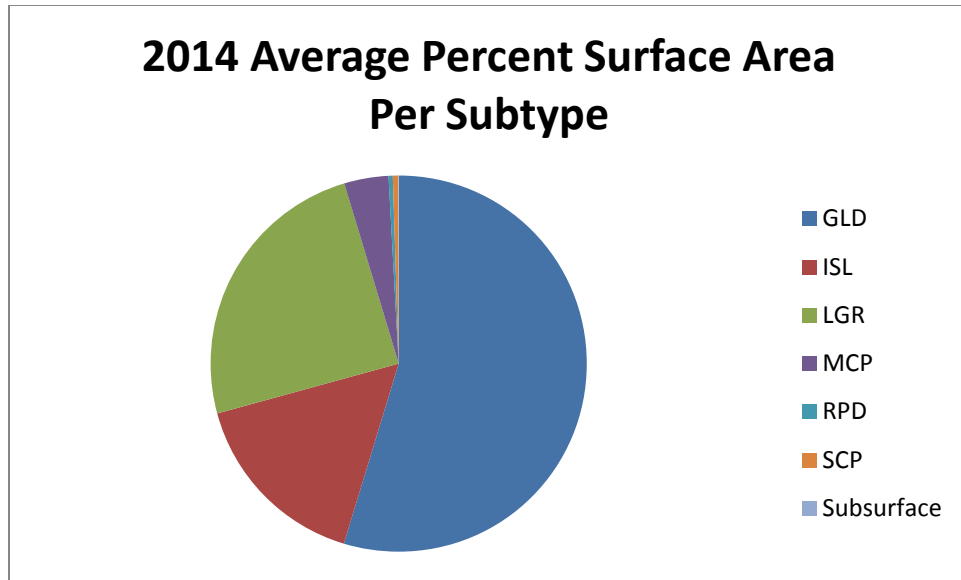
Low-gradient riffles, glides, and islands are the most abundant habitat unit subtypes, in order of prevalence; in total, they account for 88% of all habitat units surveyed. Table 7 provides summary statistics for habitat unit types by reach. In terms of combined average percent surface area per subtype, glides account for 55%, low gradient riffles for 25%, and islands for 16% (Figure 4, Table 8).

**Figure 4.** 2014 Combined average percent surface area per subtype. Habitat subtypes are as listed in Table 5: glide (GLD), island (ISL), low gradient riffle (LGR), main channel pool (MCP), rapid (RPD), lateral scour pool (SCP), and subsurface.

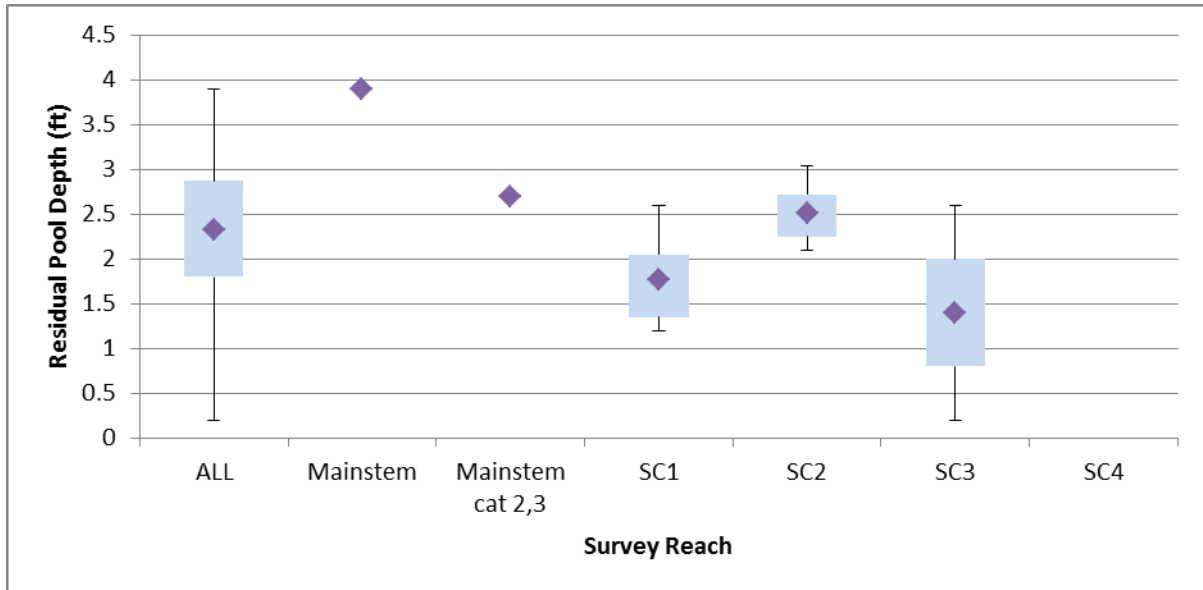
Residual pool depth measurements for a given stream provide the number and spatial distribution of deep pool habitats that can support aquatic life even through annual low-flow periods. Residual pool depth is the maximum wetted depth minus the wetted pool crest depth (Lisle 1987). Median residual pool depths were comparable between reaches, ranging from 1.4 ft (SC-1) to 3.9 ft (mainstem). Residual depths were most variable in SC-3 (Figure 5).

In all cases, residual pool depth on average was 2.3 ft with the first quartile measuring about 1.8 ft. However, survey measurements likely underestimated actual residual pool depths. Low visibility made it difficult to locate maximum depth accurately, and one pool in SC-3 that did not exist in 2007 was too deep to safely measure.

Figure 5. Box-and-whisker plots of surveyed residual pool depth by survey reach. The boundary of a box closest to zero indicates the 25th percentile, diamond within a box marks the median and the boundary of a box farthest from zero indicates the 75th percentile. Box whiskers indicate the minimum and maximum values.

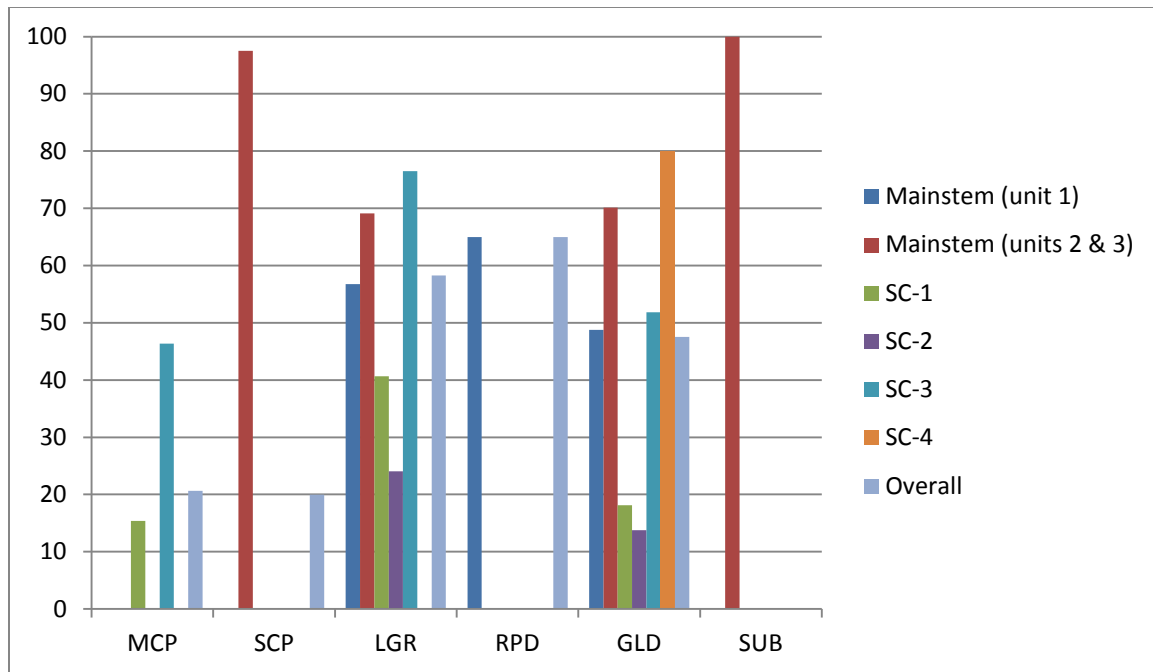
Bar edge habitat is described as gravel bars along stream margins, either wetted or immediately adjacent to the wetted fringe. In this regard, it was primarily present in low-gradient riffle and glide habitats (Figure 6).

Figure 6. Average length (expressed as a percent) of bar edge per subtype by reach in the lowermost 2.7 miles of the Sultan River, including side channels.

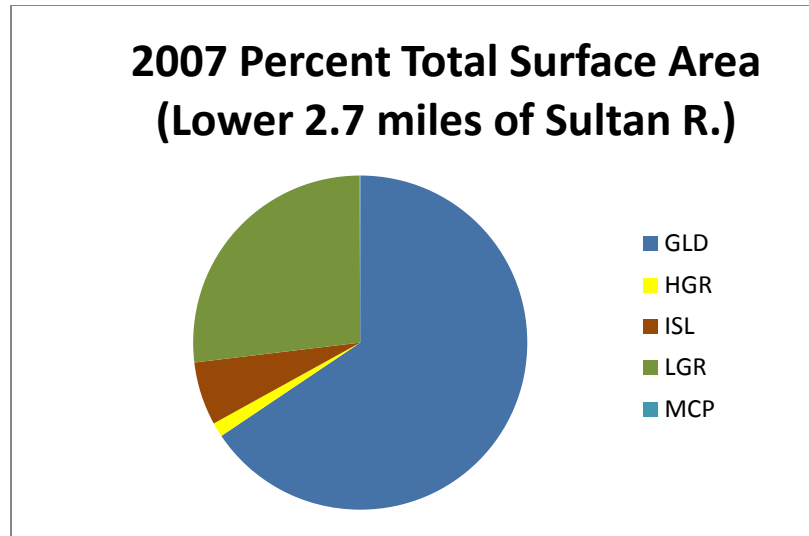
**Figure 7.** 2007 percent surface area per subtype for the lower 2.7 miles of the Sultan River. Habitat subtypes as described in Table 3: glide (GLD), HGR (high gradient riffle), island (ISL), low gradient riffle (LGR), and main channel pool (MCP).

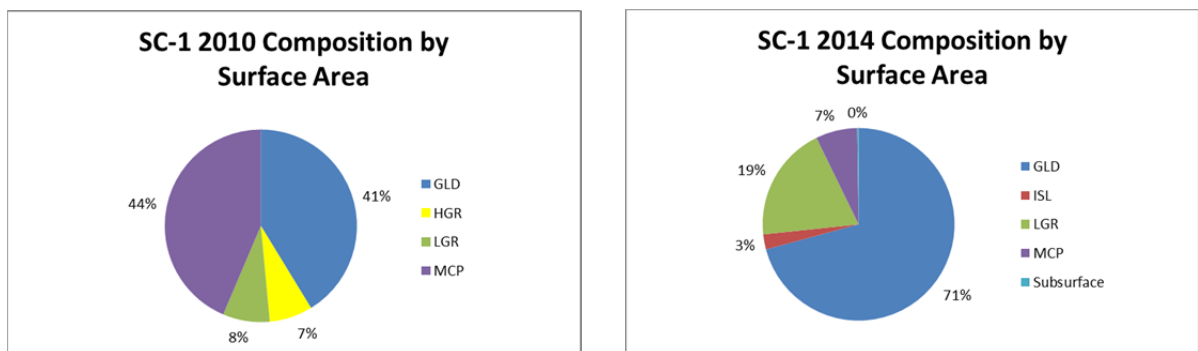
Figure 8. Comparison of SC-1 composition by surface area in 2010 and 2014.

In 2010, investigators mapped long contiguous areas of SC-1 as main channel pools, notably six contiguous pool units SC1-10 through SC1-15. In 2014, field observations indicated that this entire stretch should be mapped as a single glide unit (SC1-6), reflecting its homogeneous nature

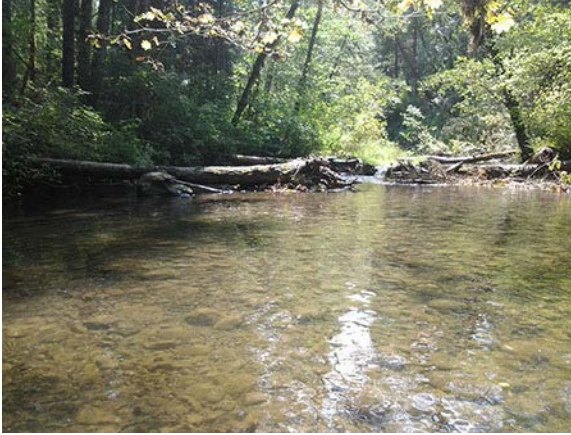
Since 2010, there have been abundant wood structures (helicopter-placed logs) placed in many of these areas (i.e., mapped as pools in 2010 and as glide in 2014) at the north end of SC-2. Figures 10 and 11 illustrate two such areas near each other (SC2-5 in 2010 and SC2-15 in 2014).

Figure 10. Glide (SC2-15) with helicopter placed logs (2014).

Given the large amount of wood placed throughout SC-2 and visual comparisons such as these, the greater degree of habitat complexity and more, smaller habitat units in 2014 is likely an accurate indication of actual habitat changes between the two survey years, rather than simply an artifact of different mapping techniques between crews, or differences in flow.

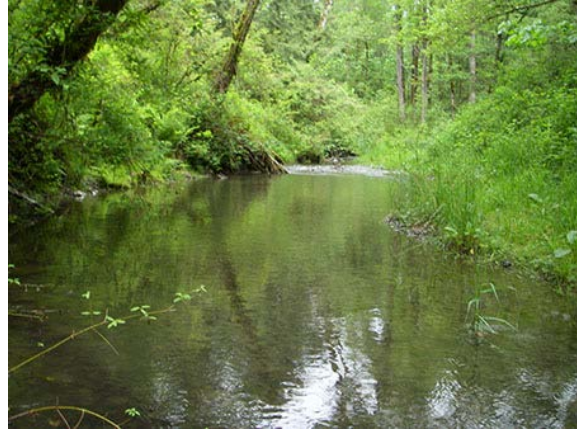
Figure 11. Pool unit (SC2-5, 2010).

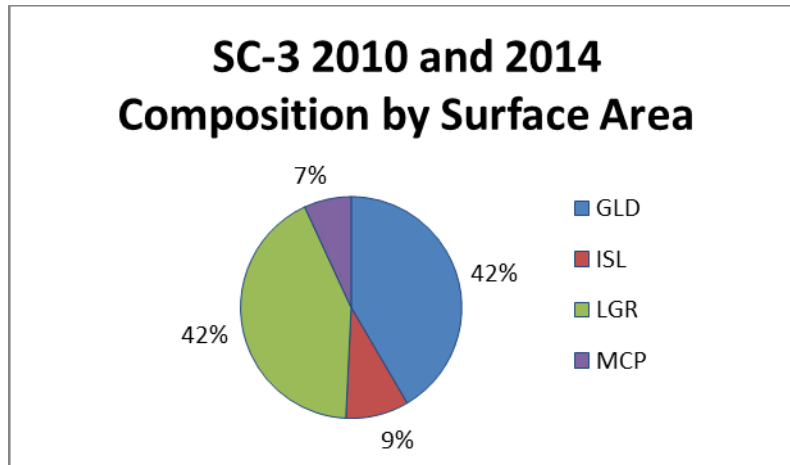
- bar edge lengths increased for a net gain of 489 ft on the left bank and 219 ft on the right bank;
- undercut banks were no longer observed in unit 50;
- an island was formed at unit 1-54B;
- the length of the island at 1-55 was reduced by 83 ft ; and
- the length of the pool at 1-57 was reduced by 9 ft and its residual depth decreased by 4 ft.

Figure 12. SC-3 composition by surface area in 2007 and 2014.

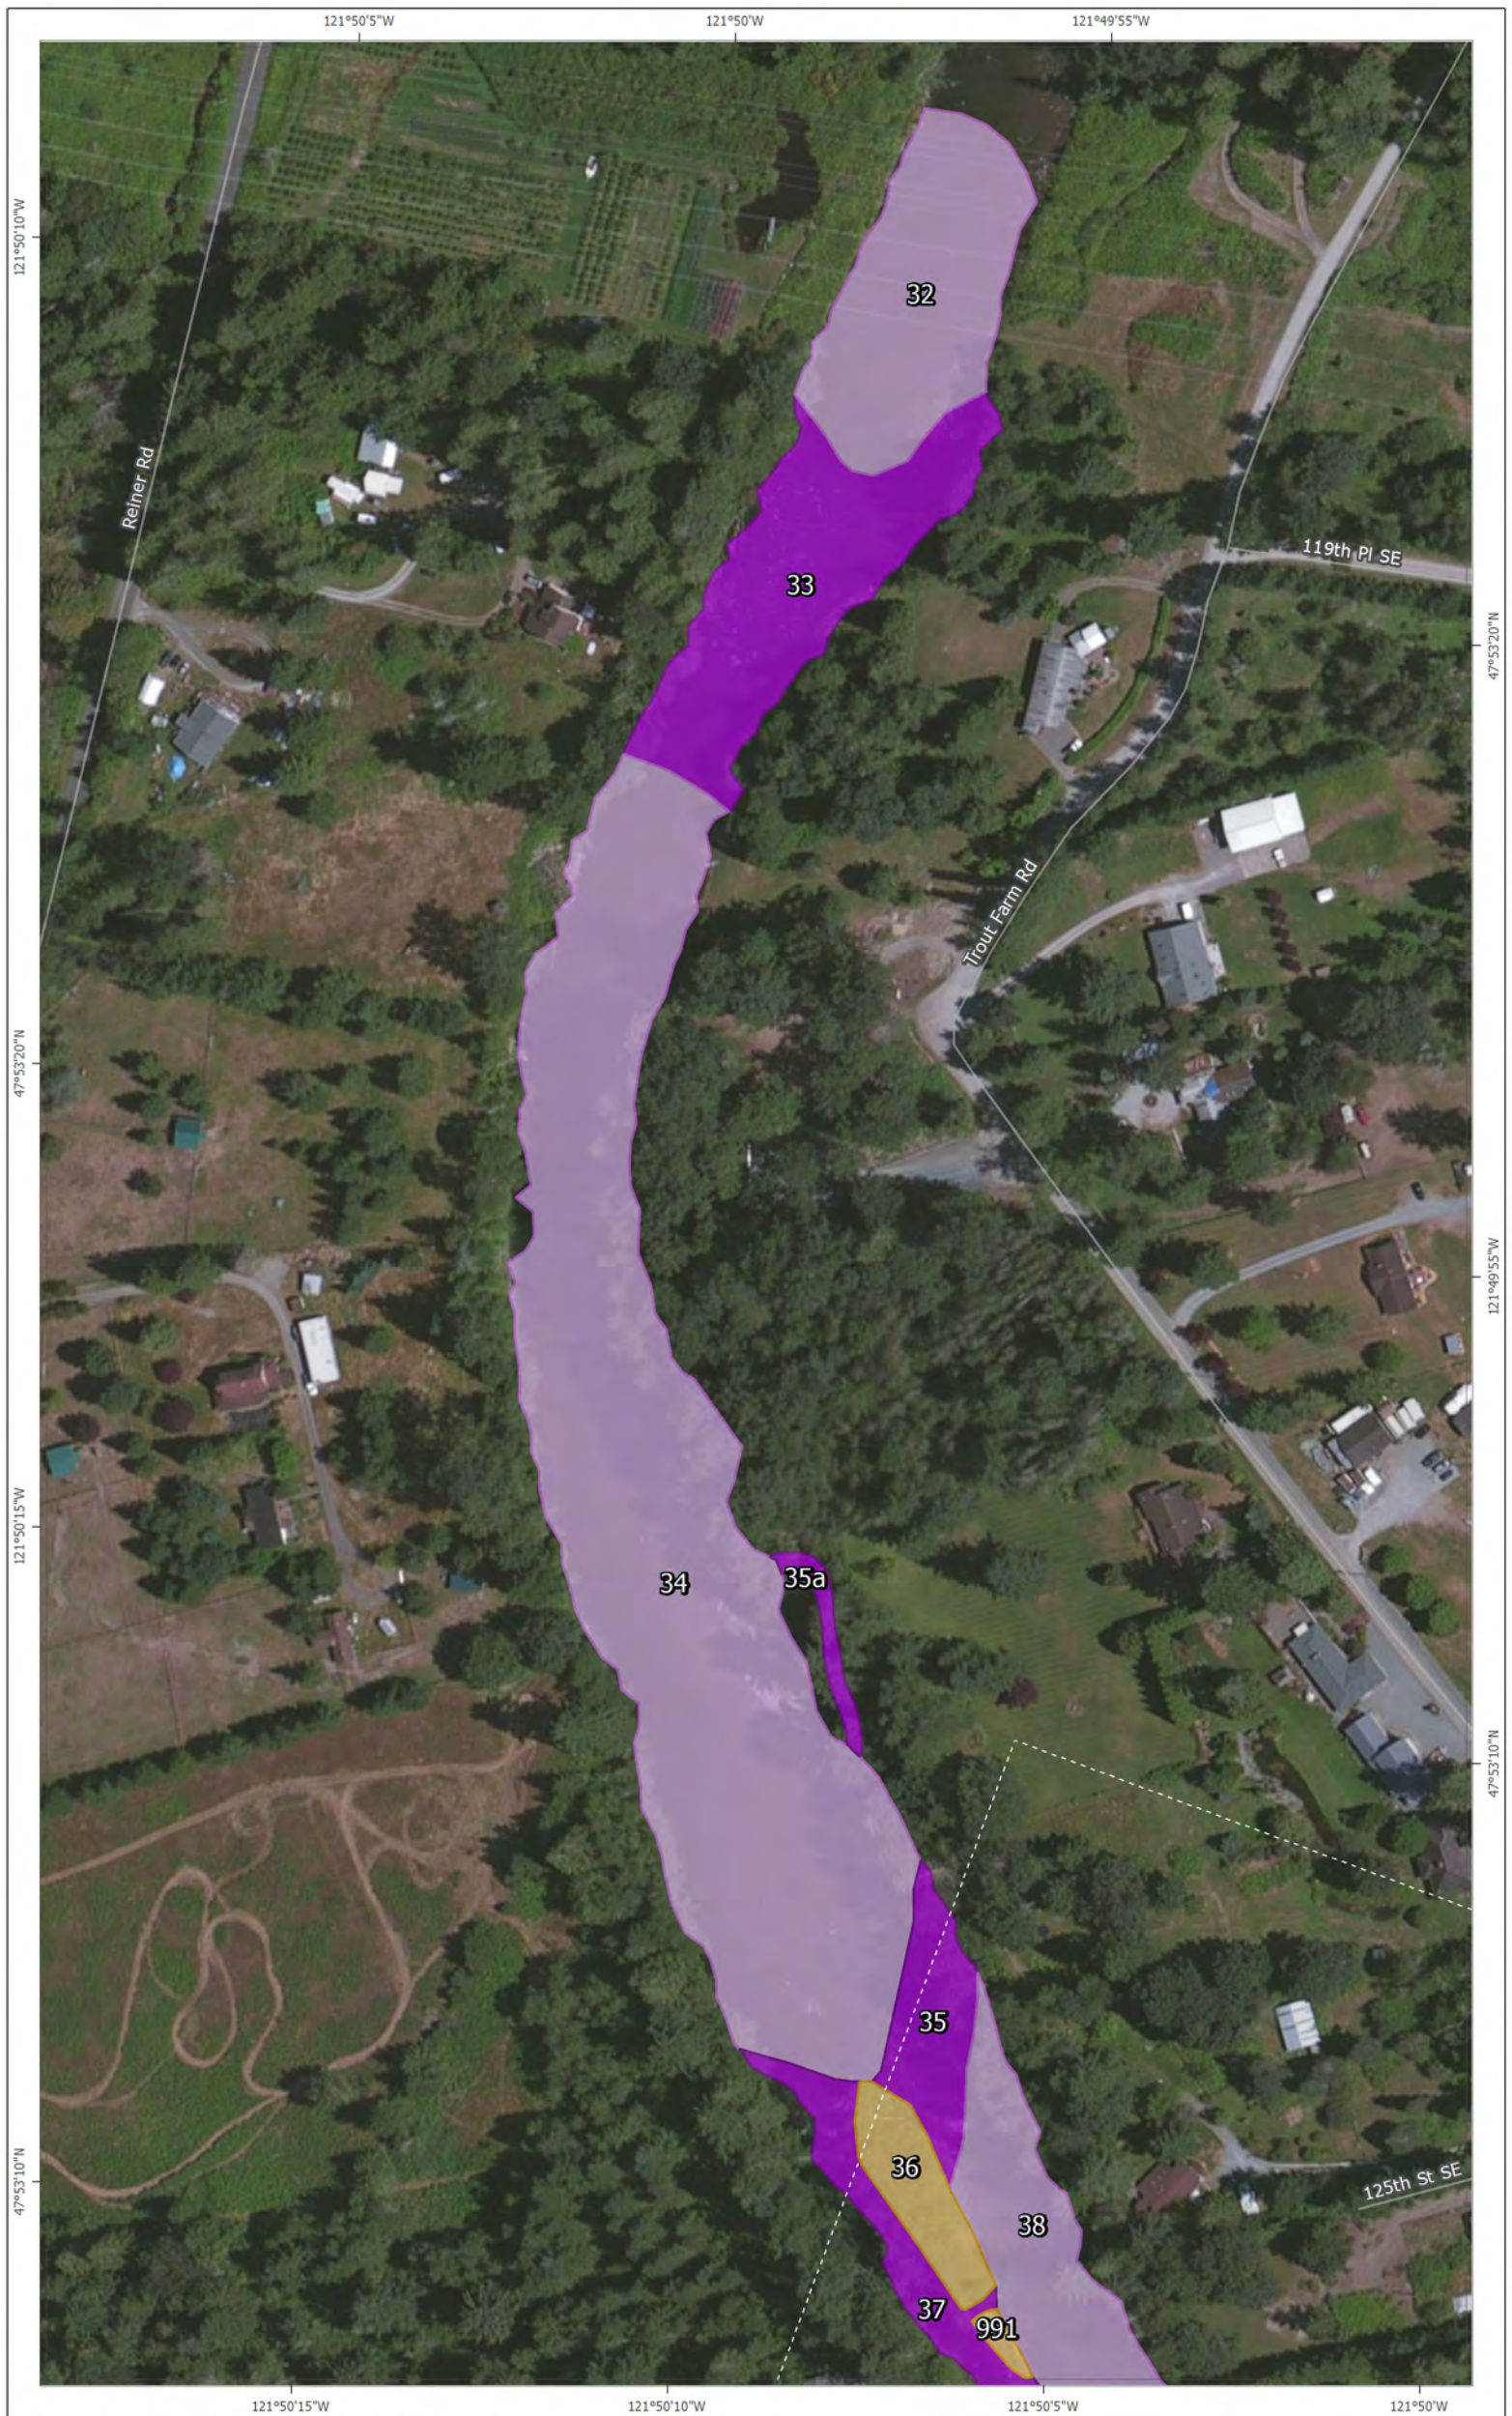
SULTAN RIVER LARGE WOODY DEBRIS  
Habitat Types

- Glide
- Low-gradient riffle
- Rapid
- Island
- Main channel pool
- Subsurface flow

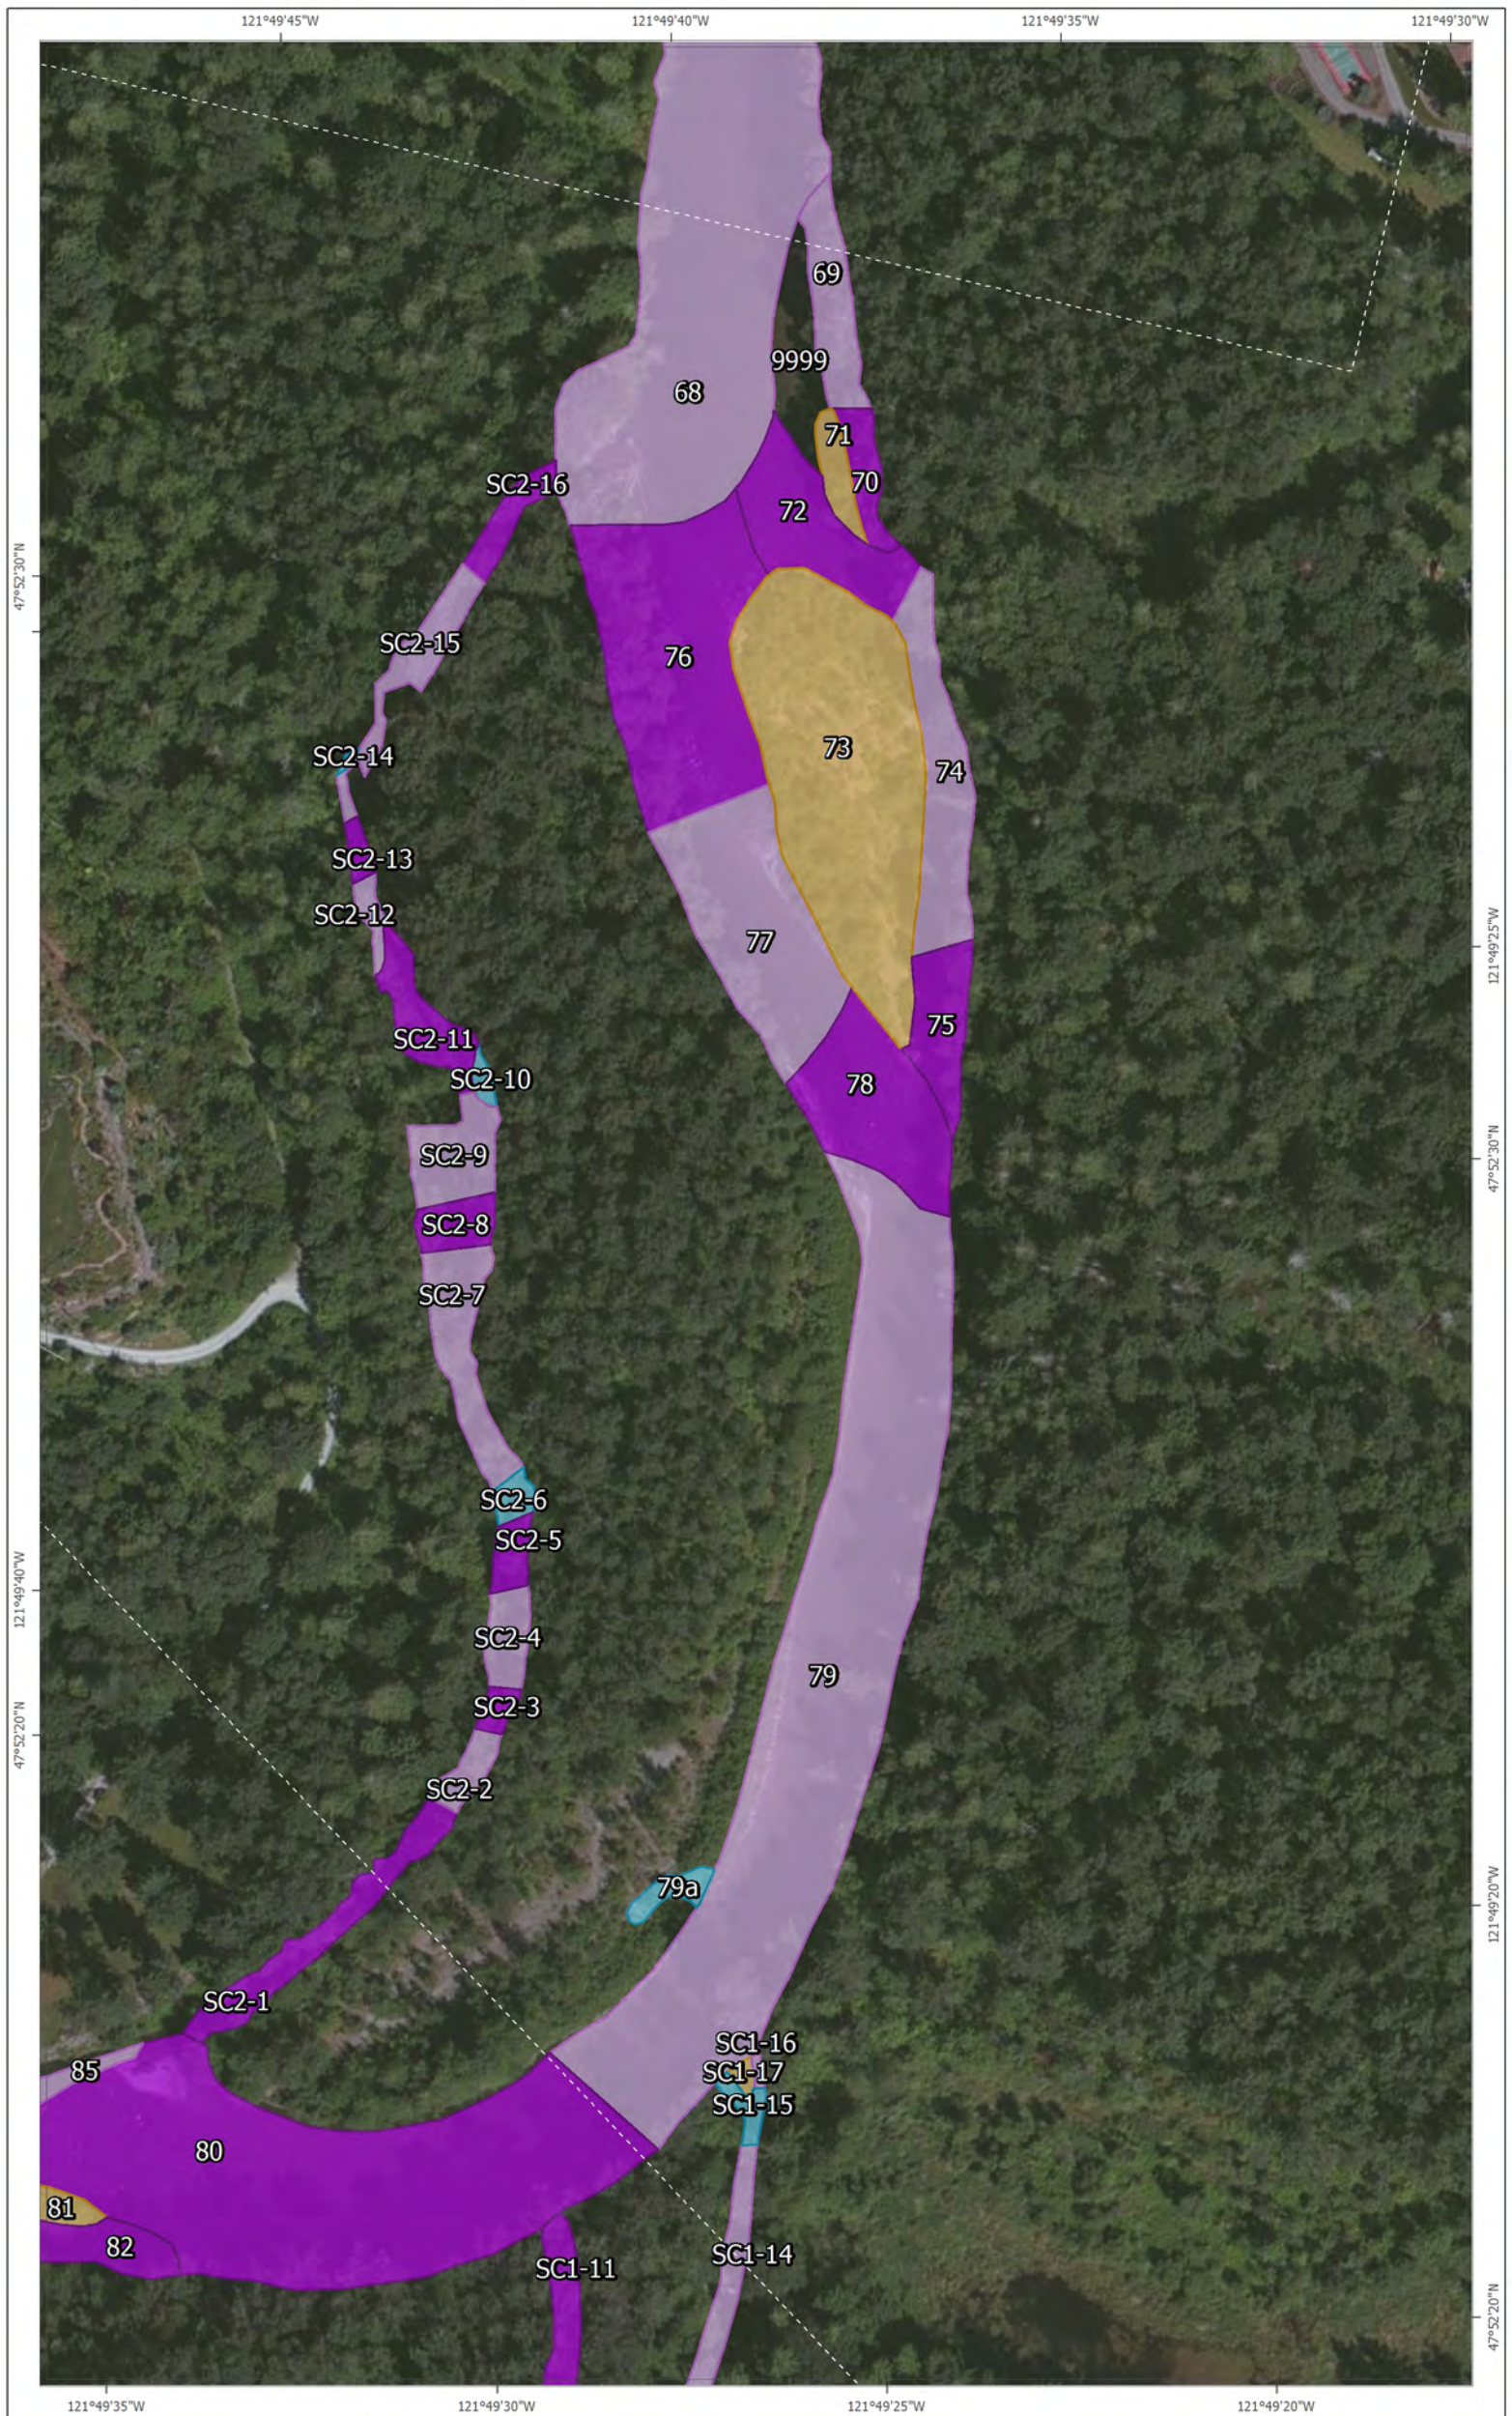
SULTAN RIVER LARGE WOODY DEBRIS  
Habitat Types

- Glade
- Low-gradient riffle
- Rapid
- Island
- Main channel pool
- Subsurface flow

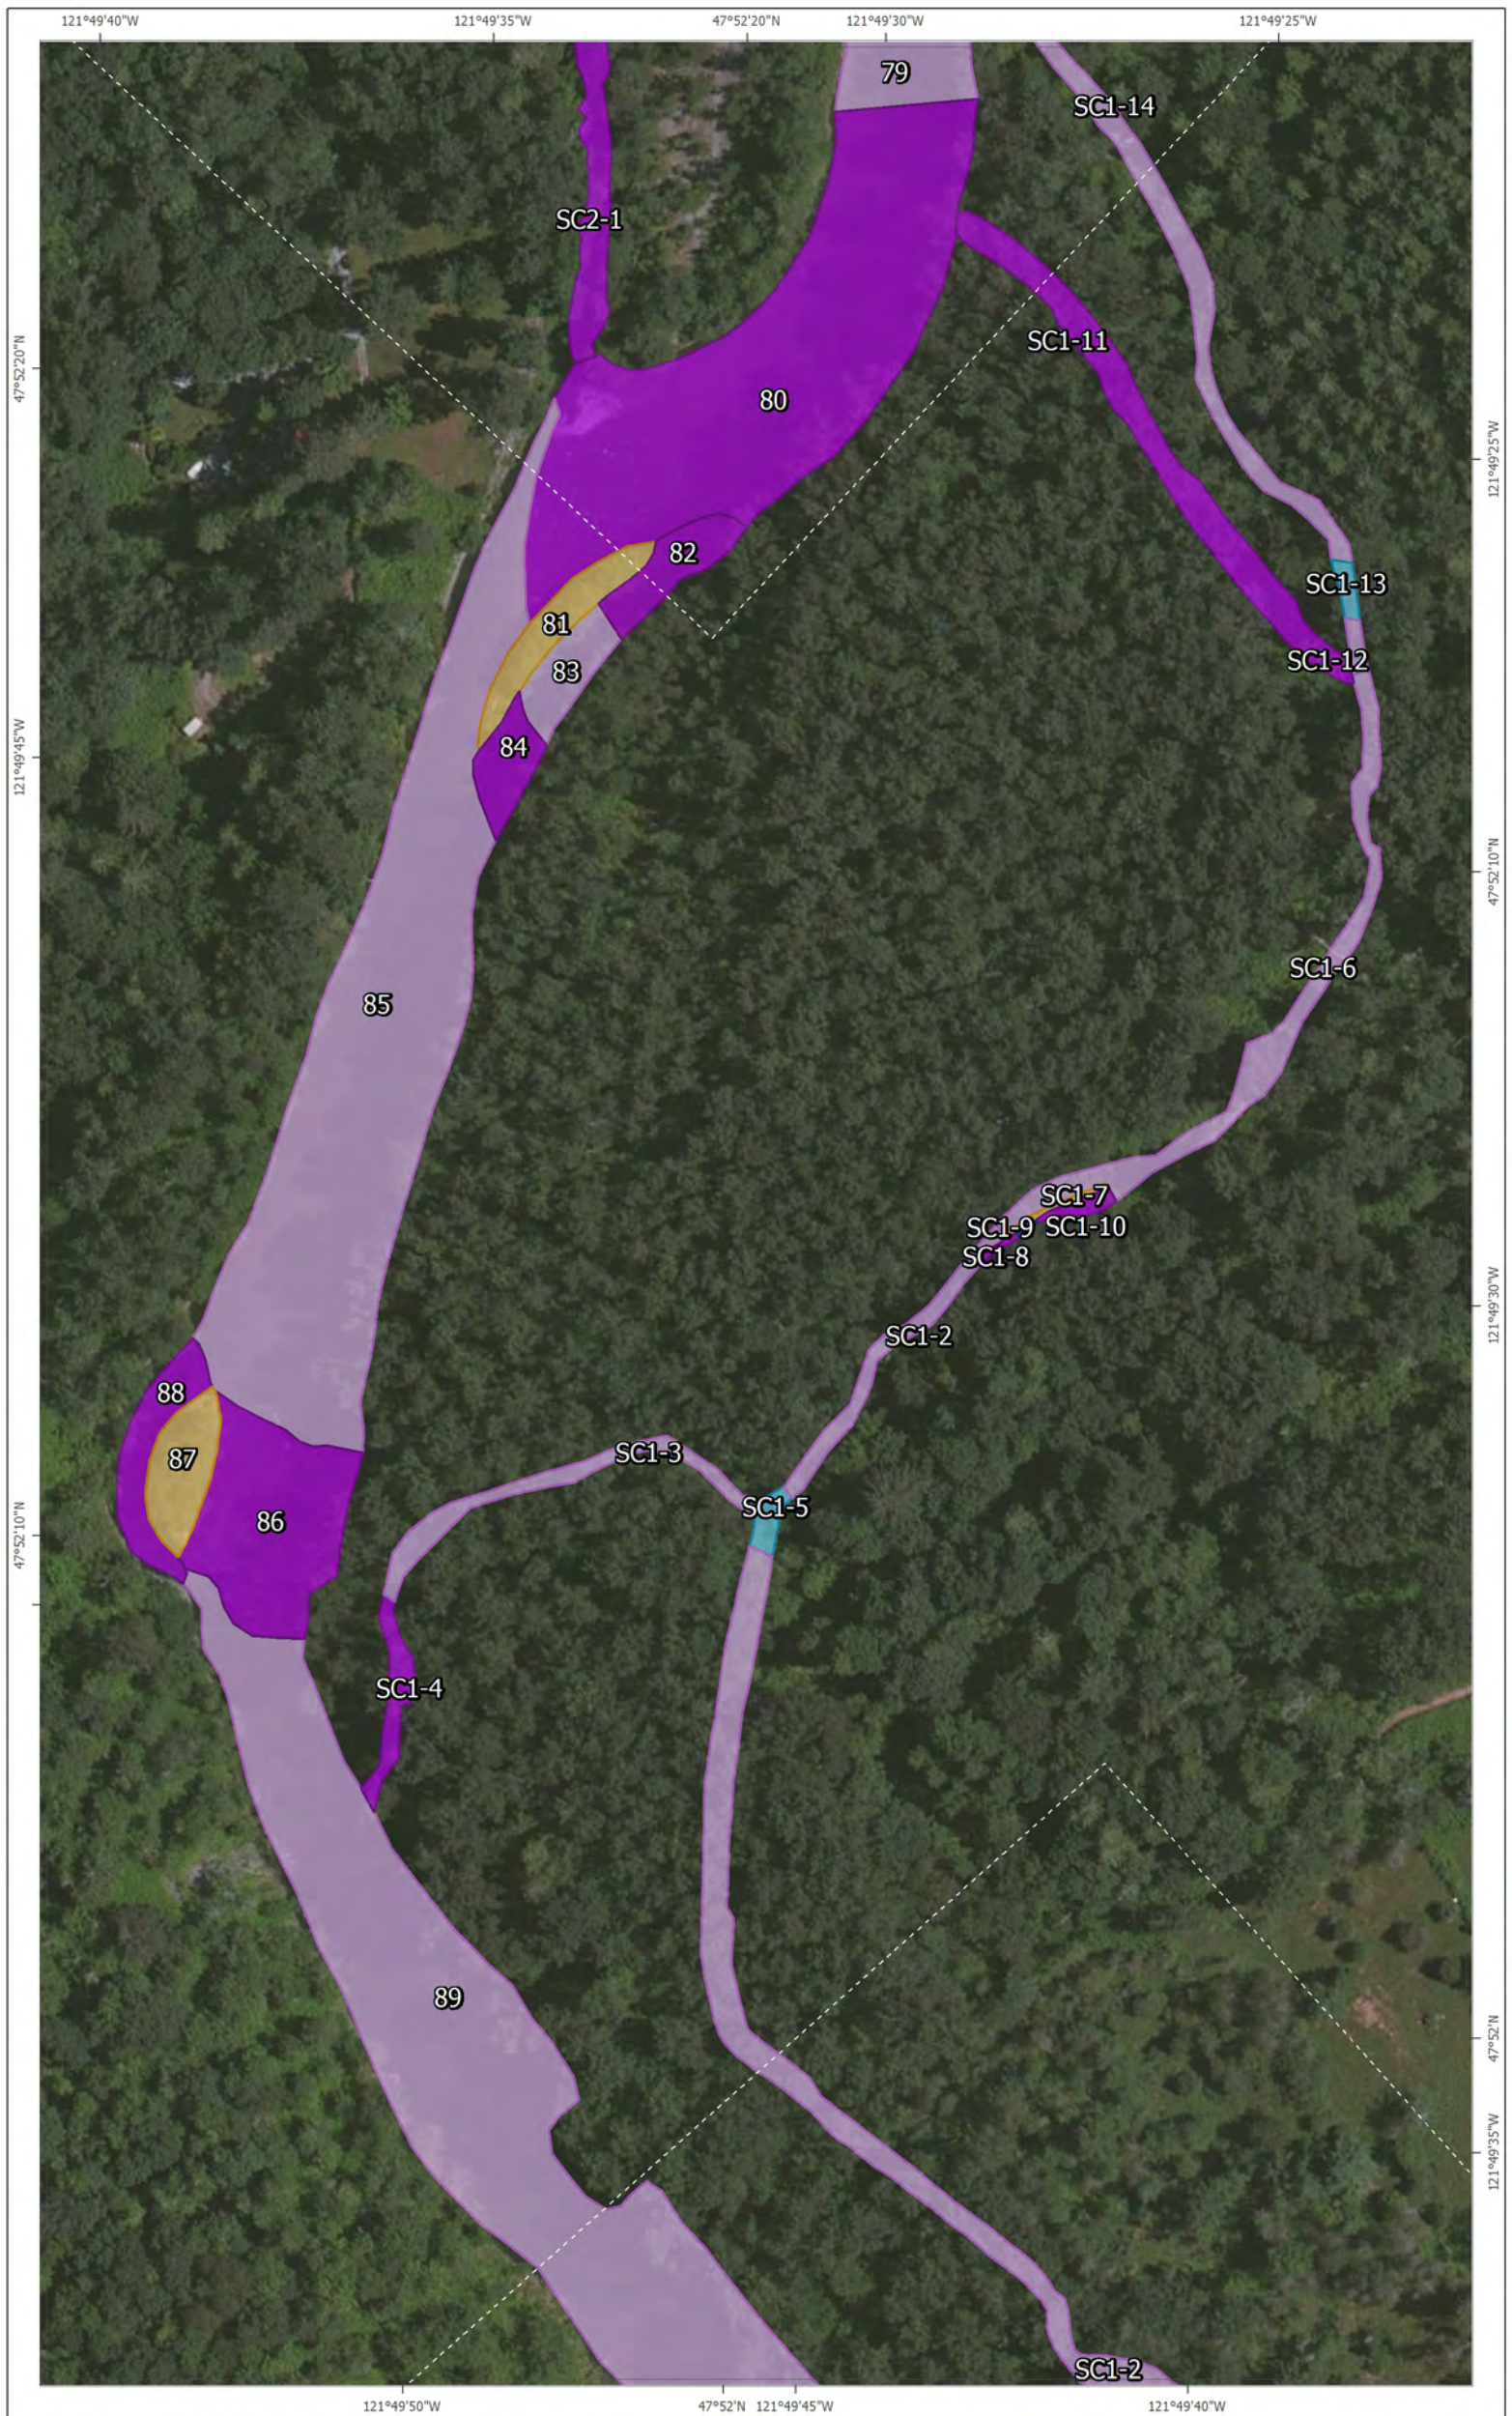
SULTAN RIVER LARGE WOODY DEBRIS  
Habitat Types

- Glide
- Low-gradient riffle
- Rapid
- Island
- Main channel pool
- Subsurface flow
