FINAL REPORT • FEBRUARY 2015

# Sultan River

## Riverine Habitat Monitoring

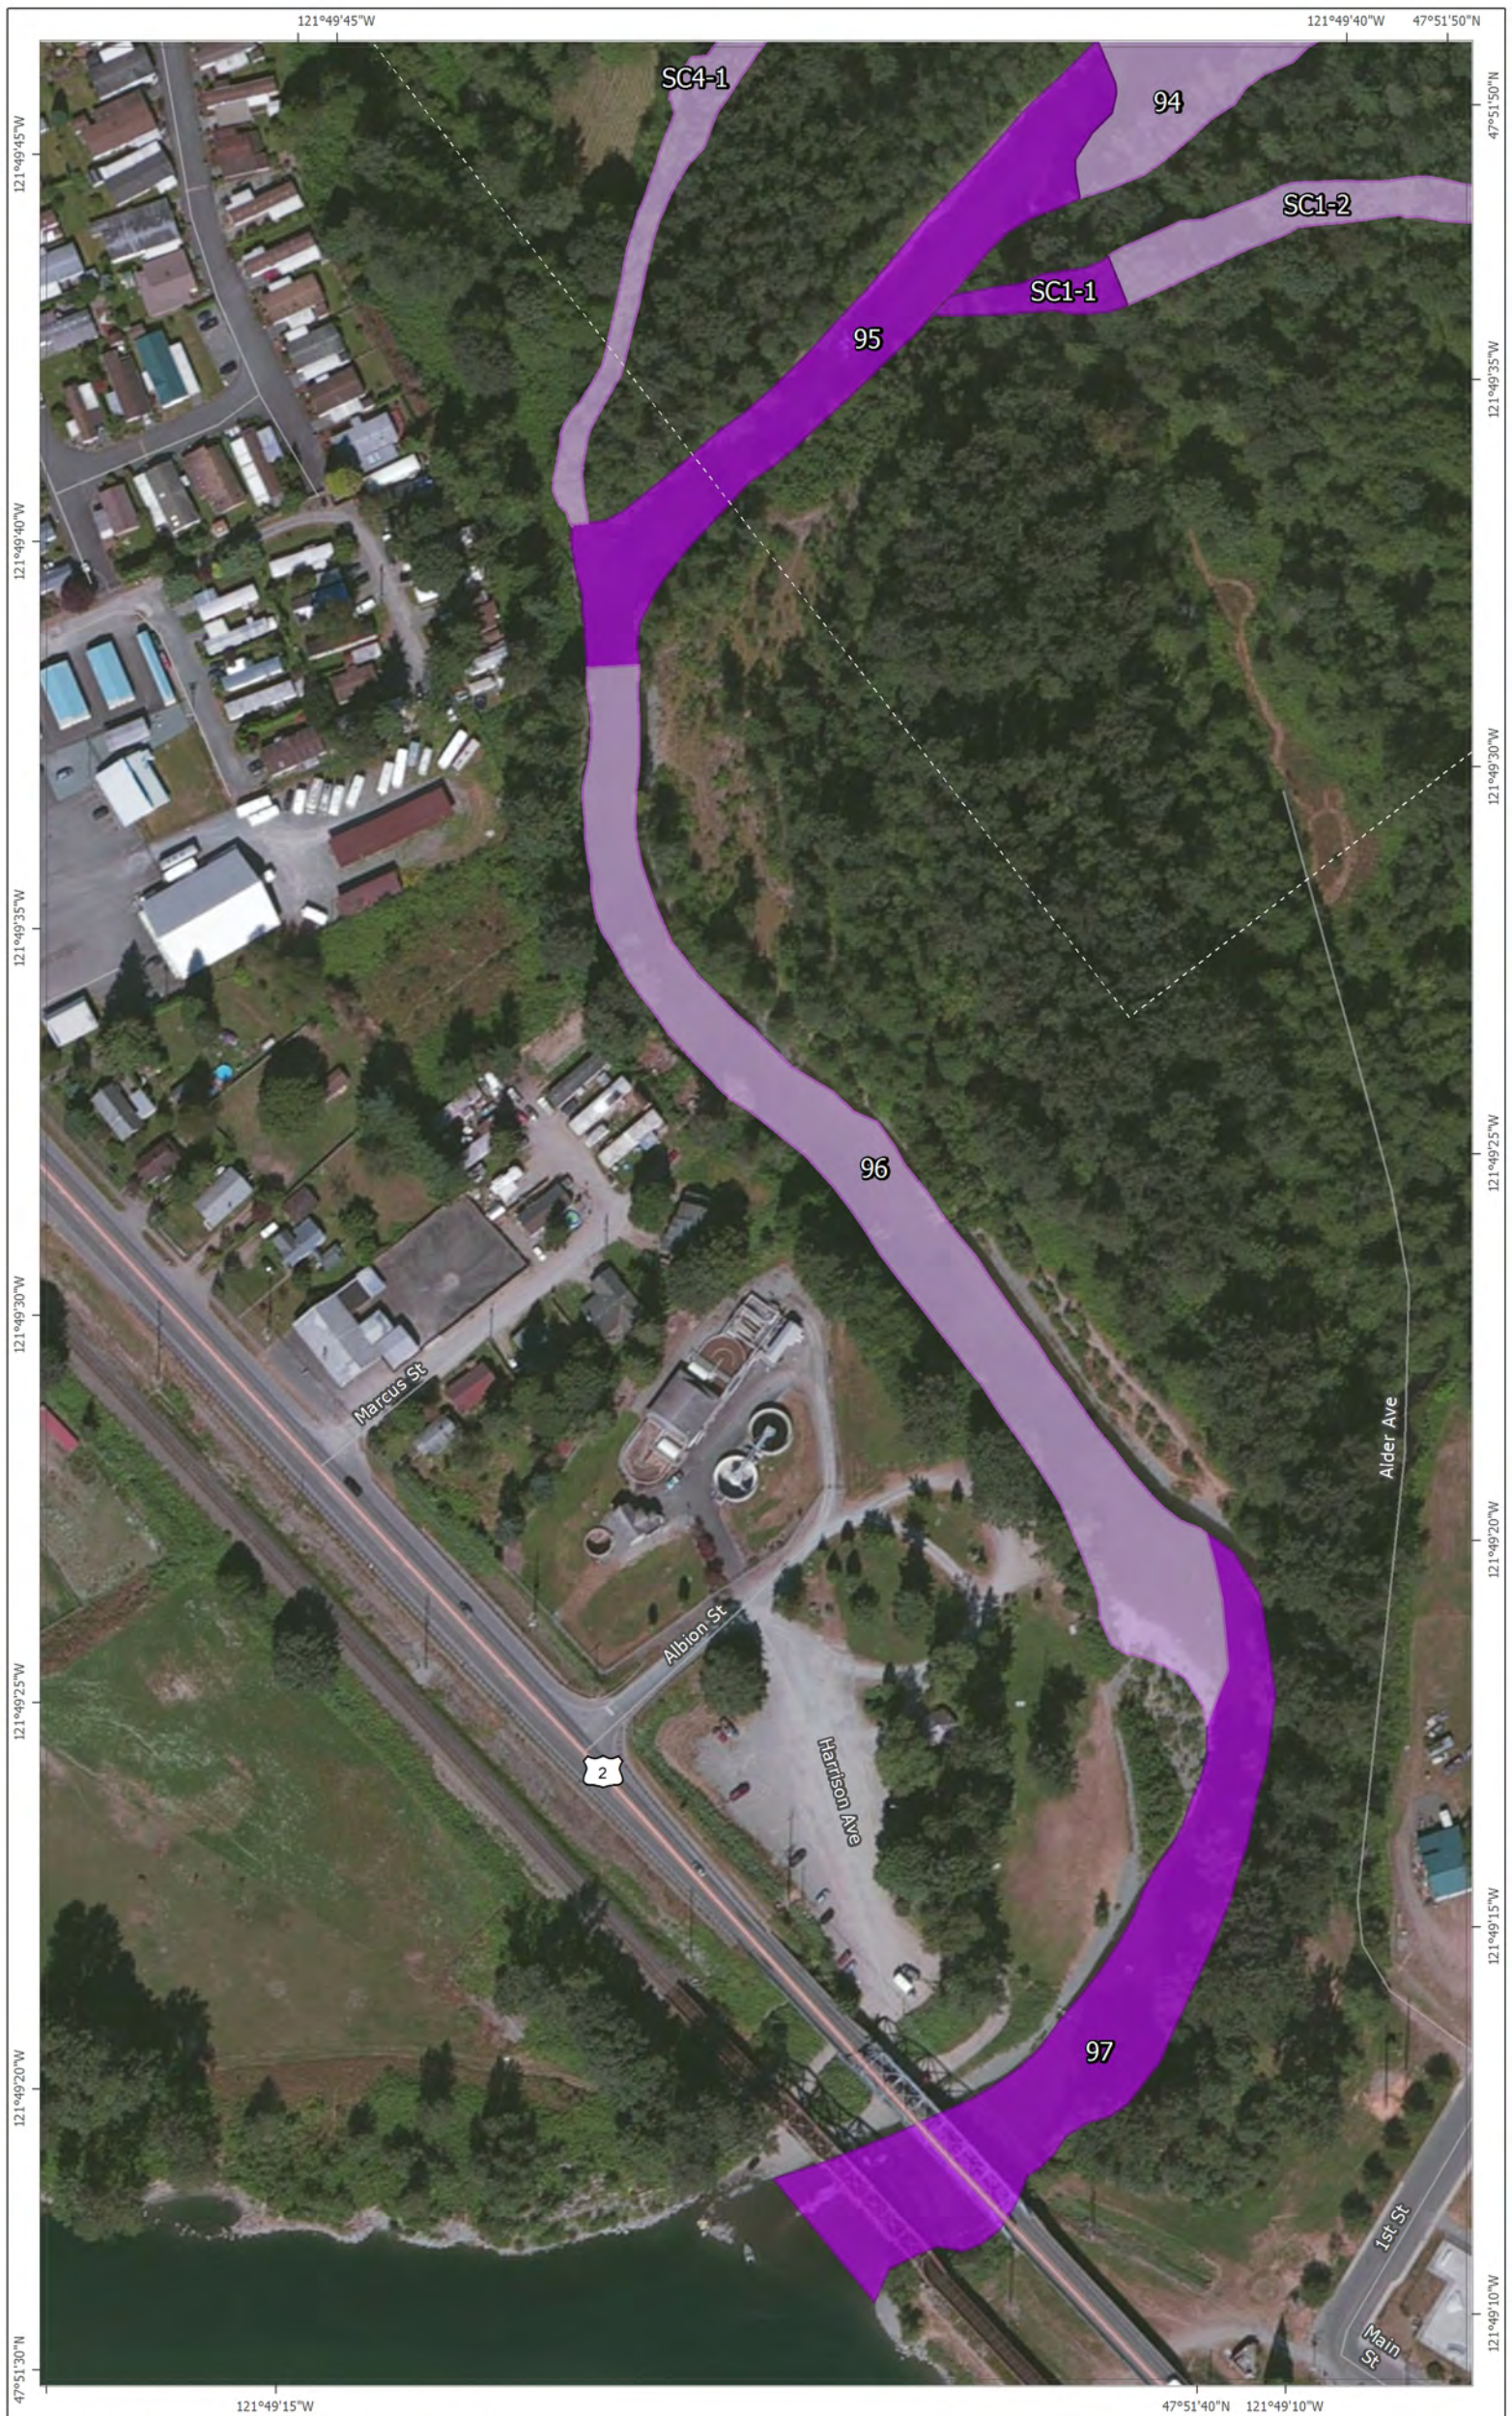
SULTAN RIVER LARGE WOODY DEBRIS  
Habitat Types

- Glide
- Low-gradient riffle
- Rapid
- Island
- Main channel pool
- Subsurface flow

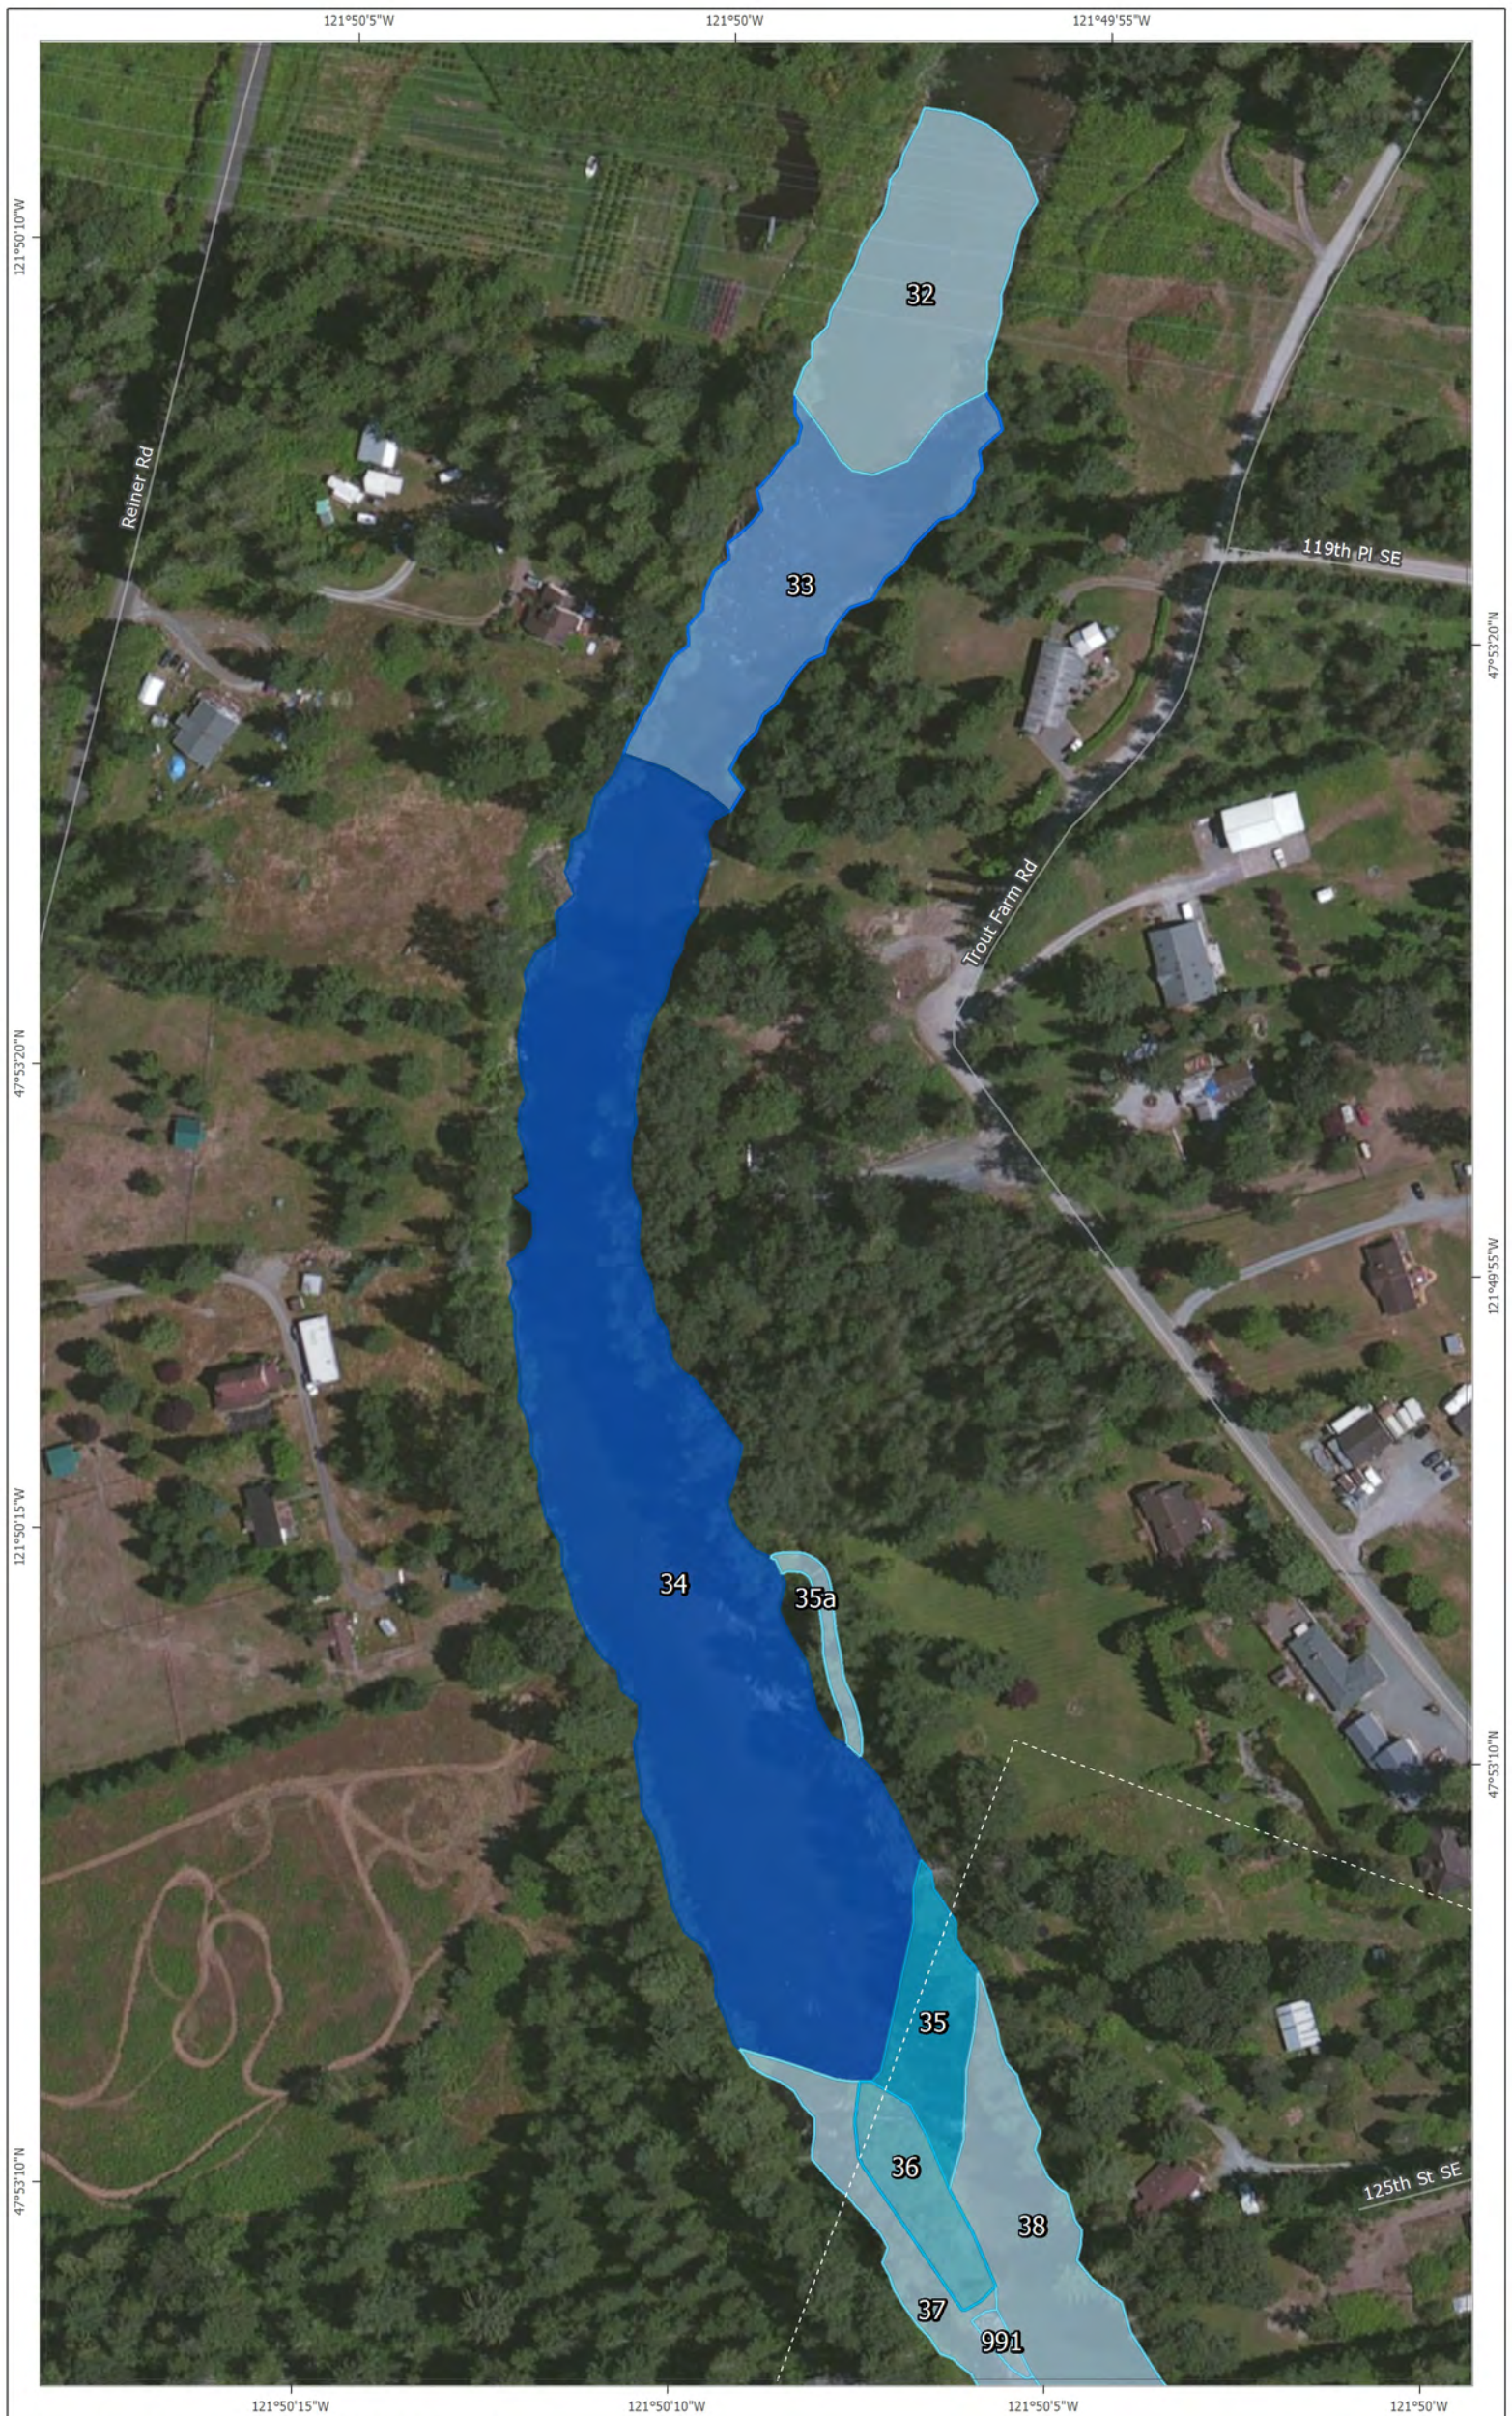
SULTAN RIVER LARGE WOODY DEBRIS  
Large Woody Debris (LWD)

- LWD count by Habitat Unit
- |       |         |         |

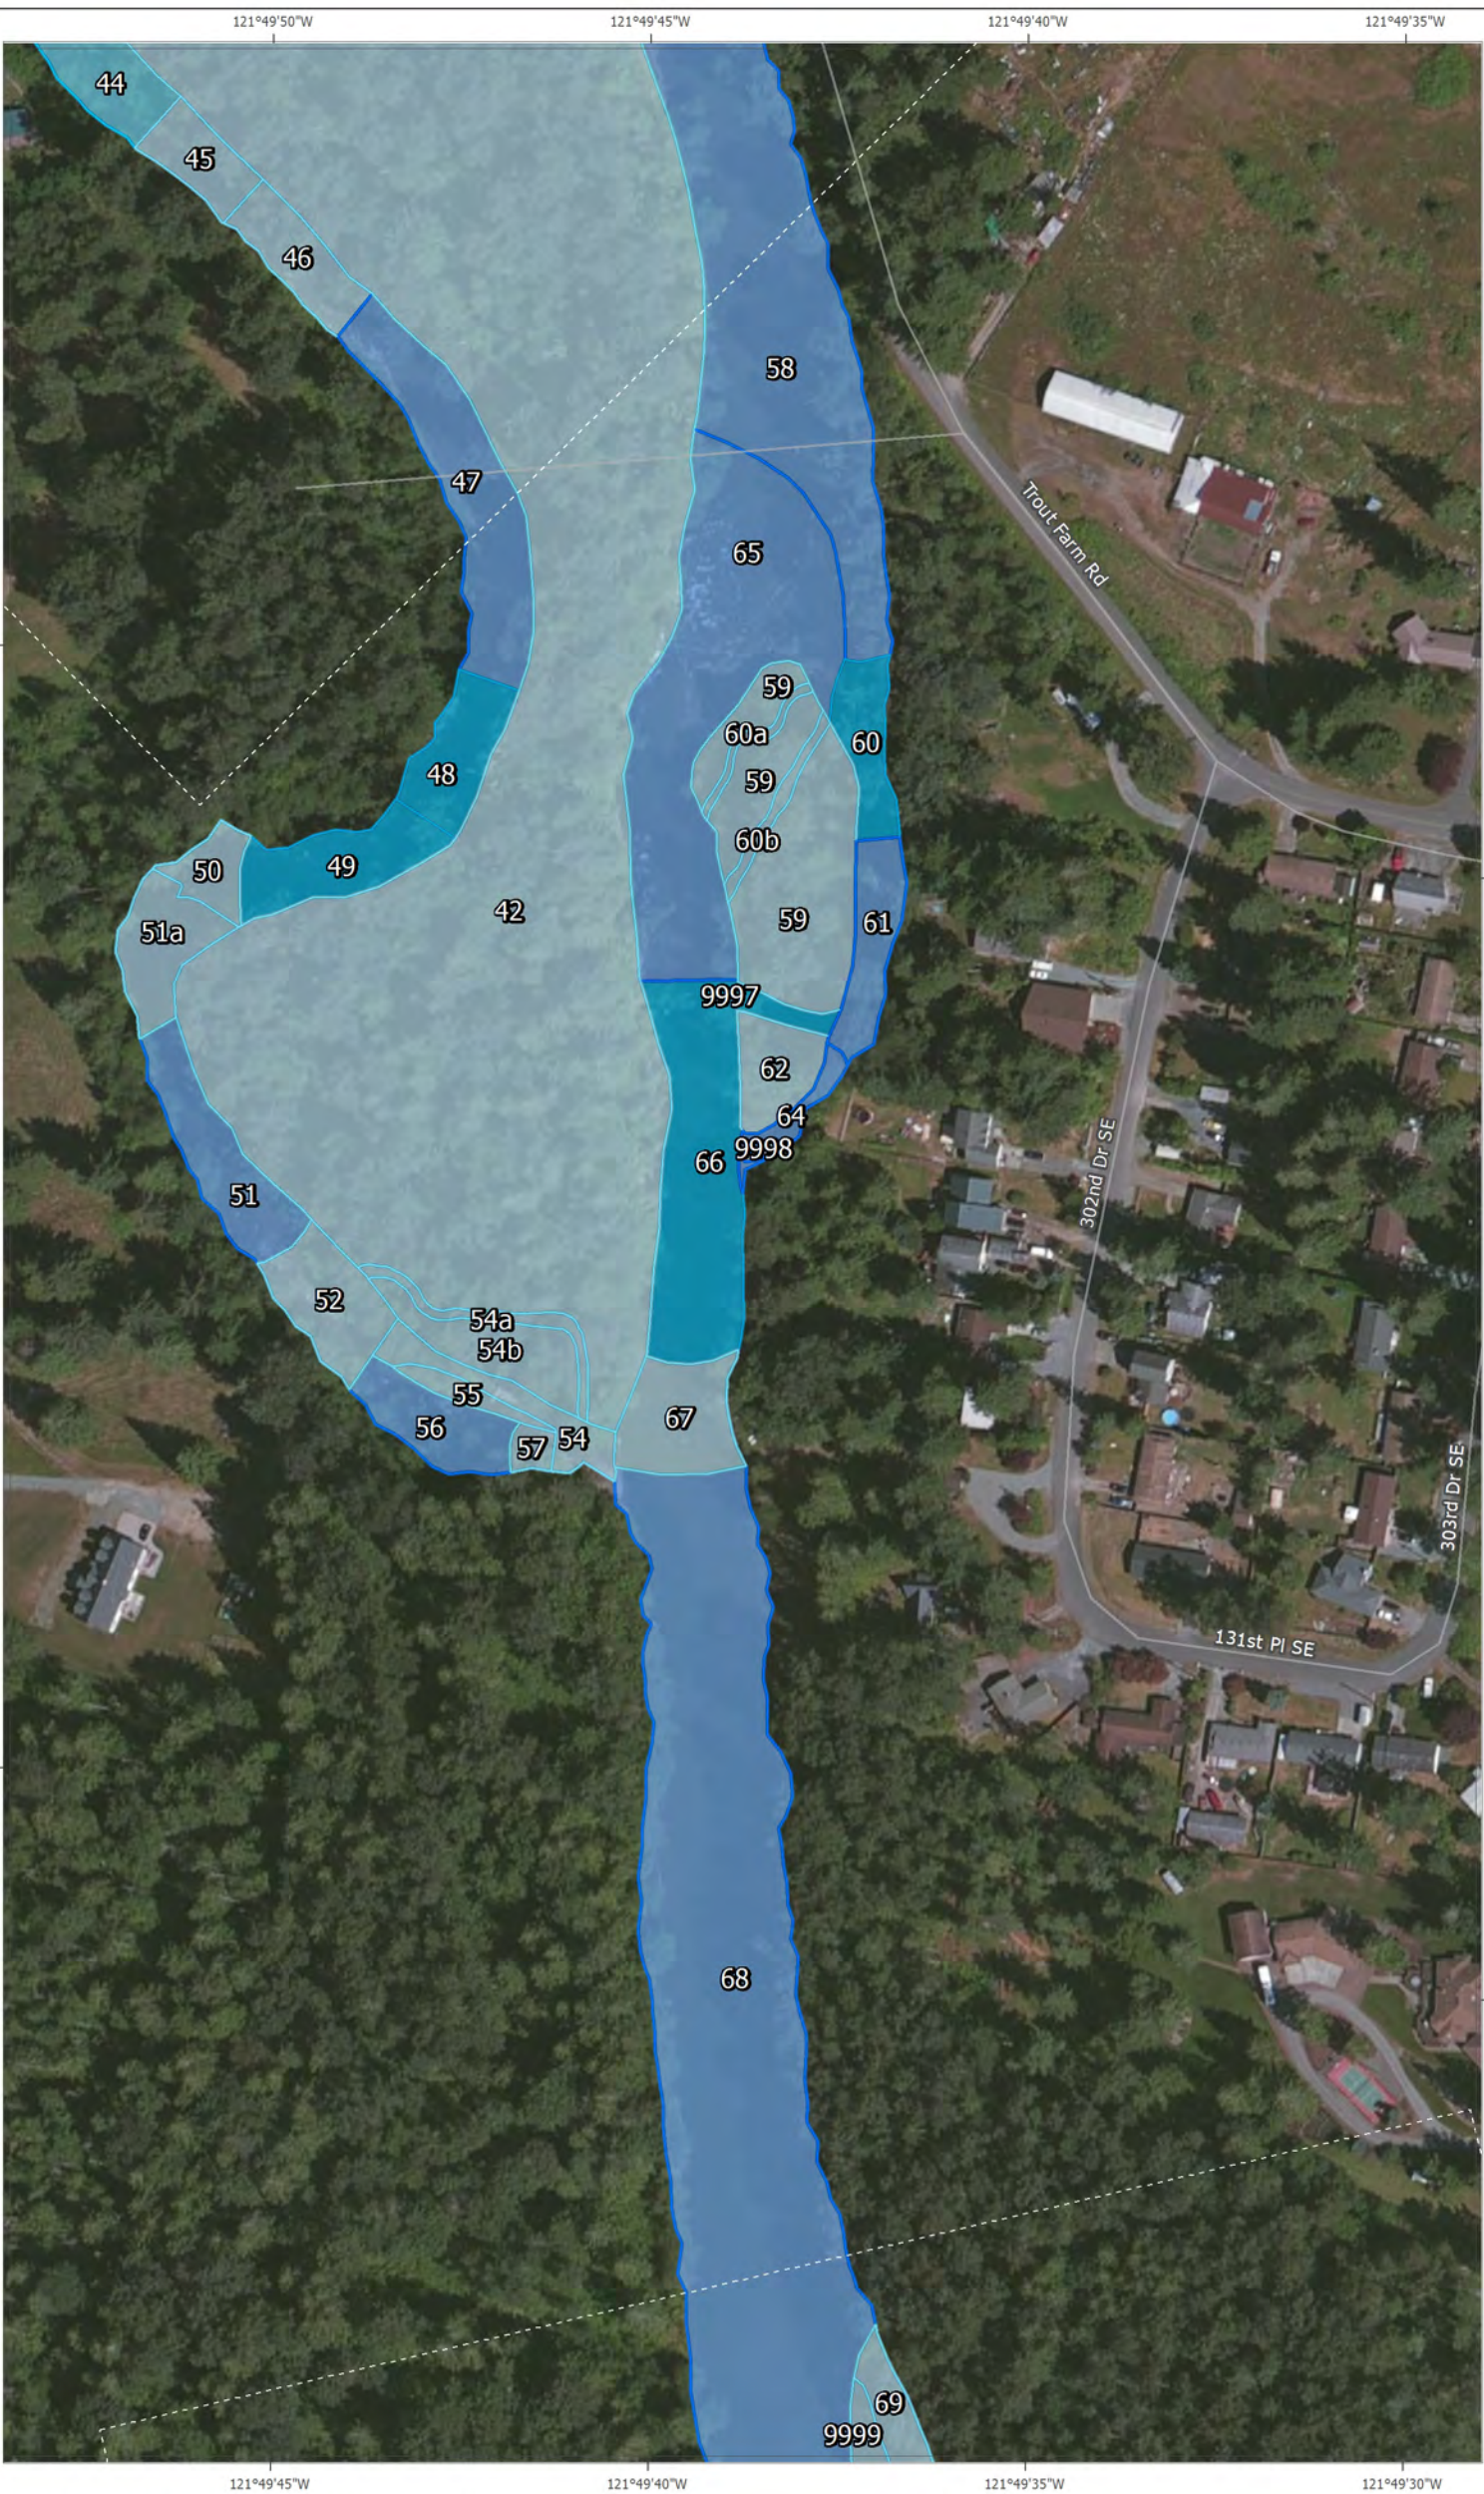
SULTAN RIVER LARGE WOODY DEBRIS  
Large Woody Debris (LWD)

- LWD count by Habitat Unit
- |       |         |         |

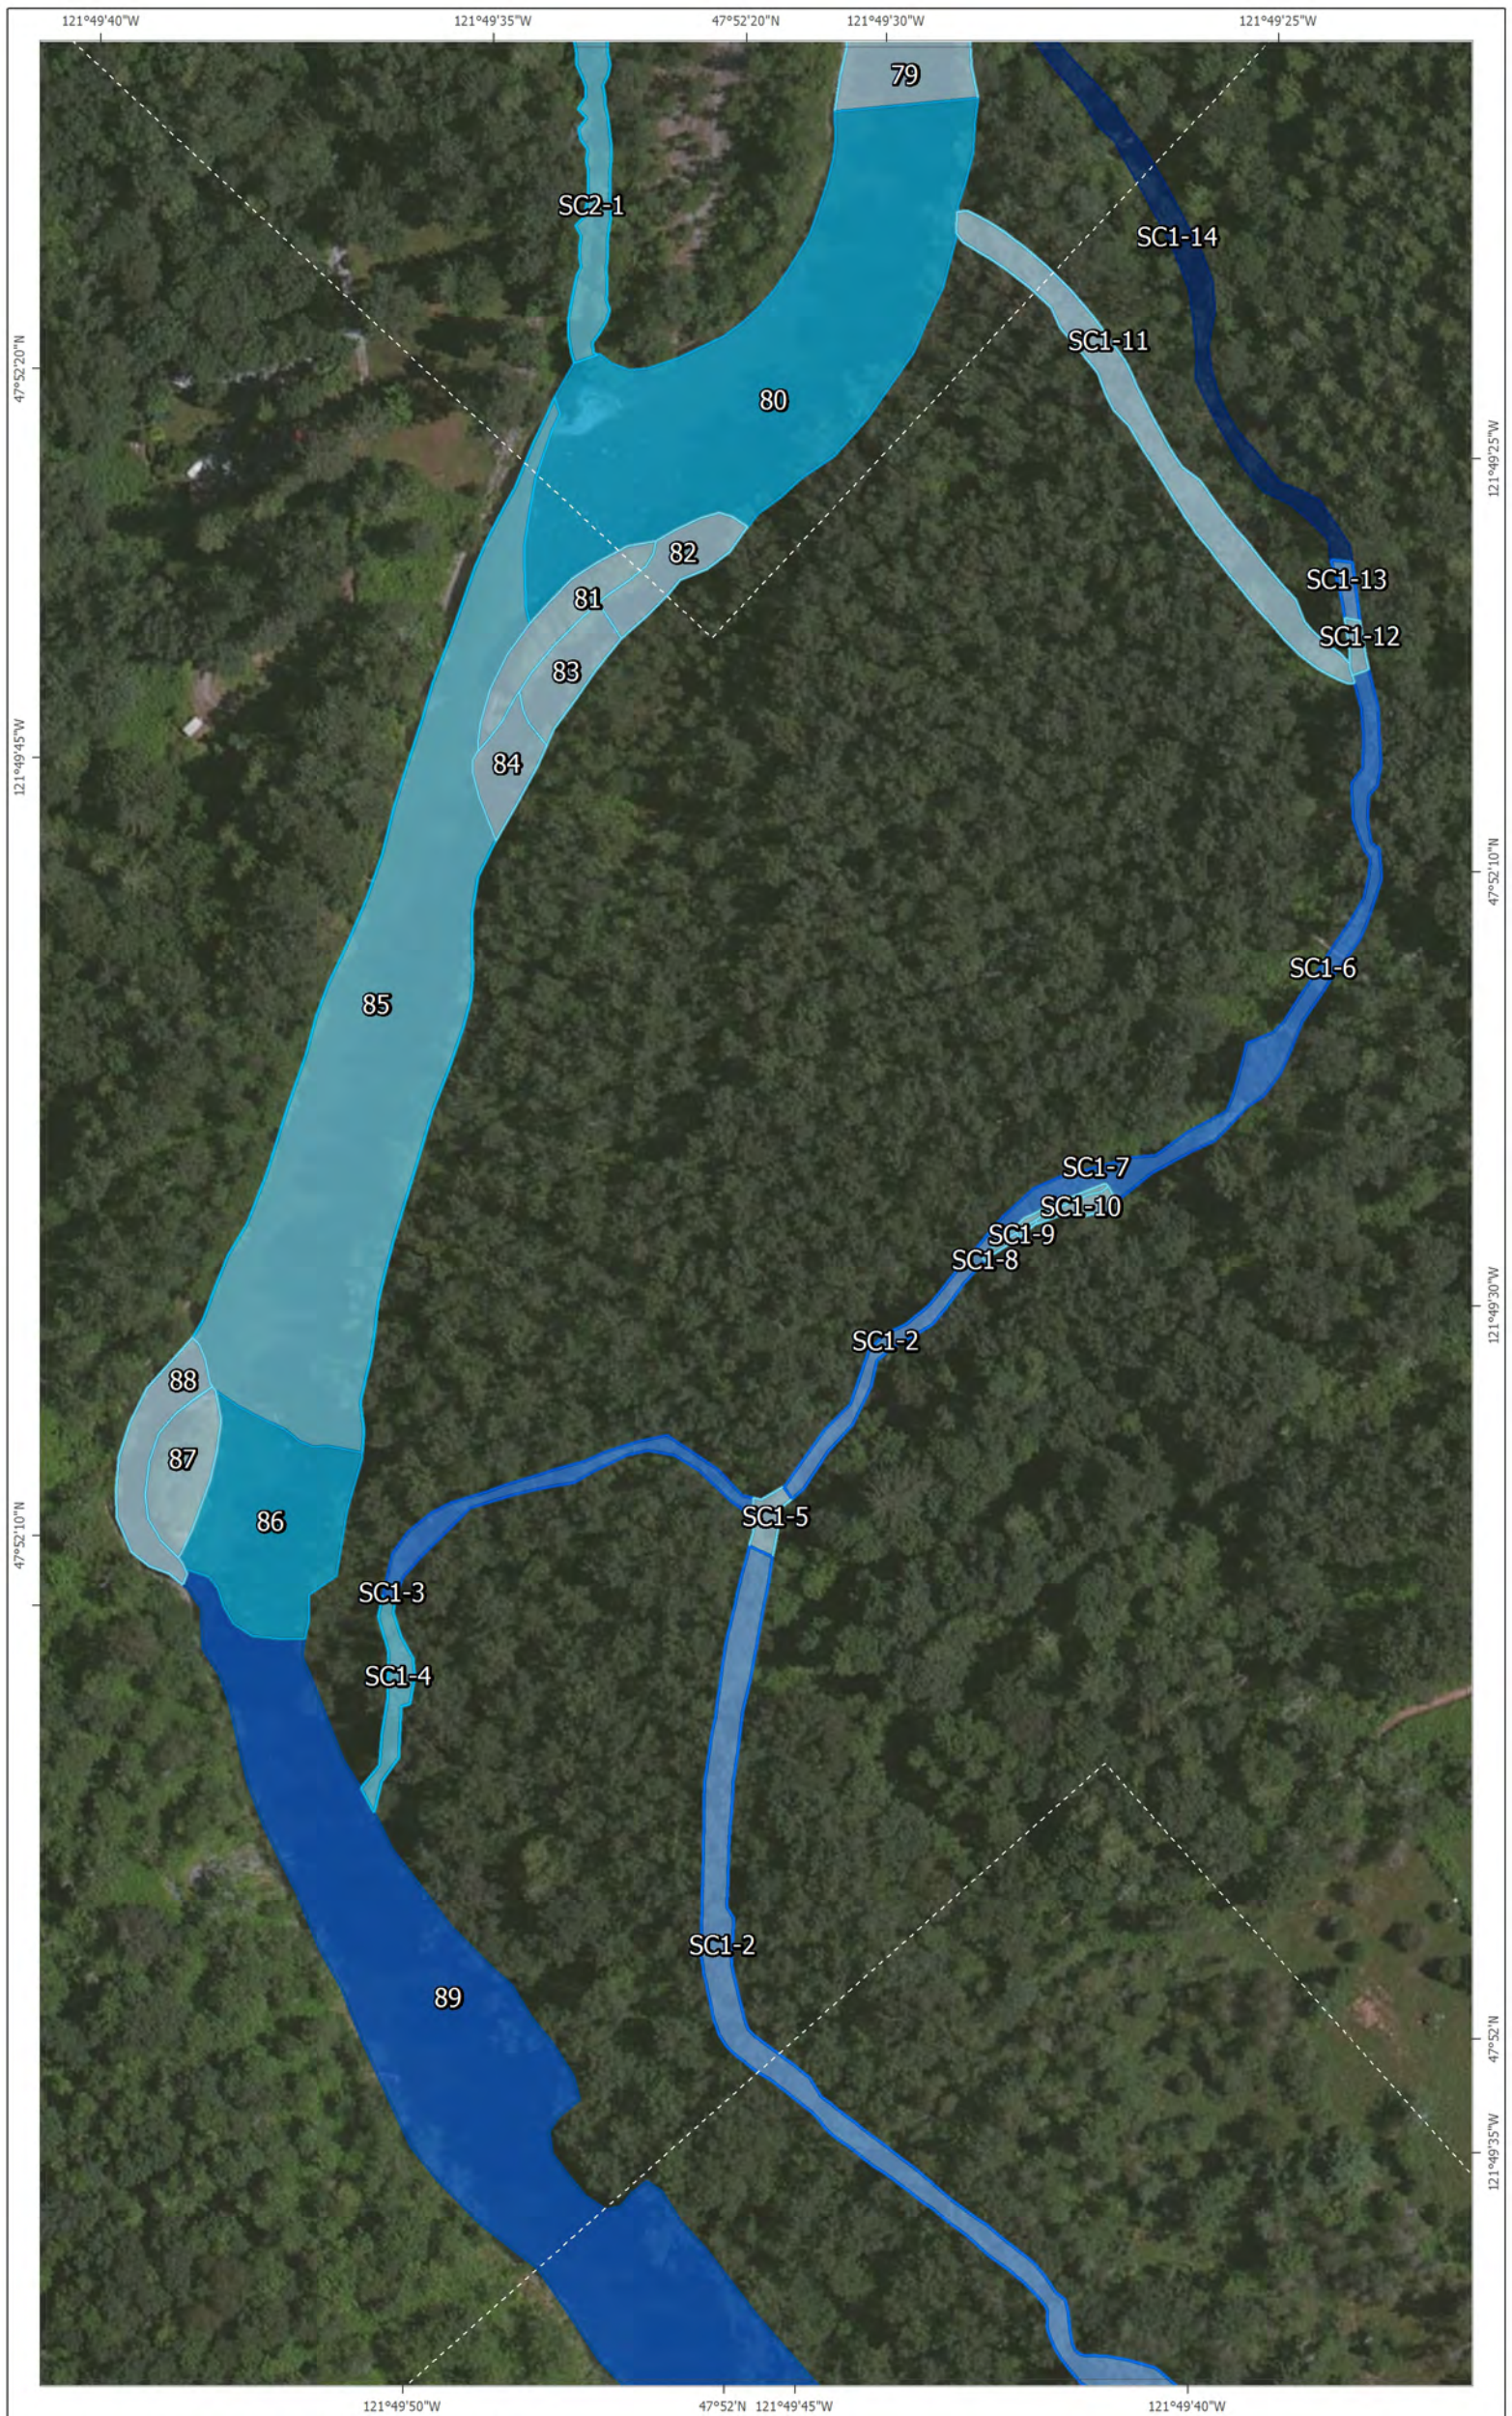
SULTAN RIVER LARGE WOODY DEBRIS  
Large Woody Debris (LWD)

LWD count by Habitat Unit
