FINAL REPORT • DECEMBER 2016

Sultan River

Riverine Habitat Monitoring

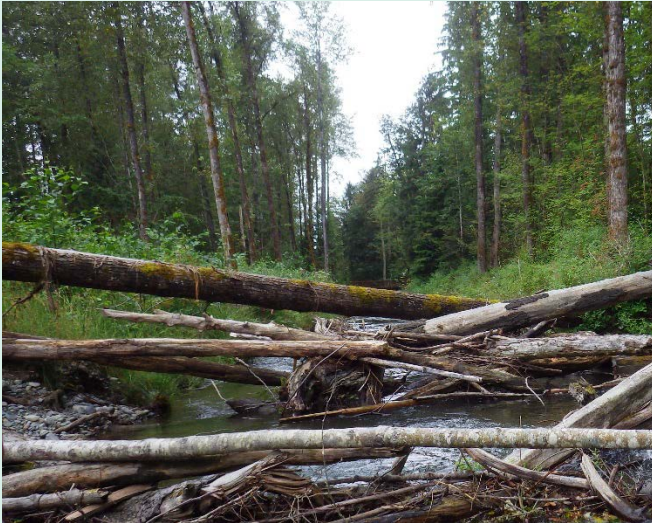
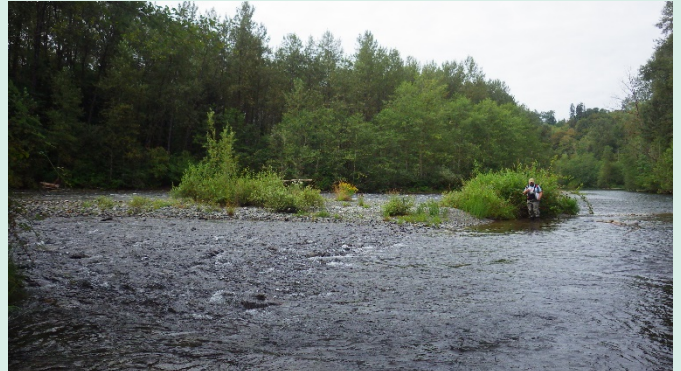
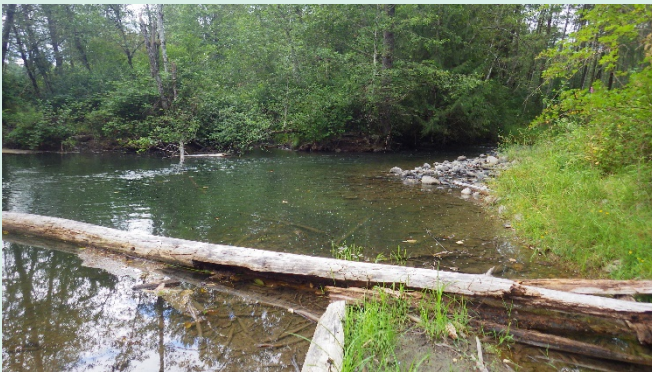
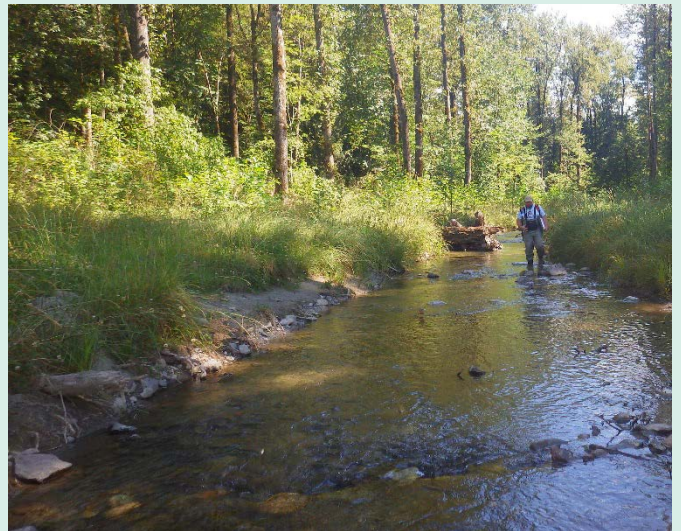
Cover photos: Clockwise from top left: Pool feature formed by installed wood at the head of Side Channel 4; gravel accumulation at outlet of Side Channel 2; riffle near the head of Side Channel 1; outlet of a newly formed pool in Side Channel 3.

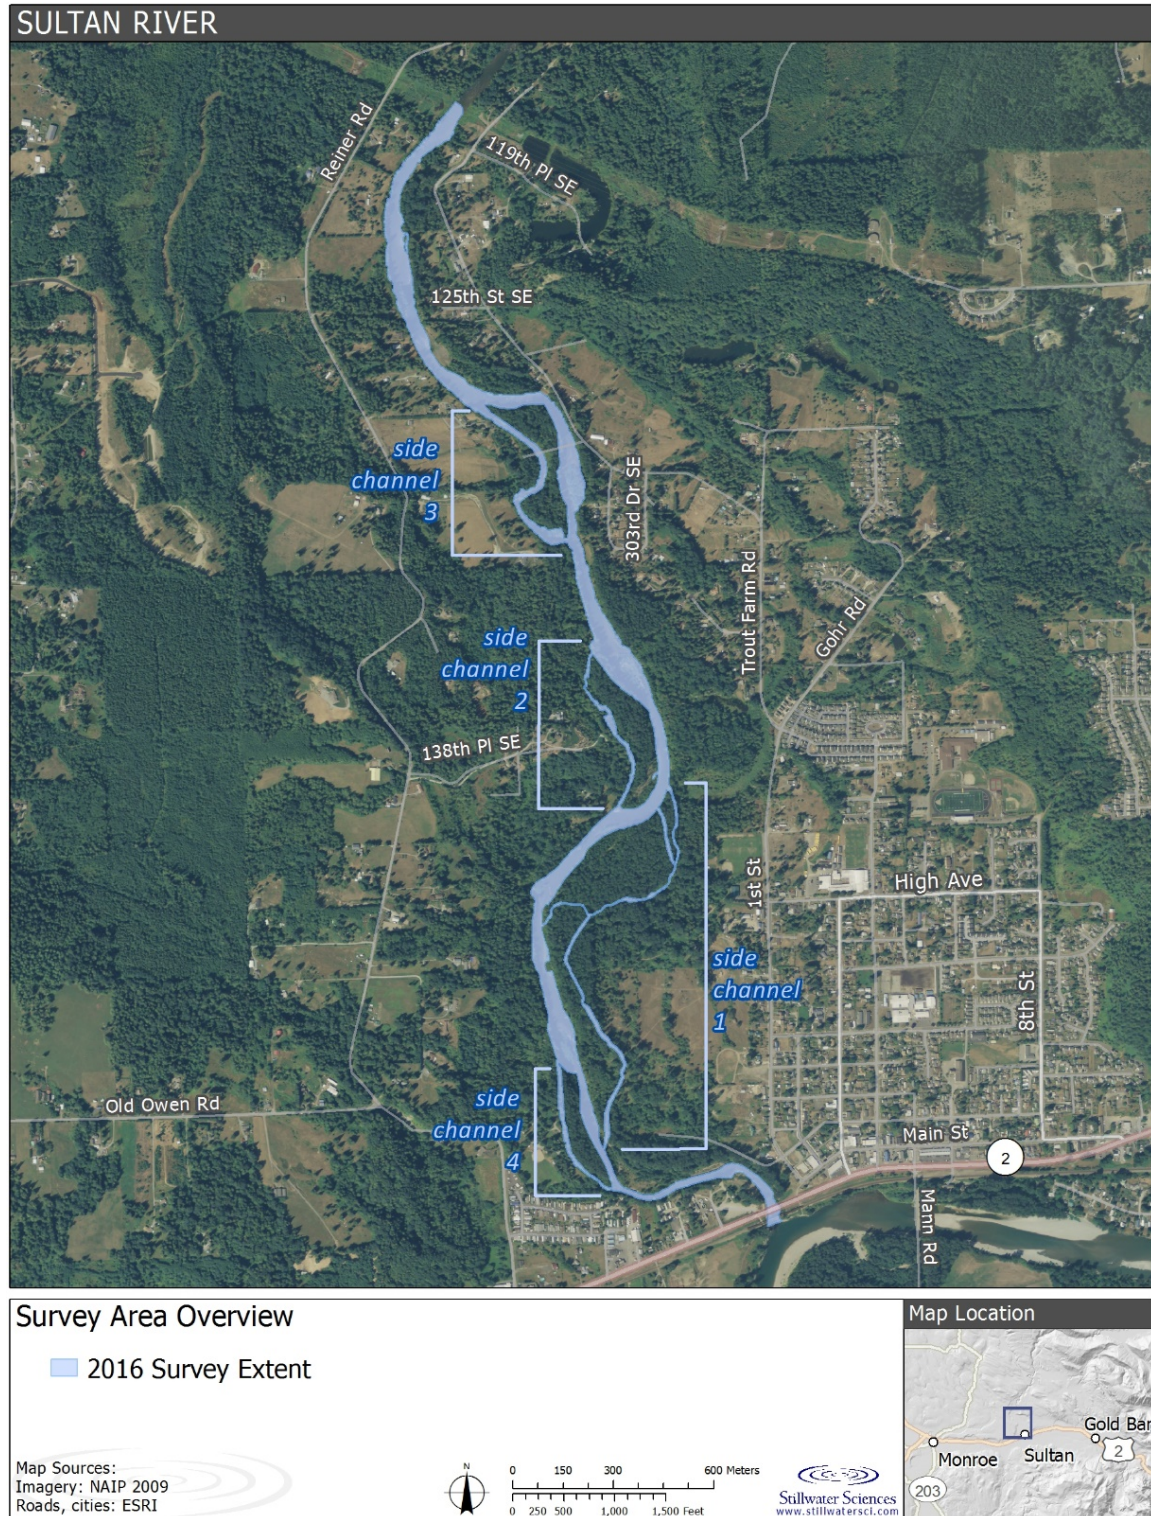
Figure 1. Overview map of Study Area, spanning the lowermost 2.7 miles of the Sultan River upstream of its confluence with the Skykomish River (bottom right portion of the image). The four side channels covered by this survey are labeled.

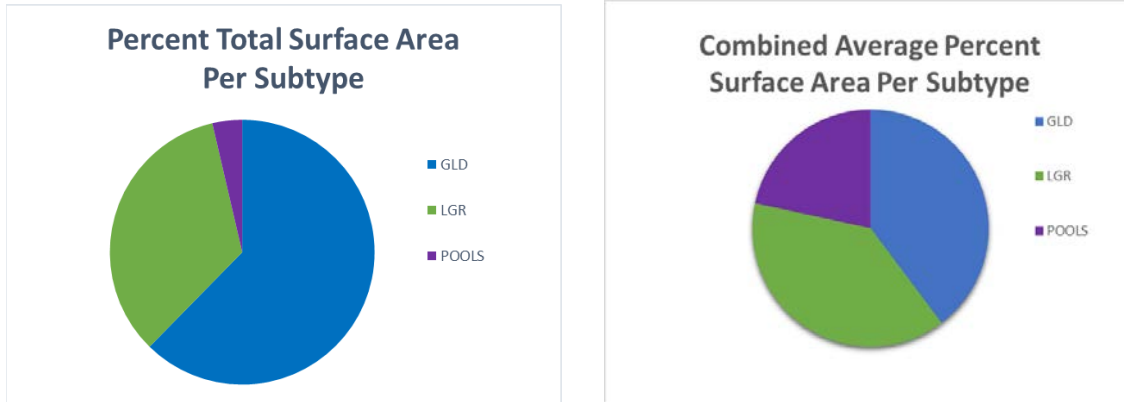
Figure 2. 2016 survey percent total surface area and combined average percent surface area per subtype. Habitat subtypes are as listed in Table 5: glide (GLD), low-gradient riffle (LGR), POOLS (including pool complexes and main channel, lateral scour, backwater, intermittent, and isolated pools).

Figure 2 provides two alternative representation of the relative proportion of the primary habitat types and subtypes. The first graph (left) displays the total surface area per type/subtype across all reaches (i.e., mainstem and side channels) as a percent of the study reach total surface area (from Table 6). The second graph (right) displays the sum of each type/subtype’s average percent surface area as calculated for each side channel and the mainstem individually (from Table 7).

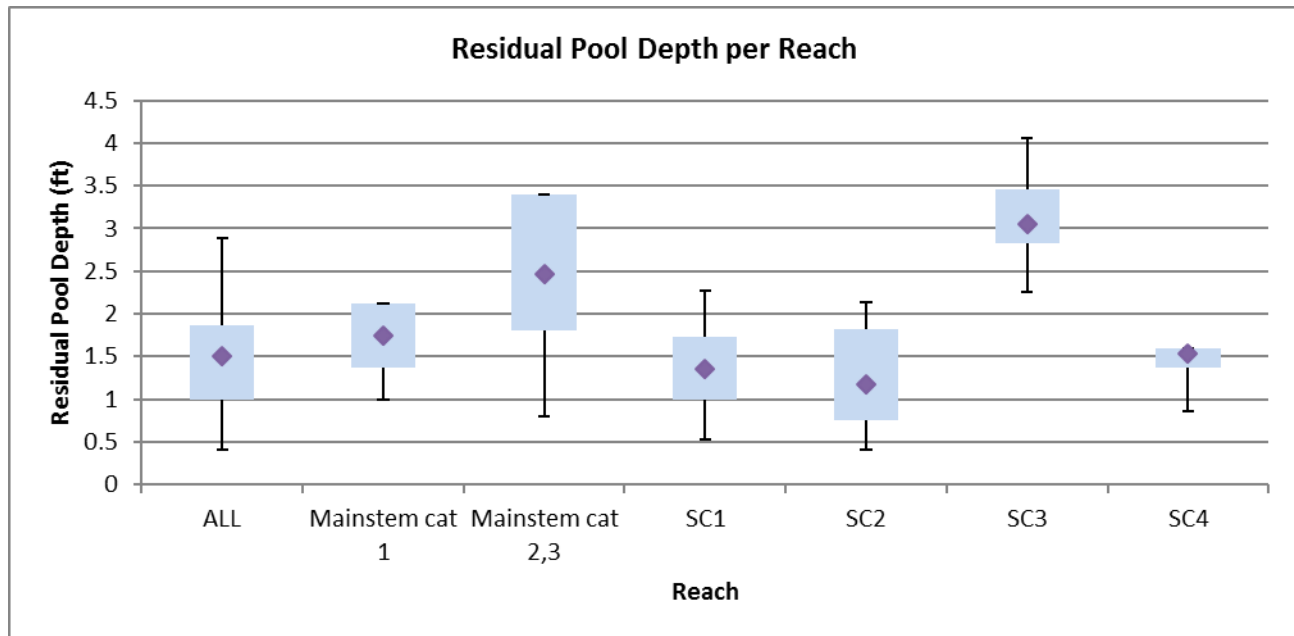
Figure 3. Box-and-whisker plots of surveyed residual pool depth by survey reach. The boundary of a box closest to zero indicates the 25th percentile, the diamond within a box marks the median, and the boundary of a box farthest from zero indicates the 75th percentile. Box whiskers indicate the minimum and maximum values.

Residual pool depth measurements for a given stream provide the number and spatial distribution of deep pool habitats that can support aquatic life, even through annual low-flow periods. Residual pool depth is the maximum wetted depth minus the wetted pool crest depth (Lisle 1987). In all cases, the average residual pool depth was 1.5 ft, with the first quartile measuring 0.96 ft. Median residual pool depths were comparable between reaches, ranging from 1.25 ft (SC1) to 3.4 ft (SC3). Residual depths were most variable in the mainstem (Figure 3). The smaller channels in the mainstem (categories 2 and 3) have greater residual pool depth because their downstream controls tend to be much shallower than the large mainstem pools². SC3 is a natural channel and not recently constructed, which may explain its deeper residual pool depth than those measured in SC1, SC2 and SC4.

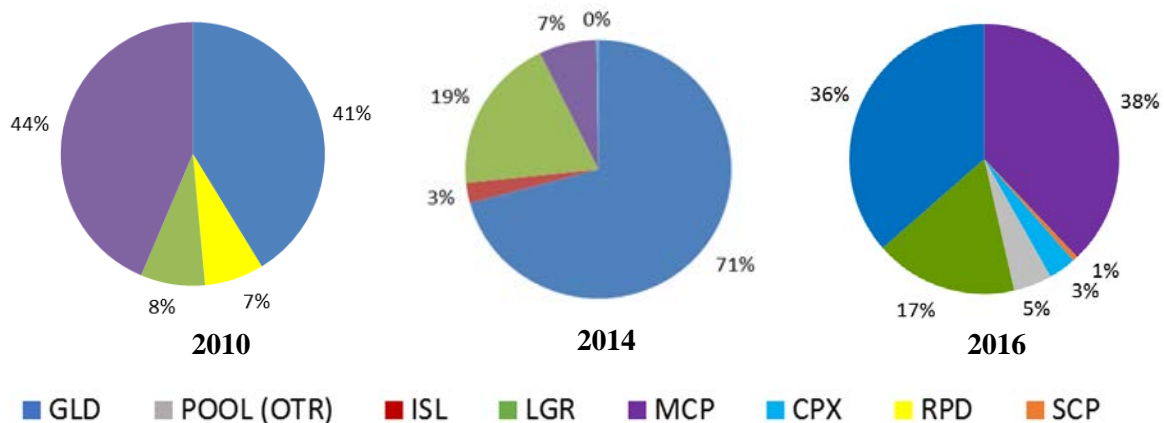
SC1 Composition by Surface Area in 2010, 2014, and 2016

Figure 5. Comparison of SC1 composition by surface area in 2010, 2014, and 2016. Habitat subtypes are as listed in Table 5: Glide (GLD), Intermittent and isolated pools POOL (OTR), high gradient riffle (HGR), island (ISL), low-gradient riffle (LGR), main channel pool (MCP), pool complexes (CPX), rapid (RPD), and lateral scour (SCP).

Since 2014, SC1 has evolved from a relatively homogenous channel that comprised 18 units (primarily main channel pools, low-gradient riffles, and glides) to one that is now made up of 93 units including 35 pools, stretches of dry channels and isolated pools, as well as a marsh, islands, and glides and low-gradient riffles.

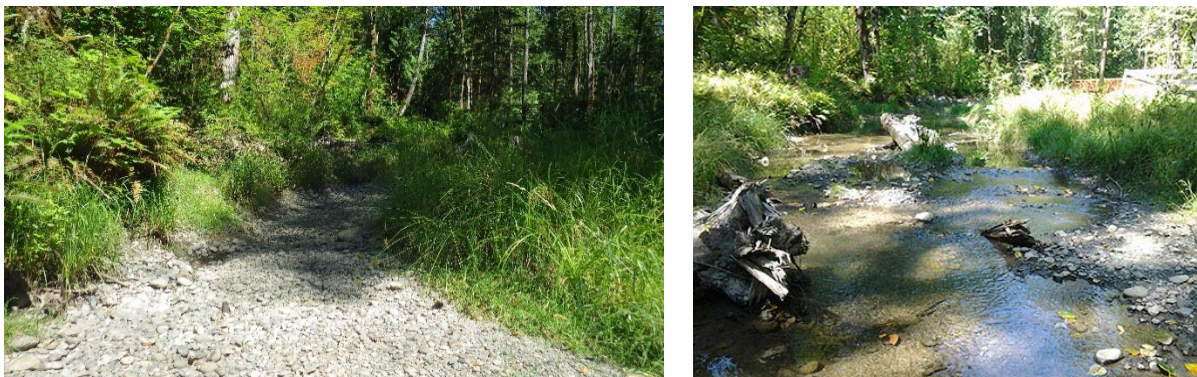
Figure 6. SC1 downstream of the distributary split in SC1-5 was locally dry in 2016 (left); in 2014, the channel was wet in its entirety (right) from the head to its outlet.

Discharge from the mainstem into the inlet of SC1 during the habitat assessment of 2016 was little different from 2014 and does not explain these results. What has changed between these two surveys is the split of flow at near the midpoint of the side channel (at SC1-5), where a short segment of channel returns flow to the mainstem river while the side channel itself continues for more than 1,000 ft farther before rejoining the Sultan River. Although this distributary network has increased the total length of side channels it has also allowed for the natural redistribution of water between the branches, which at present favors the shorter return segment back to the mainstem at low flows and a consequent reduction in wetted area and an increase in areas of dry channel and marsh downstream of the split along the other segment.

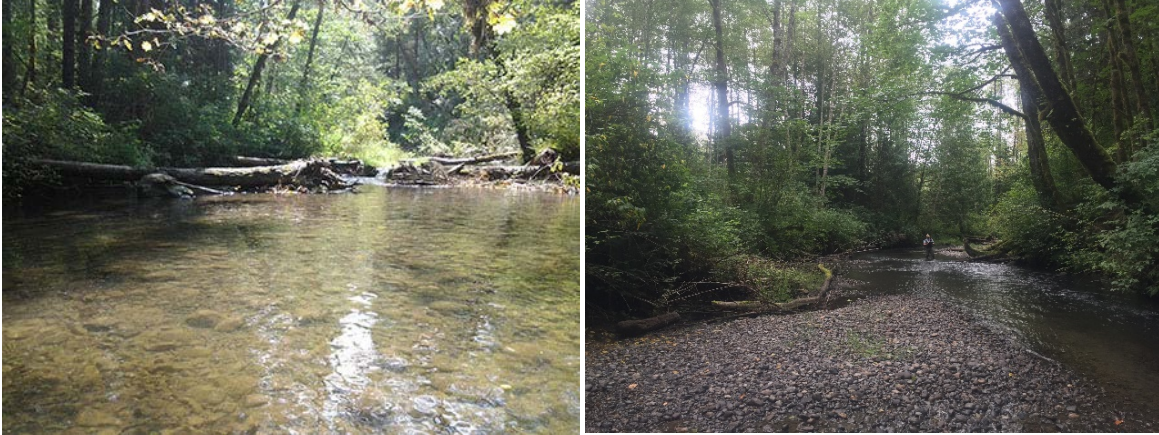
Figure 8. NSO SC2-15 was classified as a 274-ft-long glide in 2014 (left); as of the 2016 survey, it had become a shorter 45-ft glide surrounded by a large main channel pool and riffle (right).

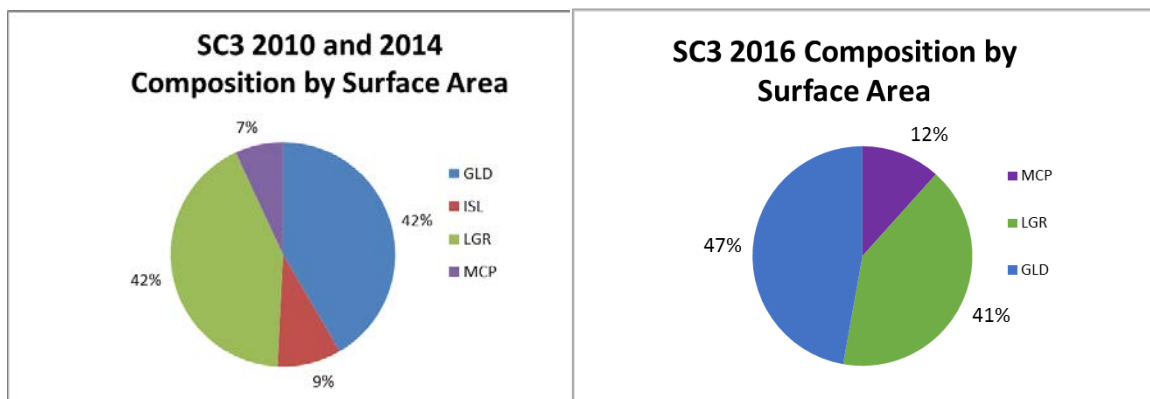
Figure 9. SC3 composition by surface area in 2010, 2014, and 2016.

- the stream length increased by 390 ft (16%), likely due to increasing meander;
- average wetted width for main channel pools doubled, from 15.5 ft in 2014 to 31.2 ft in 2016; and
- undercut banks were not observed in any unit on the left bank and were observed to be present in only 34 ft of the right bank.

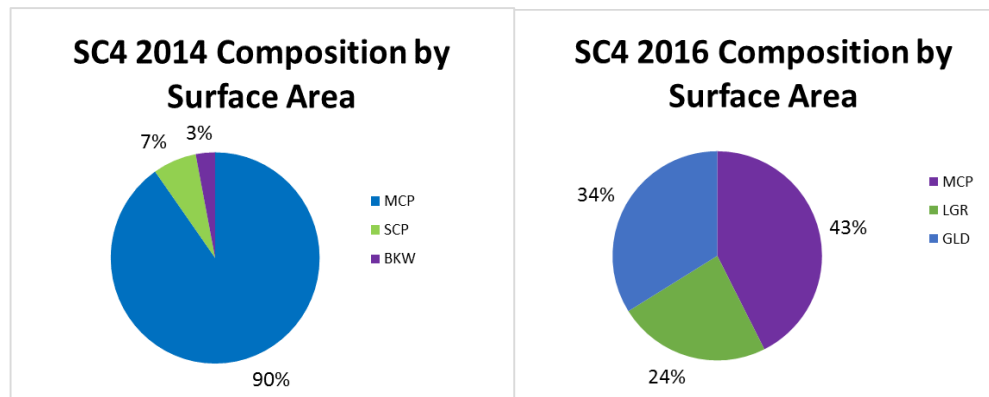
Figure 10. SC4 composition by surface area in 2014 and 2016.

The observed changes to SC4 were the most dramatic, and beneficial to fish habitat, of any side channel in the Study Area. Since 2014, SC4 has been transformed from essentially one long glide (with a small pool at its mouth and one riffle) to a variable pool-riffle-glide reach (Figure 10). Depths in SC4 now range from 0.8 to 2.7 ft, compared to 2014 when depths ranged from only 0.9 to 1.2 ft. The mixture of flows and depths derived from the more variable habitat now present is key to sustaining fish and invertebrate species. Undercut habitat also increased since 2014, by 392 ft on the left and 72 ft on the right banks.
