RE: Henry M. Jackson Project – FERC No. 2157  
Project License Article 53 – Annual Report  
Wildlife Habitat Management Program

**1997 ANNUAL PROGRESS REPORT**

**WILDLIFE HABITAT MANAGEMENT PROGRAM**

**HENRY M. JACKSON HYDROELECTRIC PROJECT**

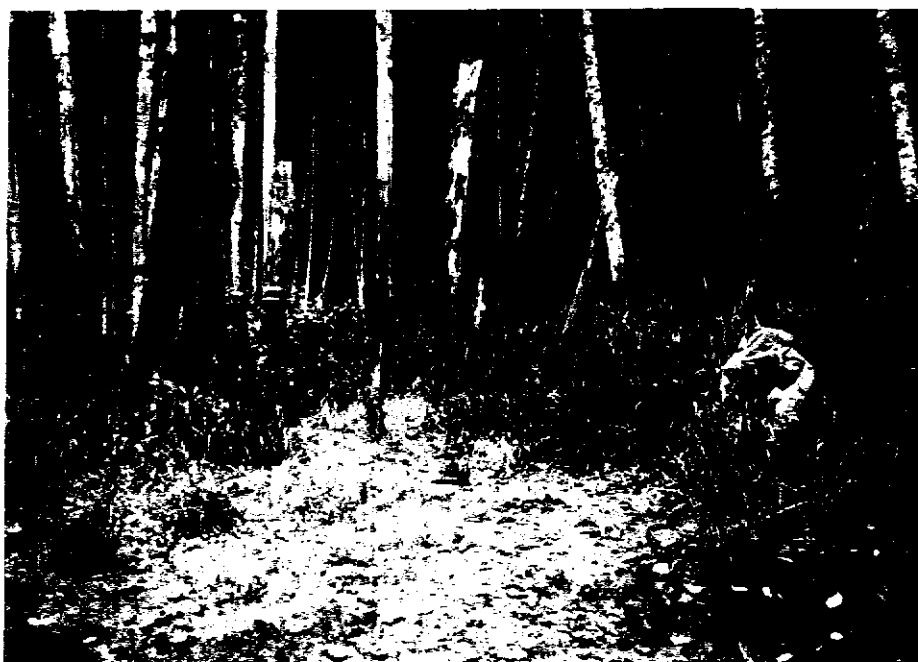
Williamson Creek revegetation site. September 1997.  
Planted and volunteer slough sedge growing between 1438 ft and 1441 ft elevation.

Plantings at Williamson Creek were monitored in September 1997. Survival of plantings at the Williamson Creek site was much better than at the North Fork site because they are less subject to damage by wave action and floating debris. The sedges survived in greater numbers than other species between 1437-1441 ft. elevation, similar to the North Fork site. About 80 percent of the planted slough sedge (C. obnupta) at Williamson Creek have survived. Volunteers of this species are present on the site in the same elevation range. Some planted hardstem bulrush (Scirpus acutus) also survived, but volunteer small-fruited bulrush is the dominant species, similar to the North Fork site.

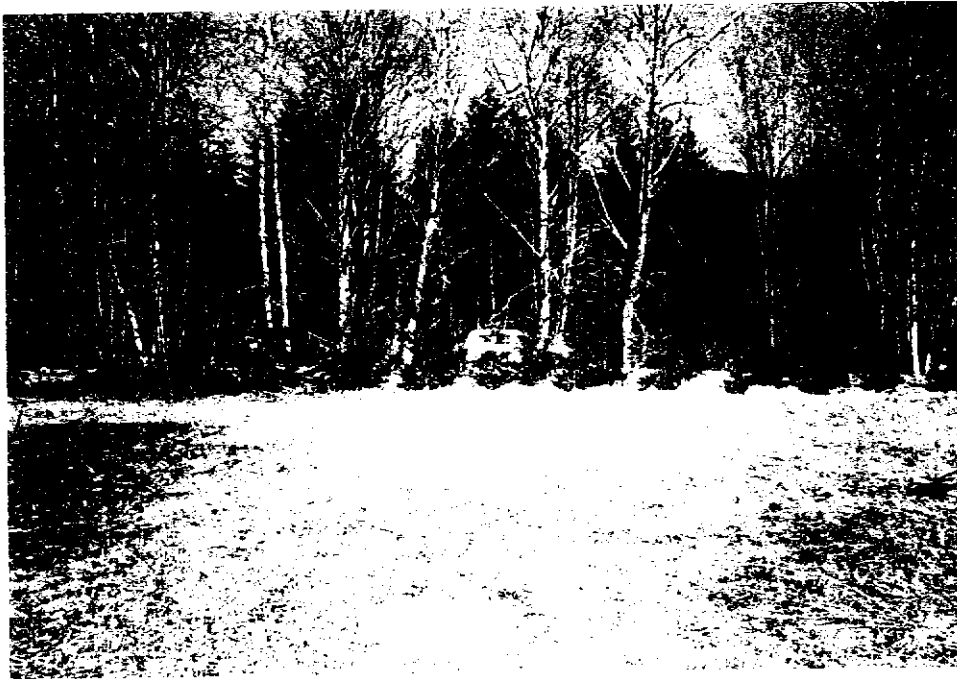
FIGURE 5. North End of Lake Chaplain. February 1997. Planted row of Douglas fir and western red cedar viewed from lakeshore toward access road.

Douglas fir and western red cedar seedlings were planted in 1992 at the north end of Lake Chaplain to provide a visual screen between the lake and the adjacent road (Figure 5). The trees were monitored in February 1997. There has been no change in this area since the 1996 Annual Report, except that the trees have become taller. As reported in 1996, the Douglas fir trees are generally in excellent condition, with very little mortality since planting. Average height is over ten feet. Approximately 60 percent of the western red cedar trees have died since planting, and the remainder are in fair to good condition. Average height of red cedars is about six feet.

**Bernice** - The photo in Figure 5 shows the planted visual screen from a point on the lakeshore looking toward the road. You can see we're beginning to get a bit of a screen there after planting the seedlings in 1992. Douglas fir is doing well, but the western red cedar, which was planted in a moist area, is not doing as well. We're expecting to go out this year and remove some alders to prevent them from shading the surviving cedars.

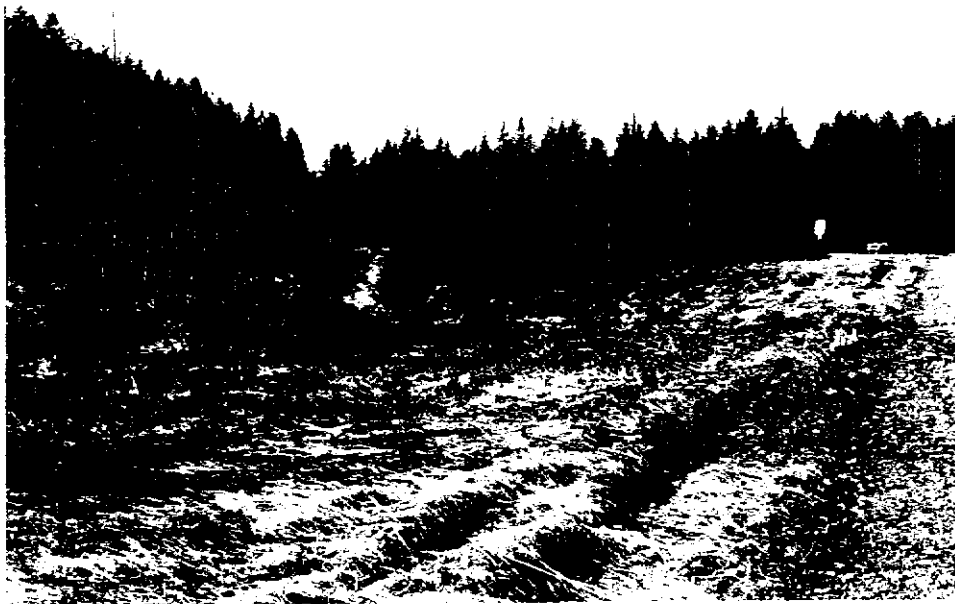
View of planted Douglas fir trees from south to north. February 1997.

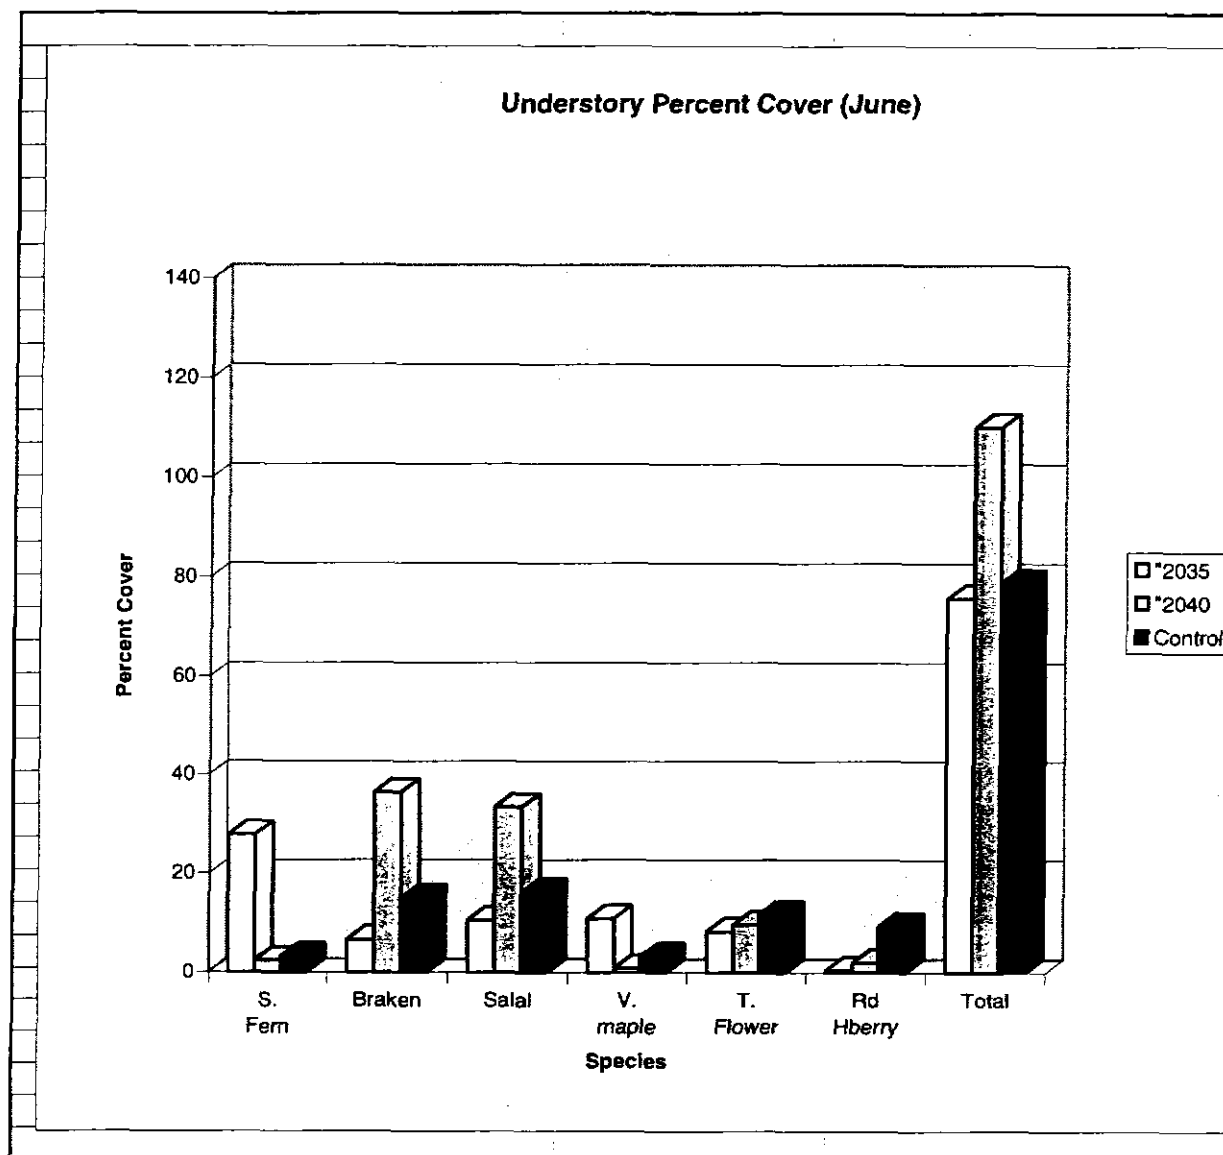
FIGURE 8a. Biosolids Application Project. Understory Vegetation Monitoring Results in June 1997.

4. Biosolids Application Sites. Dan showed the two treatment units (2035 and 2040 final harvest) and the control for the 2040 stand. The group noted the response of elderberry, fern and twinflower in particular, on the treatment stands. Dan presented graphs of understory data collected in June 1997, and said that in spite of the observed response on treated stands, the difference between treated and untreated sites was not statistically significantly different. Gwill requested the September data sets when they become available.

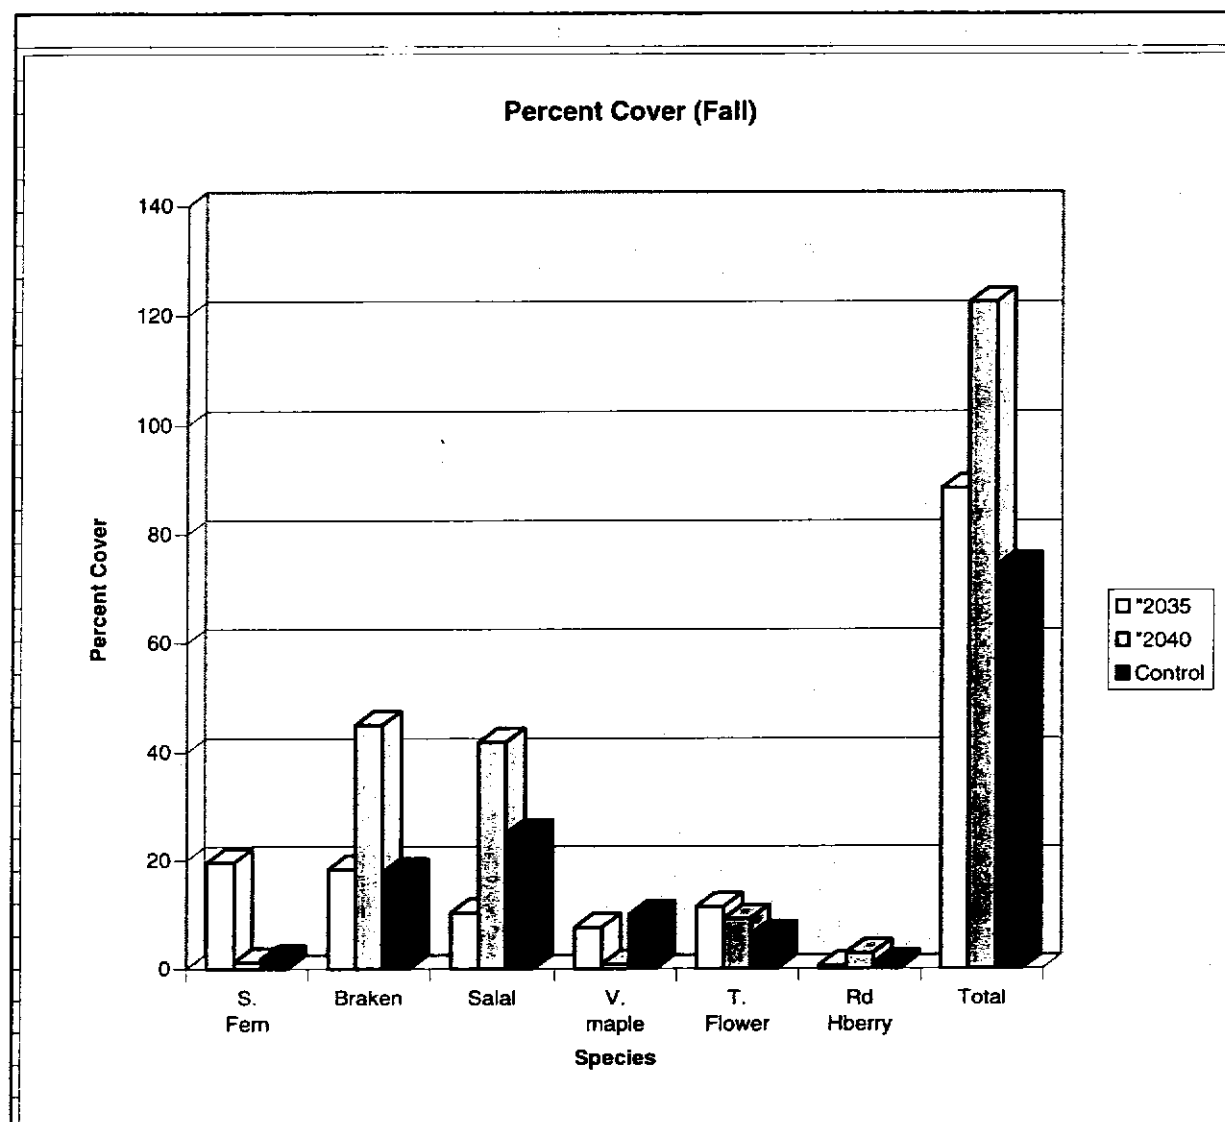
FIGURE 8b. Biosolids Application Project. Understory Vegetation Monitoring Results in Fall 1997.

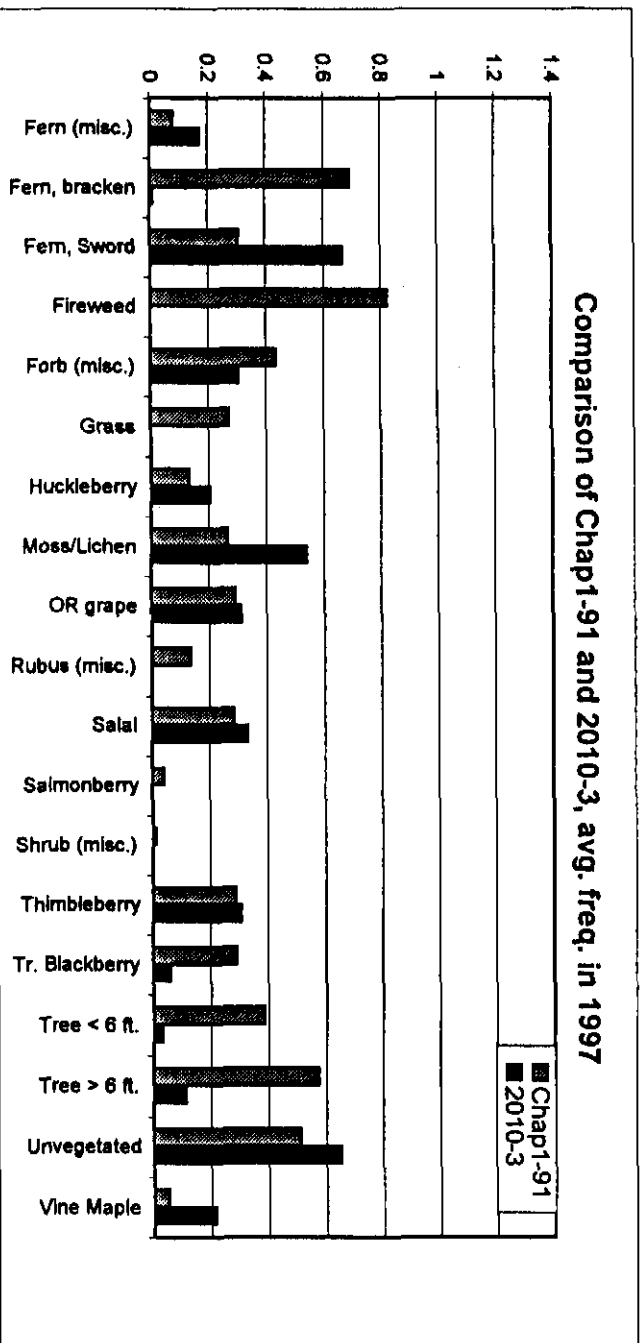
Figure 9. Availability of Major Forage Species on Two Lake Chaplain Harvest Units and Unharvested Control Units

a) Chaplain Sale Unit, harvested in 1991, and Control Unit 2010-3

Deer forage availability was sampled on the two harvested units that have been previously studied: one unit of the Chaplain Sale, harvested in 1991, and one unit of the diversion Sale, harvested in 1995. In addition, one unharvested unit adjacent to each of the harvest units was sampled. Results are presented in Figure 9. The 1991 harvest unit had greater frequency of bracken fern, Rubus species and fireweed than its forested control unit. Fireweed is a very desirable species for deer forage, and evidence of browsing on fireweed was noted on several sampling transects. Sapling trees, which consisted primarily of Douglas fir, but also included hardwoods such as cherry and willow, had high frequency of occurrence on the clearcut and were rare in the control unit. The 1995 harvest unit had very high occurrence of fireweed and various forbs, in comparison with its forested control. The control unit had a lot of salal present, but the clearcut did not. Sapling trees were not frequently encountered on sample quadrats in the clearcut, because only one year had elapsed since the unit was planted.

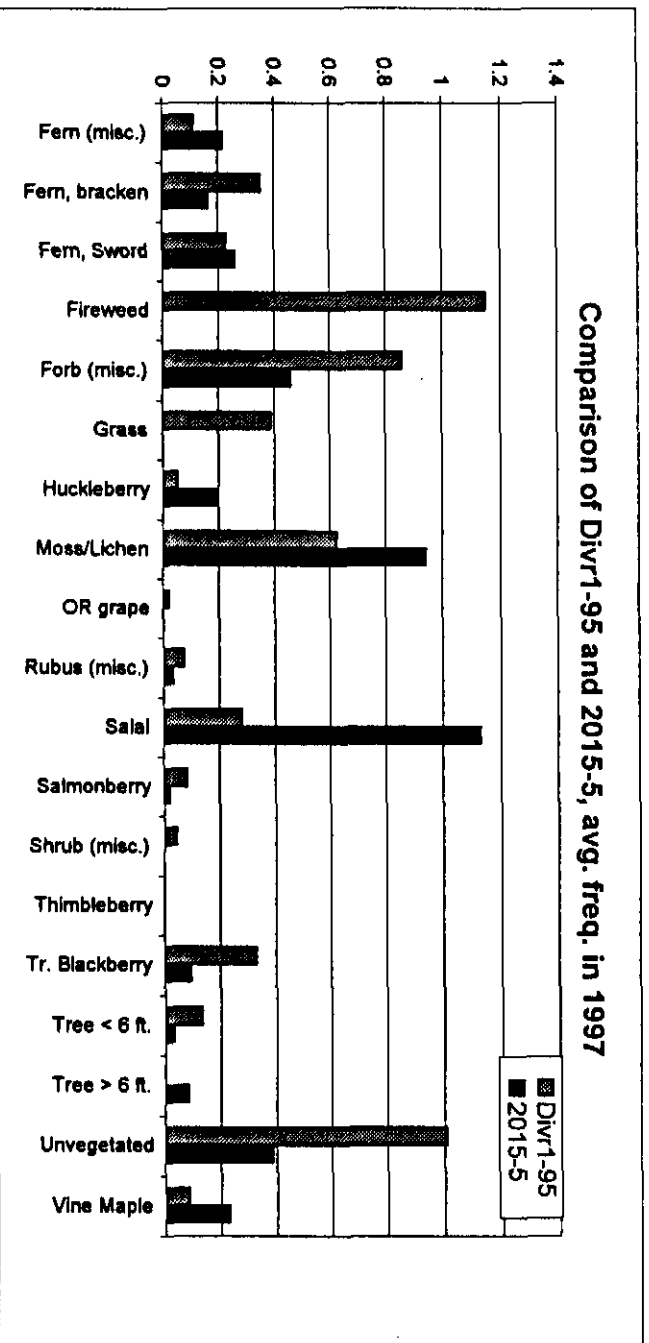
b) Diversion Sale unit, harvested in 1995, and Control Unit 2015-5

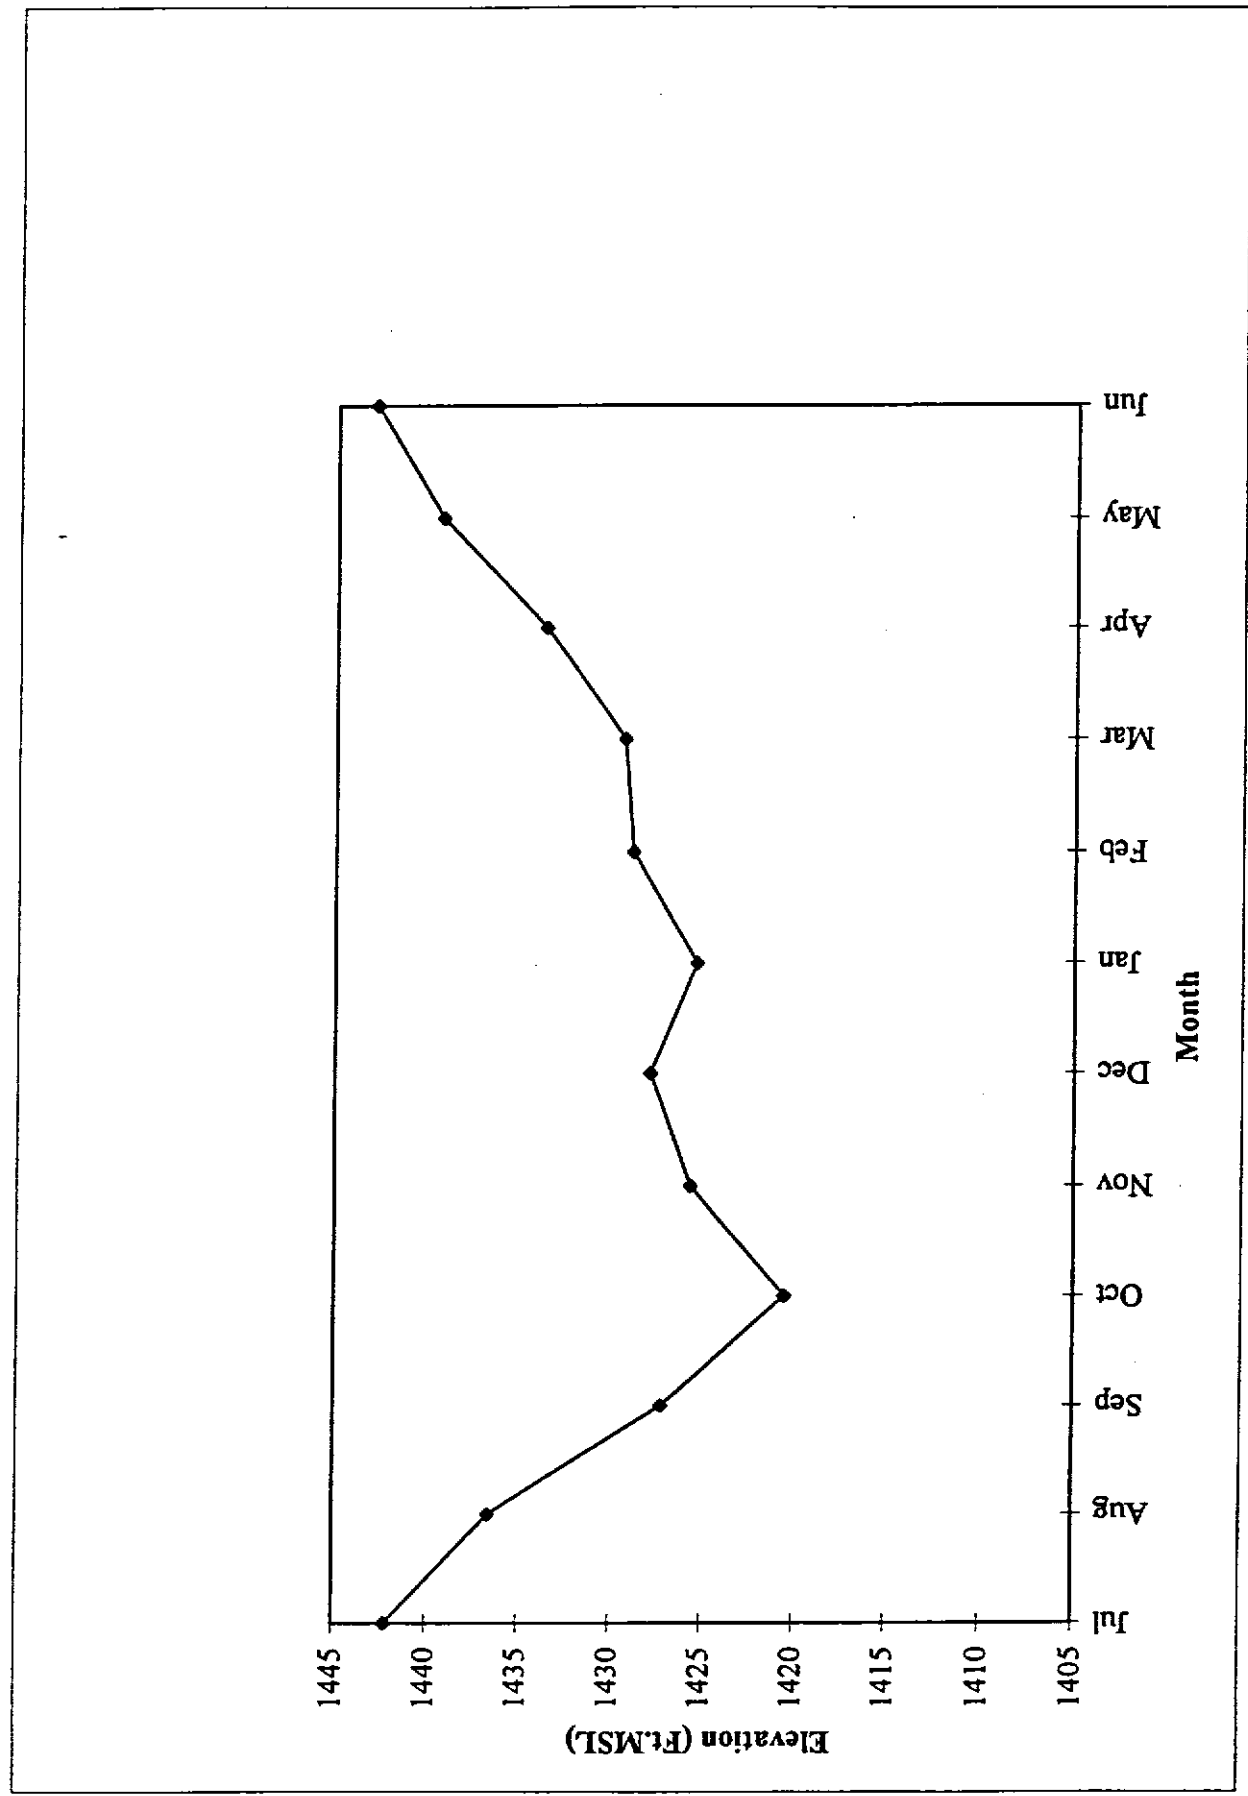
Elevation and fluctuations in the water level of the reservoir are key factors that determine whether a wetland species can become established and how far down the drawdown zone it will grow. The band between 1438 ft and 1441 ft was the most successful for species we introduced on the site and volunteer species. Only one wetland species has become established below the 1437 ft elevation, and it covers a fairly small area at present. This elevation appears to be the limit for emergent species, below which the period of inundation during the growing season (see Figure 12) is too prolonged, even where wave scour is not a problem. Submergent and floating species, such as duckweed or pondweed, are not establishing at lower elevations in the drawdown zone, possibly because they also cannot tolerate the water level fluctuations and scour. Vegetation of the drawdown zone will continue to be limited by the magnitude of water level fluctuations. The lower limit of the vegetated zone is expected to change somewhat from year to year, but the lower drawdown zone is likely to remain unvegetated over time.

Figure 12. Spada Lake Mean Monthly Elevations, 1991-1995
