Subject: Response Letter  
Wetlands/Streams  
Proposed Arlington Local Office Replacement and Substation  
Arlington, Washington  
File No. 0482-051-03

#### Site Map

Arlington Office Replacement/Substation  
Arlington, Washington

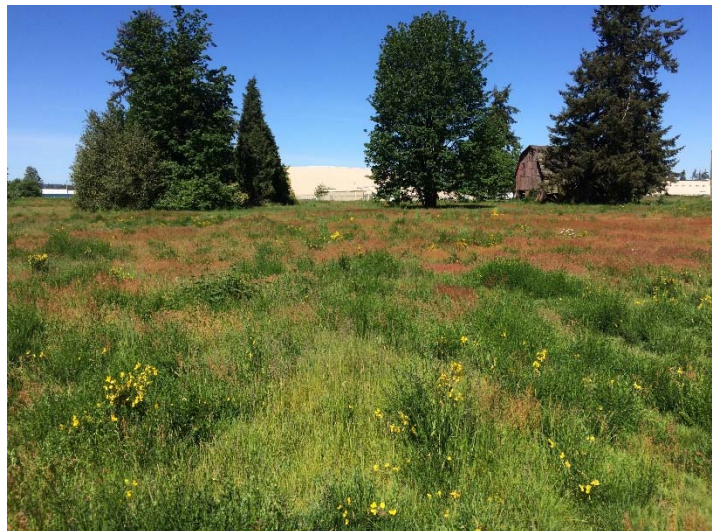
Photo 1. Representative condition of the site, May 10, 2016.

undeveloped and relatively flat uplands with no structures except for an abandoned barn located near the north-central portion of the project site (Photo 1). The parcel is predominantly vegetated with mowed grasses, forbs and Scotch broom (*Cytisus scoparius*); as well as, trees including big leaf maple (*Acer macrophyllum*), Douglas fir (*Pseudotsuga menziesii*) and ornamental apple (*Malus spp.*) which are indicative of uplands. While on site, GeoEngineers' PWS looked for wetland indicators such as changes in vegetation type, depressional areas and the presence of surface water. However, no wetlands were observed on the site during the pedestrian survey.

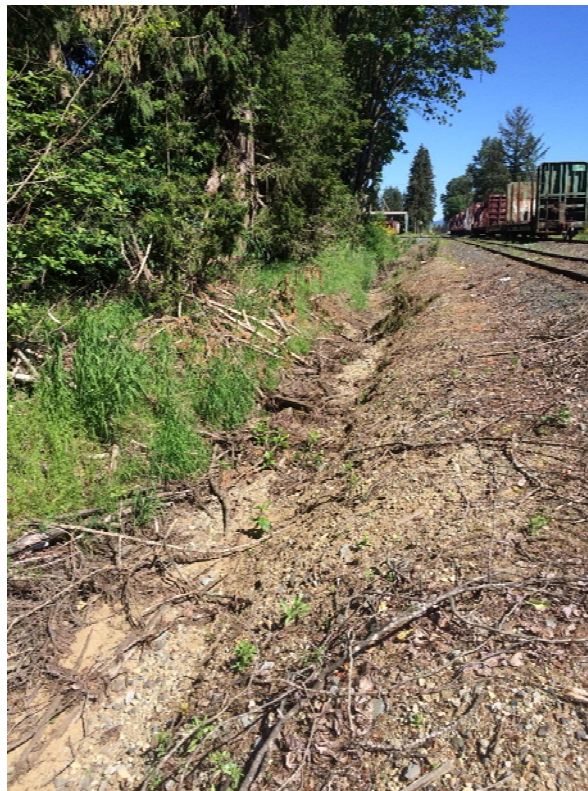
The GeoEngineers PWS returned to the site on May 10, 2016 to verify public data and investigate the hydrology of the ditch. Precipitation data collected at the Arlington Airport (Weather Underground, 2016) indicates very little rain (0.02 inches) in the week prior to the May site visit. The ditch (Photo 2) was completely dry with vegetation establishing in the bed of the channel. We observed indications of recent inundation but it appears that this ditch experiences intermittent flow. This ditch is likely inundated during the winter when shallow groundwater is elevated and surface runoff is high. However, the ditch is not expected to flow perennially.

Photo 2. Ditch adjacent to site, May 10, 2016.

As mapped by the City of Arlington (2016a), we observed less than 0.5 cubic feet per second (cfs) of flow from the stormwater ponds located 2,500 feet north of the site into a closed conveyance in the 67<sup>th</sup> Avenue NE right-of-way. Because of private property access issues, the PWS was not able to observe the mapped outfall of this stormwater system into the ditch adjacent to the BNSF railway. Most likely, the ditch adjacent to the BNSF railway conveys flow from the stormwater system located north of the site. According to Marc Hayes, City of Arlington Manager of Community and Economic Development (2016), smaller volumes, such as the 0.5 cfs observed entering the stormwater system on May 10, 2016, likely infiltrate into the sandy substrate of the nearly level ditch prior to flowing past the site.

We expect the ditch to be inundated only after periods of rain and runoff from the developed areas east of the site. It is our opinion that this ditch primarily functions as a stormwater conveyance and infiltration feature. We observed inundation in the ditch approximately 450 feet south of the site. At this location we observed water flowing into the ditch from a 24-inch round concrete pipe culvert that conveys flow under the BNSF railway from the area east of the railway. The City of Arlington (2016a) identifies the area east of the BNSF railway as constructed stormwater feature.
