Critical Areas Study

Sills Corner to North Stanwood 115 kV
Reconductor Project, Phase 3

Snohomish County Public Utilities District No. 1
Snohomish County, Washington

February 3, 2024

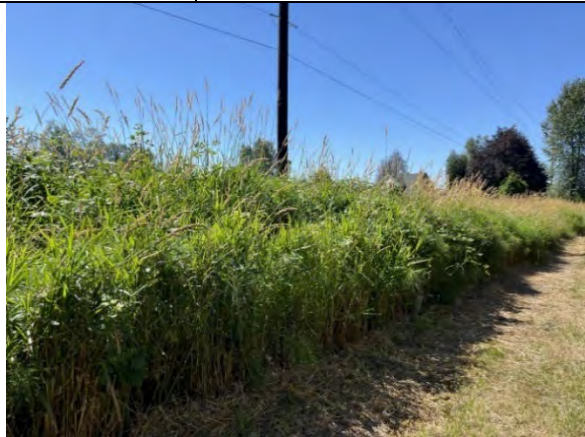
Table 6. Wetland 8/7 Summary

Local Jurisdiction	Snohomish County
	WRIA	5
	Ecology Rating (Hruby 2014)	II
	Water Quality	7
	Hydrologic	7
	Habitat	6
	Local Rating	II
	Local Buffer Width	110 feet
	Wetland Size (Total)	0.07 acre
	Cowardin Classification	PEM
	HGM Classification	Depressional
	Wetland Data Sheet(s)	SP 8/7-1
Upland Data Sheet(s)	SP 8/7-2	
Dominant Vegetation	Wetland 8/7 is a depressional wetland that is located at the northwest end of the study area. It was identified during the field investigation for Phase 2 of the project, and formal paired sample plots were established. Dominant vegetation consists of reed canary grass (<i>Phalaris arundinacea</i>) and Himalayan blackberry (<i>Rubus armeniacus</i>). Other vegetation present includes Canada thistle (<i>Cirsium arvense</i>) and giant horsetail (<i>Equisetum telmateia</i>). Vegetation in Wetland 8/7 meets criteria for hydrophytic vegetation.

Soils	Soils in Wetland 8/7 are mapped as Puget silty clay loam, which is a hydric soil. Wetland 8/7 soils consist of a surface dark layer underlain by a depleted matrix with redoximorphic features. Soils in Wetland 8/7 meet hydric soil indicators for a depleted matrix (F3) and depleted below dark surface (A11).	
Hydrology	Primary sources of hydrology in Wetland 8/7 include runoff from the surrounding area. It is also located in the floodplain of the Stillaguamish River. Oxidized rhizospheres, which support a positive hydrology determination, were observed in the second soil layer in Wetland 8/7.	
Rationale for Delineation	The boundaries of Wetland 8/7 were recorded with a GPS device where indicators of wetland vegetation, hydric soil, and wetland hydrology were present. The boundary was generally along a topographic break where vegetation shifted to upland plant-dominated composition and hydric soil indicators were no longer present.

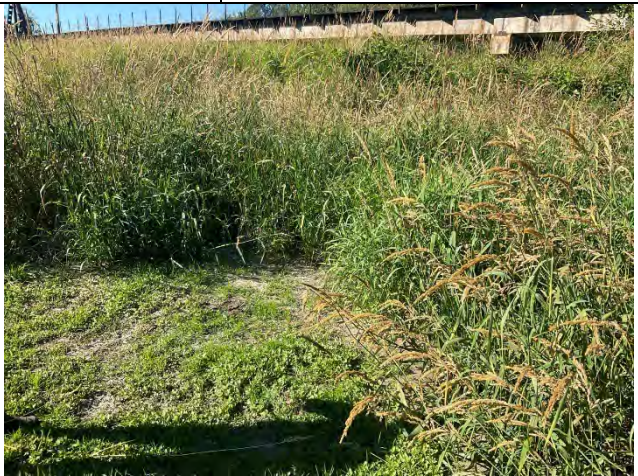
Table 7. Wetland 8/7B Summary

Local Jurisdiction	Snohomish County
	WRIA	5
	Ecology Rating (Hruby 2014)	III
	Water Quality	7
	Hydrologic	7
	Habitat	5
	Local Rating	III
	Local Buffer Width	60 feet
	Wetland Size (Total)	0.02 acre
	Cowardin Classification	PEM
	HGM Classification	Depressional
Wetland Data Sheet(s)	SP 8/7B-1	
Upland Data Sheet(s)	SP 8/7B-2	
Dominant Vegetation	Wetland 8/7B is a small, depressional wetland. It is located within the study area, adjacent to an agricultural field. Vegetation in the wetland is dominated by reed canary grass and Himalayan blackberry. Vegetation in Wetland 8/7B meets criteria for hydrophytic vegetation.	
Soils	Soils in Wetland 8/7B are mapped as Puget silty clay loam, which is rated as a hydric soil. Wetland 8/7B soils consist of a surface layer of dark silty clay loam underlain by depleted silty clay loam with redoximorphic features. Sampled soils meet hydric soil indicators for depleted below dark surface (A11) and depleted matrix (F3).

Hydrology	Wetland 8/7B is an isolated wetland with no outlet. Hydrologic observations in the wetland included water-stained leaves and oxidized rhizospheres on living roots. Hydrology in the wetland is likely due to runoff from the nearby agricultural field, as the wetland is located in a low spot adjacent to the field. The wetland is also located in the floodplain of the Stillaguamish River.	
Rationale for Delineation	The boundaries of Wetland 8/7B were recorded with a GPS device where indicators of wetland vegetation, hydric soil, and wetland hydrology were present.	
Rationale for Local Rating	Wetland 8/7B is rated Category III using the current Ecology rating system because it provides moderate water quality (7), moderate hydrologic (7), and low habitat (5) functions, scoring 19 points on the wetland rating form.	
Wetland Functions Summary		
Water Quality	Wetland 8/7B has moderate potential to improve water quality. It is vegetated with dense herbaceous vegetation and does not have a surface water outlet. The wetland receives untreated runoff from the adjacent agricultural fields. It is located in a basin with an aquatic resource on the 303(d) list and in the Stillaguamish River watershed, which has a TMDL.

Hydrologic	Wetland 8/7B has a moderate potential to reduce flooding and erosion due to dense vegetation that can reduce the velocity of floodwater. It has the potential to support hydrologic functions as the contributing basin consists mainly of agricultural land use with increased runoff, and the area downgradient experiences flooding that damages human and natural resources.	
Habitat	Wetland 8/7B has limited wildlife habitat potential due to a high proportion of high-intensity land use in the surrounding area, due mainly to agriculture. There is no accessible habitat. Priority habitats identified by WDFW in the vicinity of the wetland include riparian and in-stream areas as well as biodiversity areas for swan species (WDFW 2023b); these contribute to a high habitat value to society.

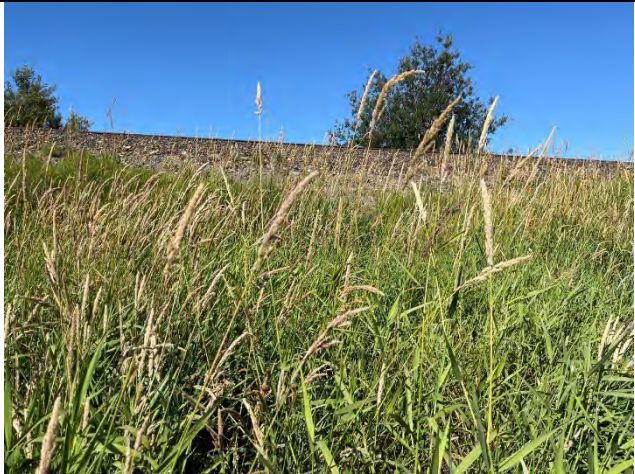
Table 8. Wetland 8/5 Summary

Local Jurisdiction	Snohomish County
	WRIA	5
	Ecology Rating (Hruby 2014)	II
	Water Quality	8
	Hydrologic	8
	Habitat	5
	Local Rating	II
	Local Buffer Width	75 feet
	Wetland Size (Total)	0.48 acre
	Cowardin Classification	PEM/PSS
	HGM Classification	Depressional
Wetland Data Sheet(s)	SP 8/7-1	
Upland Data Sheet(s)	SP 8/7-2	
Dominant Vegetation	Wetland 8/5 is a depressional wetland located between an agricultural field and the BNSF railroad embankment. Vegetation is dominated by reed canary grass and Himalayan blackberry. Other vegetation in the wetland includes red elderberry (<i>Sambucus racemosa</i>) and snowberry (<i>Symphoricarpos albus</i>). The vegetation community in Wetland 8/5 is hydrophytic.	
Soils	Soils in Wetland 8/5 are mapped as hydric (Puget silty clay loam). Wetland 8/5 soils consist of depleted silty clay loam with redoximorphic features. Sampled soils meet the hydric soils indicators for a depleted matrix (F3).

Hydrology	Primary sources of hydrology in Wetland 8/5 include runoff from the railroad embankment and runoff from adjacent agricultural fields. Wetland 8/5 is located in the floodplain of the Stillaguamish River. Positive hydrology determination is supported by the geomorphic position of the wetland and observations of saturated soils during previous wet season delineations (January 2016).	
Rationale for Delineation	Wetland 8/5 was identified based on the presence of all three wetland criteria. The boundary was delineated based on the presence of hydric soil indicators as well as topography.	
Rationale for Local Rating	Wetland 8/5 is rated Category II using the current Ecology rating system because it provides high water quality (8), high hydrologic (8), and low habitat (5) functions, scoring 21 points on the wetland rating form.	
Wetland Functions Summary		
Water Quality	Wetland 8/5 has high potential to improve water quality. It is a depressional wetland with no outlet. The wetland receives untreated runoff from adjacent agricultural fields, the BNSF railroad, and stormwater discharge. It is located in a basin with aquatic resources on the 303(d) list and with TMDLs. Therefore, Wetland 8/5 has high potential to support water quality functions and high value to society to perform this function.

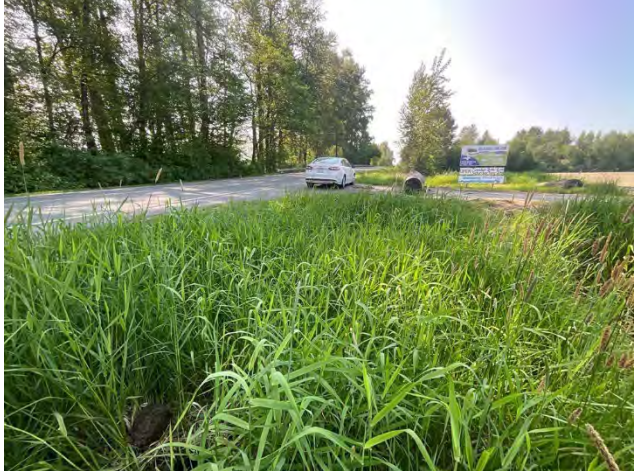
Table 9. Wetland 7/B Summary

Local Jurisdiction	Snohomish County
	WRIA	5
	Ecology Rating (Hruby 2014)	III
	Water Quality	7
	Hydrologic	7
	Habitat	7
	Local Rating	III
	Local Buffer Width	60 feet
	Wetland Size (Total)	0.02 acre
	Cowardin Classification	PEM
	HGM Classification	Depressional
	Wetland Data Sheet(s)	SP 7/B-1
Upland Data Sheet(s)	SP 7/B-2	
Dominant Vegetation	Wetland 7/B is a narrow depressional wetland located in a swale between an agricultural field and Pioneer Highway. Vegetation is dominated by meadow foxtail (<i>Alopecurus pratensis</i>) and Himalayan blackberry. The vegetation community in Wetland 7/B is hydrophytic.	
Soils	Soils in Wetland 7/B are mapped as hydric (Puget silty clay loam). Wetland 7/B soils consist of depleted silty clay loam with redoximorphic features. Sampled soils meet the hydric soils indicators for a depleted matrix (F3).

Hydrology	The primary source of hydrology in Wetland 7/B is runoff from the agricultural field and Pioneer Highway. The wetland is also located in the floodplain of the Stillaguamish River. Hydrologic observations in the wetland included water-stained leaves. The wetland is also in a geomorphic position that is conducive to wetland conditions.	
Rationale for Delineation	The boundary of Wetland 7/B was delineated along the topographic break of the swale.	
Rationale for Local Rating	Wetland 7/B is rated Category III using the current Ecology rating system because it provides moderate water quality (7), moderate hydrologic (7), and low habitat (5) functions, scoring 19 points on the wetland rating form.	
Wetland Functions Summary		
Water Quality	Wetland 7/B has moderate potential to improve water quality due to the presence of persistent, ungrazed plants. The wetland receives untreated runoff from the adjacent agricultural field and roadway. Water quality improvement from Wetland 7/B is of high value to society because it discharges to Cook Slough, which is on the 303(d) list. It is located in the Stillaguamish River basin, which has a TMDL for temperature, bacteria, dissolved oxygen, pH, mercury, and arsenic.

Hydrologic	Wetland 7/B has low potential to reduce flooding because of its depth of storage, as observed in the field. The contributing basin consists of agricultural development that generates excess runoff, and the wetland received stormwater discharge. The wetland has the potential to reduce flooding downgradient, which is of high value to the surrounding community.	
Habitat	Wetland 7/B lacks complex habitat features and has low diversity. The surrounding landscape has low potential to support habitat functions due to a high proportion of land used for agricultural purposes. The wetland has moderate habitat value due to the presence of a WDFW-designated biodiversity area for swan species (WDFW 2023b).

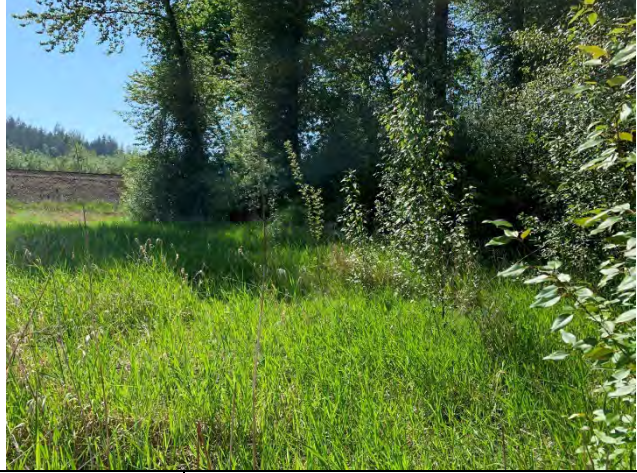
Table 10. Wetland 7/A Summary

Local Jurisdiction	Snohomish County
	WRIA	5
	Ecology Rating (Hruby 2014)	II
	Water Quality	8
	Hydrologic	8
	Habitat	5
	Local Rating	II
	Local Buffer Width	75 feet
	Wetland Size (Total)	0.72 acre
	Cowardin Classification	PEM/PFO
HGM Classification	Depressional	
Wetland Data Sheet(s)	SP 7/A-1, SP 7/A-3	
Upland Data Sheet(s)	SP 7/A-2	
Dominant Vegetation	Wetland 7/A is a depressional wetland located in a low point in a sheep pasture and adjacent to the BNSF Railway embankment. Vegetation is dominated by reed canary grass and black cottonwood (<i>Populus balsamifera</i>). The wetland meets criteria for hydrophytic vegetation.	
Soils	Soils in Wetland 7/A are mapped as hydric (Puyallup fine sandy loam). Wetland 7/A soils consist of depleted silty clay loam with redoximorphic features. Sampled soils meet the hydric soils indicators for a depleted matrix (F3).

Hydrology	Primary sources of hydrology in Wetland 7/A include runoff from the sheep pasture, adjacent railroad embankment, and roadway. Hydrologic observations in the wetland included oxidized rhizospheres on living roots. The wetland is also located in the floodplain of the Stillaguamish River.	
Rationale for Delineation	All three wetland criteria are present, despite disturbance from the sheep pasture. The boundaries of Wetland 7/A were determined using the presence of hydric soil indicators and changes in vegetation community.	
Rationale for Local Rating	Wetland 7/A is rated Category III using the current Ecology rating system because it provides high water quality (8), high hydrologic (8), and moderate habitat (5) functions, scoring 21 points on the wetland rating form.	
Wetland Functions Summary		
Water Quality	Wetland 7/A has high potential to improve water quality due to high cover of persistent plants and the lack of a surface outlet. The wetland received untreated runoff from an adjacent sheep pasture and stormwater runoff, which contributes to a high potential to improve water quality. Wetland 7/A discharges to a stream that is on the 303(d) list. The wetland is located within the Stillaguamish River basin, which has several TMDLs. Therefore, the wetland has high value to society for performing water quality functions.

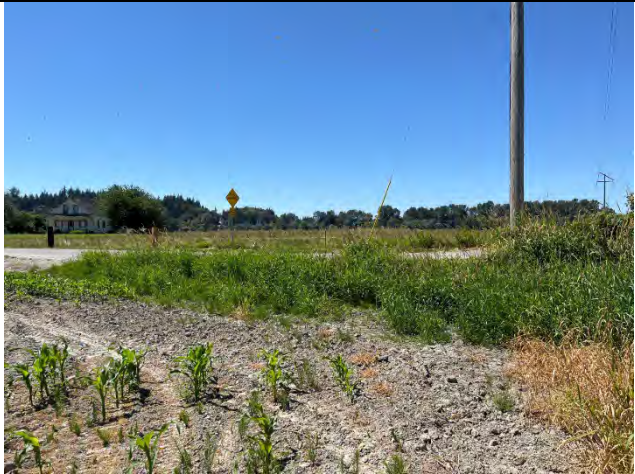
Table 11. Wetland 7/11 Summary

Local Jurisdiction	Snohomish County
	WRIA	5
	Ecology Rating (Hruby 2014)	III
	Water Quality	7
	Hydrologic	7
	Habitat	3
	Local Rating	III
	Local Buffer Width	60 feet
	Wetland Size (Total)	0.03 acre
	Cowardin Classification	PEM
	HGM Classification	Depressional
Wetland Data Sheet(s)	SP 7/11-1	
Upland Data Sheet(s)	SP 7/11-2	
Dominant Vegetation	Wetland 7/11 is a depressional wetland located in a lower corner of an agricultural field adjacent to the BNSF railroad embankment and Sather Road. Vegetation in the wetland is dominated by reed canary grass. Vegetation in Wetland 7/11 meets criteria for hydrophytic vegetation.	
Soils	Soils in Wetland 7/11 are hydric (Puget silty clay loam). Wetland 7/11 soils consist of depleted matrices with redoximorphic features. Soils meet hydric soil indicators for a depleted matrix (F3).

Hydrology	Primary sources of hydrology in Wetland 7/11 include runoff from the railroad embankment and the adjacent agricultural field. Hydrologic observations in the wetland included oxidized rhizospheres on living roots. The wetland is also located in the floodplain of the Stillaguamish River.	
Rationale for Delineation	The presence of all three wetland criteria informed the delineation of the wetland. Wetland 7/11 is located in a depression; the topographic break was also used to determine the boundary of the wetland.	
Rationale for Local Rating	Wetland 7/11 is rated Category III using the current Ecology rating system because it provides moderate water quality (7), moderate hydrologic (7), and low habitat (3) functions, scoring 17 points on the wetland rating form.	
Wetland Functions Summary		
Water Quality	Wetland 7/11 has moderate potential to improve water quality due the lack of a surface outlet and high cover of persistent plants. The wetland receives untreated runoff from roads and adjacent agricultural fields. Improving water quality in the basin downgradient from Wetland 7/11 is of high value, as the wetland is located within the Stillaguamish River basin, which has several TMDLs and aquatic resources on the 303(d) list.

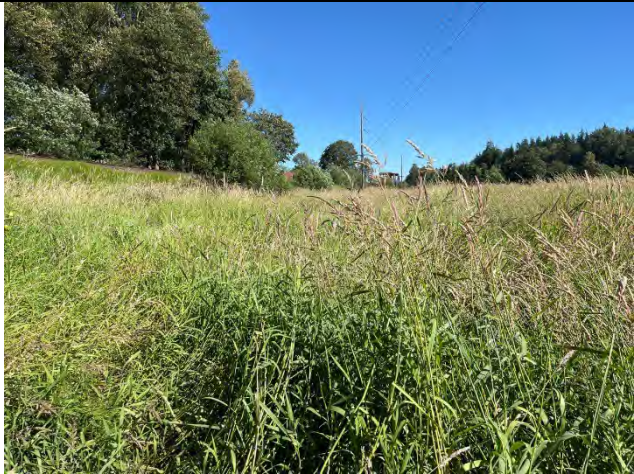
Table 12. Wetland 7/4 Summary

Local Jurisdiction	Snohomish County
	WRIA	5
	Ecology Rating (Hruby 2014)	III
	Water Quality	6
	Hydrologic	7
	Habitat	6
	Local Rating	III
	Local Buffer Width	110 feet
	Wetland Size (Total)	0.64 acre
	Cowardin Classification	PEM/PSS
	HGM Classification	Depressional
	Wetland Data Sheet(s)	SP 7/4-1
Upland Data Sheet(s)	SP 7/4-2	
Dominant Vegetation	Wetland 7/4 is a depressional wetland located within a pasture and along the toe of slope of the BNSF railroad embankment. Vegetation is dominated by reed canary grass; other species present include marsh bedstraw (<i>Galium palustre</i>) and giant horsetail. Vegetation in Wetland 7/4 meets criteria for hydrophytic vegetation.	
Soils	Soils in Wetland 7/4 are mapped as hydric (Puget silty clay loam). Wetland 10/4 soils consist of a dark surface layer underlain by layers of depleted matrices with redoximorphic features starting within 4 inches of the surface. Sampled soils meet hydric soil indicators for depleted below dark surface (A11) and depleted matrix (F3).

Hydrology	Primary sources of hydrology in Wetland 7/4 include runoff from the adjacent pasture and the railroad embankment. Hydrology in the wetland is supported by the observation of oxidized rhizospheres on living roots. The wetland is also located in the floodplain of the Stillaguamish River.	
Rationale for Delineation	The boundaries of Wetland 7/4 were recorded with a GPS device where indicators of wetland vegetation, hydric soil, and wetland hydrology were present.	
Rationale for Local Rating	Wetland 7/4 is rated Category III using the current Ecology rating system because it provides moderate water quality (6), moderate hydrologic (7), and moderate habitat (6) functions, scoring 19 points on the wetland rating form.	
Wetland Functions Summary		
Water Quality	Wetland 7/4 has low potential to improve water quality due to an intermittently flowing outlet. Wetland 7/4 receives untreated runoff from adjacent agricultural fields and the BNSF railroad, which support the landscape potential of the wetland to perform this function. Wetland 7/4 discharges to Cook Slough, which is on the 303(d) list. The wetland is also located in the Stillaguamish River basin, which has several TMDLs. These factors indicate that improvements to water quality from the wetland are of high value in the watershed.

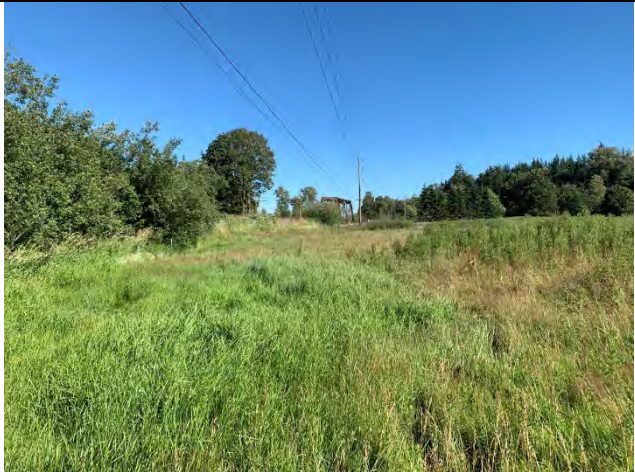
Table 13. Wetland 7/4B Summary

Local Jurisdiction	Snohomish County
	WRIA	5
	Ecology Rating (Hruby 2014)	III
	Water Quality	7
	Hydrologic	7
	Habitat	3
	Local Rating	III
	Local Buffer Width	60 feet
	Wetland Size (Total)	0.17 acre
	Cowardin Classification	PEM/PSS
	HGM Classification	Depressional
	Wetland Data Sheet(s)	SP 7/4B-1
Upland Data Sheet(s)	SP 7/4B-2	
Dominant Vegetation	Wetland 7/4B is a depressional wetland generally located within a pasture and along the toe of slope of the BNSF railroad embankment. Dominant vegetation includes reed canary grass, common bent grass (<i>Agrostis capillaris</i>), Sitka willow (<i>Salix sitchensis</i>), and red-osier dogwood (<i>Cornus alba</i>). The vegetation in Wetland 7/4B is hydrophytic.	
Soils	Soils in Wetland 7/4B are mapped as hydric (Puyallup find sandy loam). Wetland 7/4B soils consist of depleted soils with redoximorphic features. Sampled soils meet hydric soil indicators for a depleted matrix (F3).

Hydrology	Primary sources of hydrology in Wetland 7/4 include runoff from the adjacent pasture and the railroad embankment. Hydrologic observations in the wetland included oxidized rhizospheres on living roots. The wetland is also located in the floodplain of the Stillaguamish River.	
Rationale for Delineation	The boundaries of Wetland 7/4B were recorded with a GPS device where the plant community shifted from hydrophytic vegetation to upland vegetation. The boundary was also determined by the presence of hydric soils.	
Rationale for Local Rating	Wetland 7/4B is rated Category III using the current Ecology rating system because it provides moderate water quality (7), moderate hydrologic (7), and low habitat (3) functions, scoring 17 points on the wetland rating form.	
Wetland Functions Summary		
Water Quality	Wetland 7/4B has no surface outlet and moderate cover of persistent vegetation. The wetland receives untreated agricultural runoff. The wetland is located in the Stillaguamish River basin, which has several TMDLs and aquatic resources on the 303(d) list. Therefore, this function is of high value in the watershed.

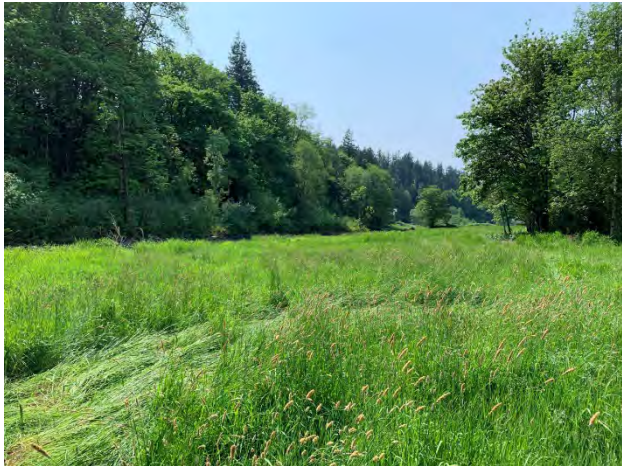
Table 15. Wetland 7/1 Summary

WETLAND 7/1 – INFORMATION SUMMARY																							
Location:	Latitude: 48.1916599, Longitude: -122.2408041

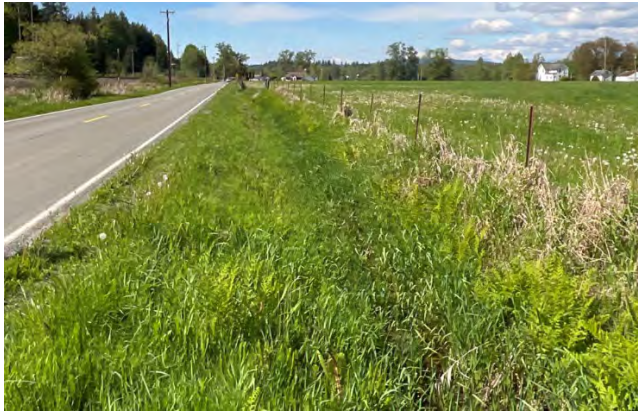
Table 17. Wetland 6/C Summary

Local Jurisdiction	Snohomish County
	WRIA	5
	Ecology Rating (Hruby 2014)	II
	Water Quality	7
	Hydrologic	8
	Habitat	5
	Local Rating	II
	Local Buffer Width	75 feet
	Wetland Size (Total)	0.09 acre
	Cowardin Classification	PEM
	HGM Classification	Depressional
Wetland Data Sheet(s)	SP 6/C-1	
Upland Data Sheet(s)	SP 6/C-2	
Dominant Vegetation	Wetland 6/C is a depressional wetland that is confined to a swale below a road prism. Dominant vegetation consists of reed canary grass. Other vegetation includes giant horsetail and stinging nettle (<i>Urtica dioica</i>). Vegetation in Wetland 6/C meets criteria for hydrophytic vegetation.	
Soils	Soils in Wetland 6/C are mapped as not hydric (Lynnwood loamy sand). Wetland 6/C soils consist of a dark layer of clay loam underlain by a depleted matrix with redoximorphic features. Sampled soils meet the hydric soil indicators for depleted below dark surfaces (A11) and a depleted matrix (F3).

Hydrology	Primary sources of hydrology in Wetland 6/C include stormwater runoff and high groundwater table. Hydrologic observations in the wetland included oxidized rhizospheres on living roots.	
Rationale for Delineation	The boundaries of Wetland 6/C were recorded with a GPS device along the toe of slope of the swale.	
Rationale for Local Rating	Wetland 6/C is rated Category II using the current Ecology rating system because it provides moderate water quality (7), high hydrologic (8), and low habitat (5) functions, scoring 20 points on the wetland rating form.	
Wetland Functions Summary		
Water Quality	Wetland 6/C has a moderate potential to improve water quality because it lacks a surface outlet and has high cover of persistent, ungrazed vegetation. The surrounding area contributes contaminants to the wetland from untreated stormwater and agricultural runoff. The wetland is located in the Stillaguamish River basin, which has several TMDLs and aquatic resources on the 303(d) list. Therefore, this function is of high value in the watershed.

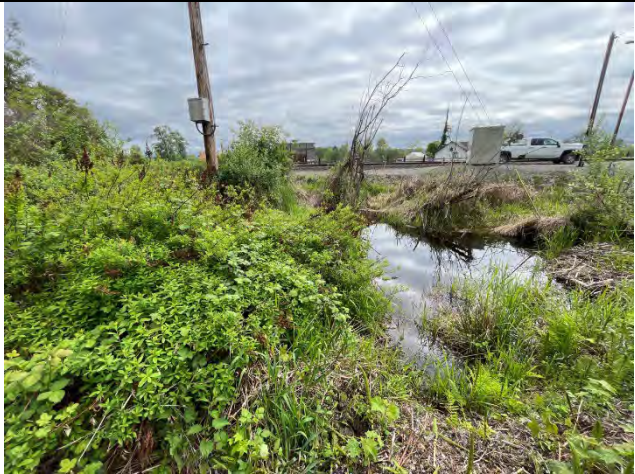
Table 18. Wetland 6/11 Summary

Local Jurisdiction	Snohomish County
	WRIA	5
	Ecology Rating (Hruby 2014)	II
	Water Quality	8
	Hydrologic	7
	Habitat	6
	Local Rating	II
	Local Buffer Width	110 feet
	Wetland Size (Total)	0.27 acre
	Cowardin Classification	PEM/PSS
	HGM Classification	Depressional
Wetland Data Sheet(s)	SP 6/11-1	
Upland Data Sheet(s)	SP 6/11-2	
Dominant Vegetation	Wetland 6/11 is a depressional wetland located below the toe of slope of the BNSF railroad embankment and adjacent road prism. Vegetation in the wetland is dominated by reed canary grass, giant horsetail, and hardhack (<i>Spiraea douglasii</i>). Vegetation in Wetland 6/11 meets criteria for hydrophytic vegetation.	
Soils	Soils in Wetland 6/11 are mapped as not hydric (Alderwood-Everett gravelly sandy loam). Wetland 6/11 soils consist of a surface layer of dark loam underlain by a depleted matrix with redoximorphic features. Soils in the wetland meet hydric soil indicators for a depleted matrix (F3).

Hydrology	The primary source of hydrology in Wetland 6/11 is ponded water that is created by a small beaver dam at the north end of the wetland. Primary hydrologic indicators at the boundary of the wetland include saturated soils and ground-water table within the upper 12 inches.	
Rationale for Delineation	The boundaries of Wetland 6/11 follow the topography of the depression where indicators of wetland vegetation, hydric soil, and wetland hydrology are present.	
Rationale for Local Rating	Wetland 6/11 is rated Category II using the current Ecology rating system because it provides high water quality (8), moderate hydrologic (7), and moderate habitat (6) functions, scoring 21 points on the wetland rating form.	
Wetland Functions Summary		
Water Quality	Wetland 6/11 has moderate potential to improve water quality because it has no surface outlet and has areas of seasonal ponding that can trap sediment and pollutants. The surrounding area contributes contaminants to the wetland from untreated stormwater runoff and adjacent septic systems. The wetland is located in the Stillaguamish River basin, which has several TMDLs and aquatic resources on the 303(d) list. Therefore, this function is of high value in the watershed.

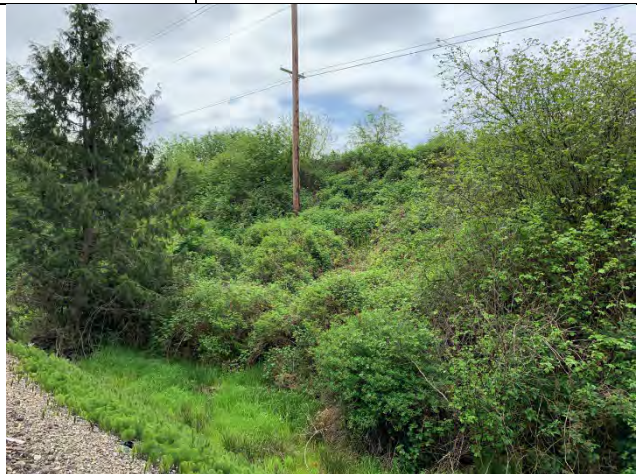
Table 20. Wetland XCC42 Summary

WETLAND XCC42 – INFORMATION SUMMARY																											
Location:	Latitude: 48.1733662, Longitude: -122.2260549

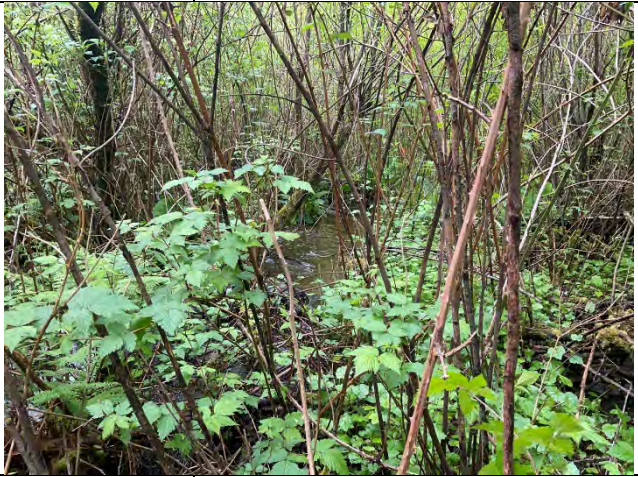
Table 21. Wetland XCC42B Summary

Local Jurisdiction	Snohomish County
	WRIA	5
	Ecology Rating (Hruby 2014)	II
	Water Quality	7
	Hydrologic	7
	Habitat	7
	Local Rating	II
	Local Buffer Width	110 feet
	Wetland Size (Total)	0.01 acre
	Cowardin Classification	PSS, PFO
	HGM Classification	Riverine
	Wetland Data Sheet(s)	SP XCC42B-2
Upland Data Sheet(s)	SP XCC42B-1	
Dominant Vegetation	Wetland XCC42B is a riverine wetland that is located along the OHWM of Stream XCC42. Dominant vegetation consists of big flower fringecup (<i>Tellima grandiflora</i>), skunk cabbage, salmonberry, and red-osier dogwood. Vegetation in Wetland XCC42B meets criteria for hydrophytic vegetation.	
Soils	Soils in Wetland XCC42B are mapped as Lynnwood loamy sand, which is not a hydric soil. Wetland XCC42B soils consist of dark, mucky-modified sandy loam. Soils in Wetland XCC42B meet hydric soil indicators for loamy mucky mineral (F1).

Hydrology	Hydrology in Wetland XCC42B is from overbank flooding from Stream XCC42. Primary wetland hydrology indicators include water table and saturation within the upper 12 inches of soil, which support a positive hydrology determination.	
Rationale for Delineation	The boundaries of Wetland XCC42B were recorded with a GPS device where indicators of wetland vegetation, hydric soil, and wetland hydrology were present. The boundary was generally along a topographic break and the OHWM of Stream XCC42.	
Rationale for Local Rating	Wetland XCC42B is rated Category II using the current Ecology rating system because it provides moderate water quality (7), moderate hydrologic (7), and moderate habitat (7) functions, scoring 21 points on the wetland rating form.	
Wetland Functions Summary		
Water Quality	Wetland XCC42B has moderate potential to improve water quality because it has dense cover of trees and shrubs. The surrounding area contributes contaminants to the wetland from stormwater runoff and agricultural development in the contributing basin. The wetland is along Stream XCC42, which discharges to Fish Creek, which is on the 303(d) list. It is located in the Stillaguamish River basin, which has several TMDLs.

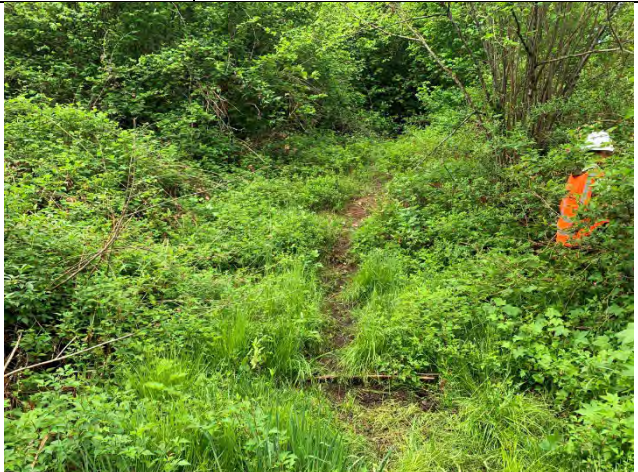
Table 22. Wetland 5/5 Summary

WETLAND 5/5 – INFORMATION SUMMARY																											
Location:	Latitude: 48.1704380, Longitude: -122.2226708

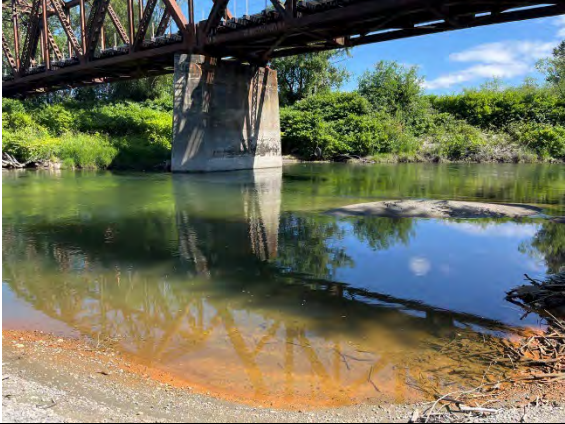
Table 25. Stream Information Summary—Stillaguamish River

<table><tr> <td>Stream Name</td> <td>Stillaguamish River</td> </tr></table>

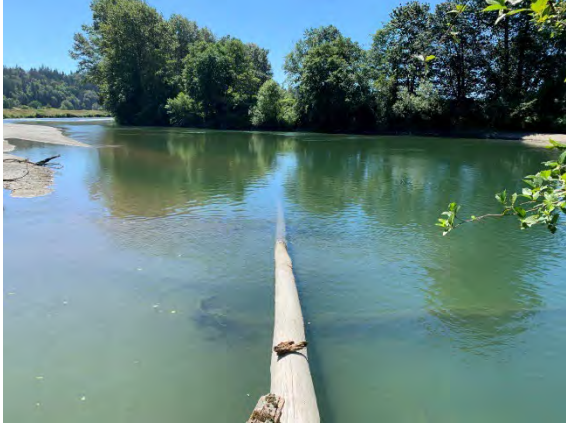
Table 26. Stream Information Summary—Cook Slough

<table><tr> <td>Stream Name</td> <td>Cook Slough</td> </tr></table>

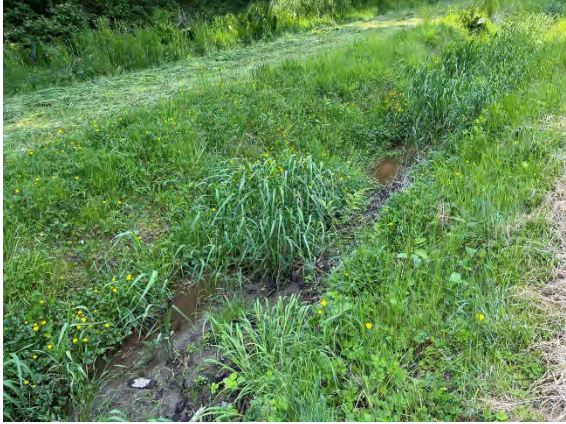
Table 28. Stream Information Summary—Stream 7/1

Stream Name	Stream 7/1
	WRIA	5
	WA Stream Catalog #	67774
	Local Jurisdiction	Snohomish County
	DNR Stream Type	F
	Local Stream Rating	Untyped
	Buffer Width	150 feet
Location of Stream Relative to Project Corridor	Stream 7/1 is along the proposed access route to the existing Poles 7/2 and 7/1. It is along the edge of an active agricultural field. Stream 7/1 is approximately 5 feet wide at the OHWM within the study area.	
Connectivity (where stream flows from/to)	Stream 7/1 is a tributary of Cook Slough and flows east to west through the project area.	
Riparian/Buffer Condition	Stream 7/1 runs along an active agricultural field. It originates along the toe of slope of a steep hill to the south; Wetland 7/1 is located along the slope and drains to Stream 7/1. Stream 7/1 appears to be maintained to drain the adjacent agricultural field. The riparian vegetation includes reed canary grass, tall fescue (<i>Schedonorus arundinaceus</i>), and small-fruited bullrush. No canopy cover or large woody debris was present in the study area.

Documented Fish Use	Chum Salmon, Coho Salmon, Chinook Salmon, Pink Salmon, and steelhead are documented as present in Stream 7/1 (SWIFD 2023). This stream is not mapped on PHS (WDFW 2023b).

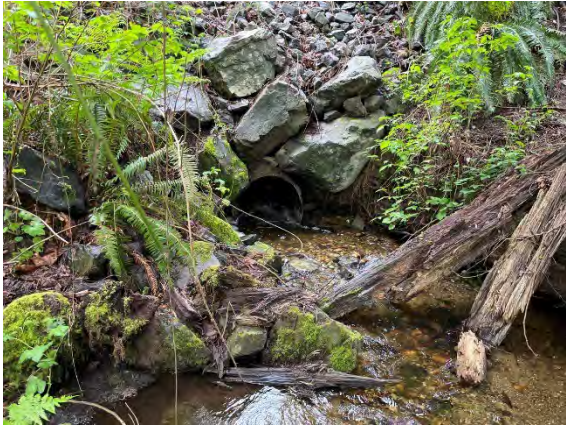
Table 29. Stream Information Summary—Stream XCC42

<table><tr> <td>Stream Name</td> <td>Stream XCC42</td> </tr></table>

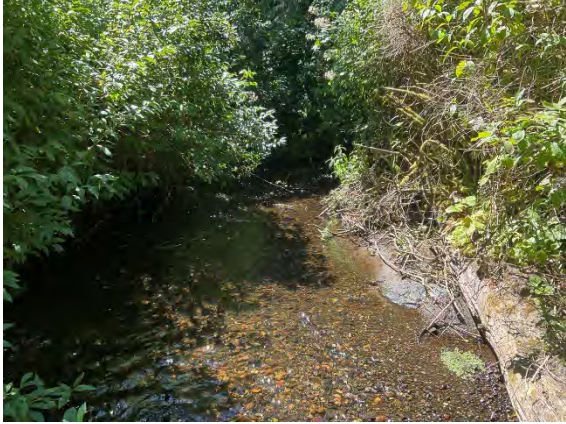
Table 30. Stream Information Summary—Fish Creek

<table><tr> <td>Stream Name</td> <td>Fish Creek</td> </tr></table>
