# Critical Areas Report and Mitigation Plan

**Sultan River Engineered Log Jams 9 and 10**

**Prepared for  
Snohomish County Public Utility District No. 1**

**Prepared by  
Herrera Environmental Consultants, Inc.**

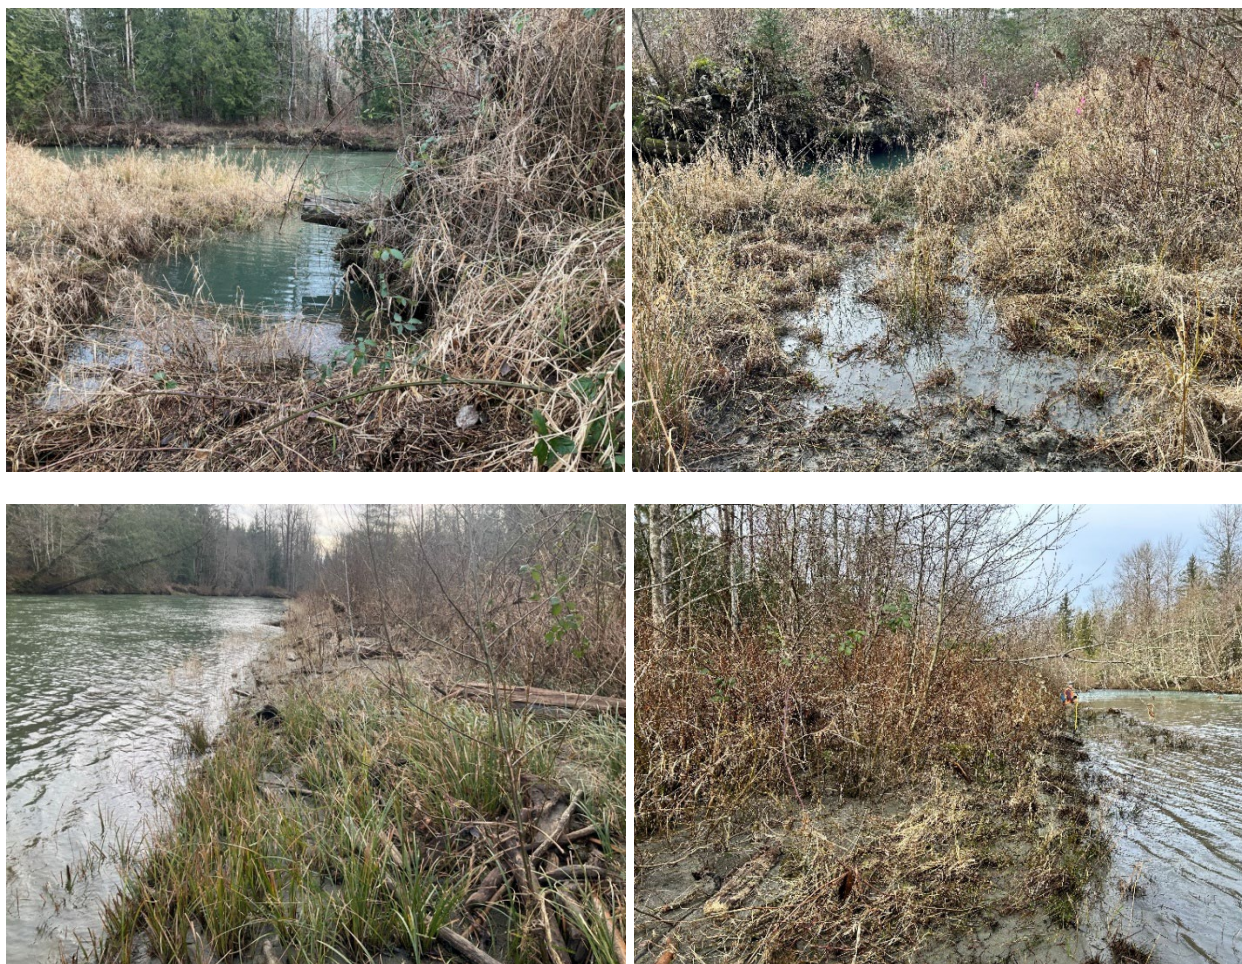
Wetlands A and B have a riverine hydrogeomorphic class, with their primary hydrology source being the main stem of the Sultan River. Both wetlands are dominated by palustrine emergent vegetation. Both wetlands also have a small amount of palustrine scrub-shrub vegetation; however, this was determined to be a minor component (i.e., <10 percent cover) and not incorporated in the wetland ratings. Dominant species include reed canarygrass (*Phalaris arundinacea*), small-fruited bulrush (*Scripus microcarpus*), soft rush (*Juncus effusus*), and slough sedge (*Carex obnupta*).

Soils at Wetland A (SP2) and Wetland B (SP4) exhibited hydric conditions and were saturated to the ground surface at the time of sampling. At Wetland A (SP2), the upper 2 inches of the soil profile consisted of a recent flood deposit from December 2025. From approximately 2 to 6 inches below ground surface, soils exhibited prominent redox concentrations meeting the Sandy Redox hydric soil indicator, which was also observed at Wetland B (SP4). A cobble layer was encountered below approximately 6 inches at Wetland A. In Wetland B, soils were observed to a depth of 16 inches, with sandy loam underlying the diagnostic layer.

Representative photos of Wetland A (top row), Wetland B (bottom row).

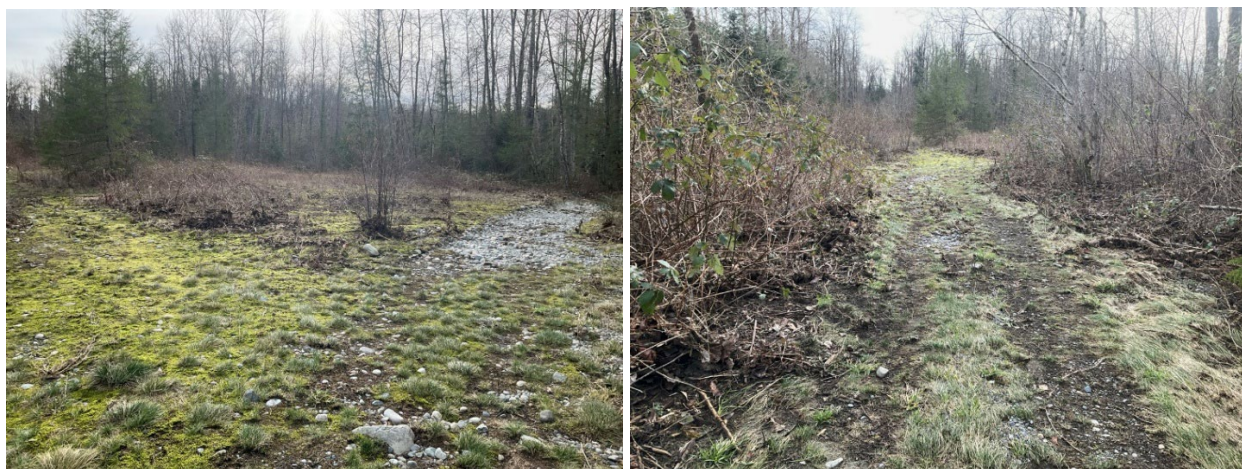
Representative photos of wetland buffer vegetation over the partially vegetated gravel bar (left) and over existing paths (right).

Vegetation in the wetland buffers are dominated by scrub-shrub species, including red alder saplings (*Alnus rubra*), salmonberry (*Rubus spectabilis*), Pacific ninebark (*Physocarpus capitatus*), red-osier dogwood (*Cornus sericea*), native willows (*Salix spp.*), and Himalayan blackberry (*Rubus armenicus*). In addition, portions of the wetland buffers have minimal vegetation. This includes existing dirt/grass paths and a regularly flooded area, which is a partially vegetated gravel bar. The minimal vegetation in these areas includes moss and grasses, and small patches of scotch broom (*Cytisus scoparius*), Himalayan blackberry, butterfly bush (*Buddleja davidii*), and red alder saplings. Based on review of historical aerial imagery (Google Earth Pro 2026), this area was an unvegetated or minimally vegetated gravel bar since at least 1989, but has subsequently partially filled in with mainly invasive species over time.

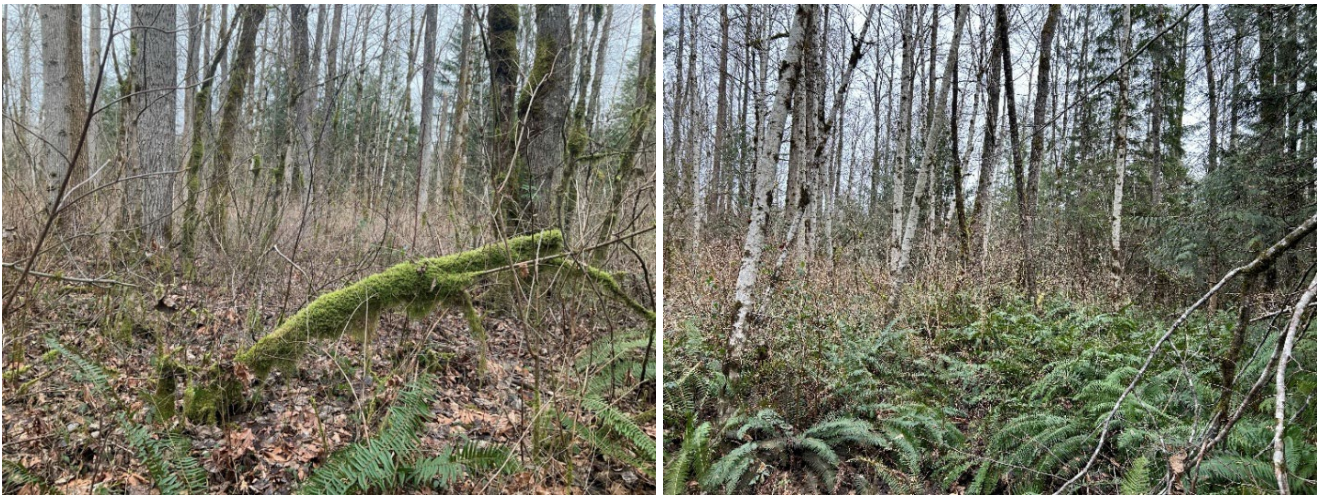
Representative photos (left and right) of riparian forest vegetation between the Sultan River and Side Channel 2.

In addition to the vegetation dominant in wetlands and wetland buffers, as described previously, the riparian buffer consists primarily of deciduous forest with some young conifers. Dominant species include bigleaf maple (*Acer macrophyllum*), black cottonwood (*Populus balsamifera*), red alder, vine maple (*A. circinatum*), salmonberry, salal (*Gaultheria shallon*), and western sword fern (*Polystichum munitum*). At the time of the site visit, coniferous forest was dominant west of the Side Channel 2 and consisted primarily of western redcedar (*Thuja plicata*), Douglas fir (*Pseudotsuga menziesii*), salmonberry, salal, low Oregon grape (*Berberis nervosa*) and western sword fern. In addition, some riparian areas have been altered by low intensity rural development (e.g., paths and recreational use).

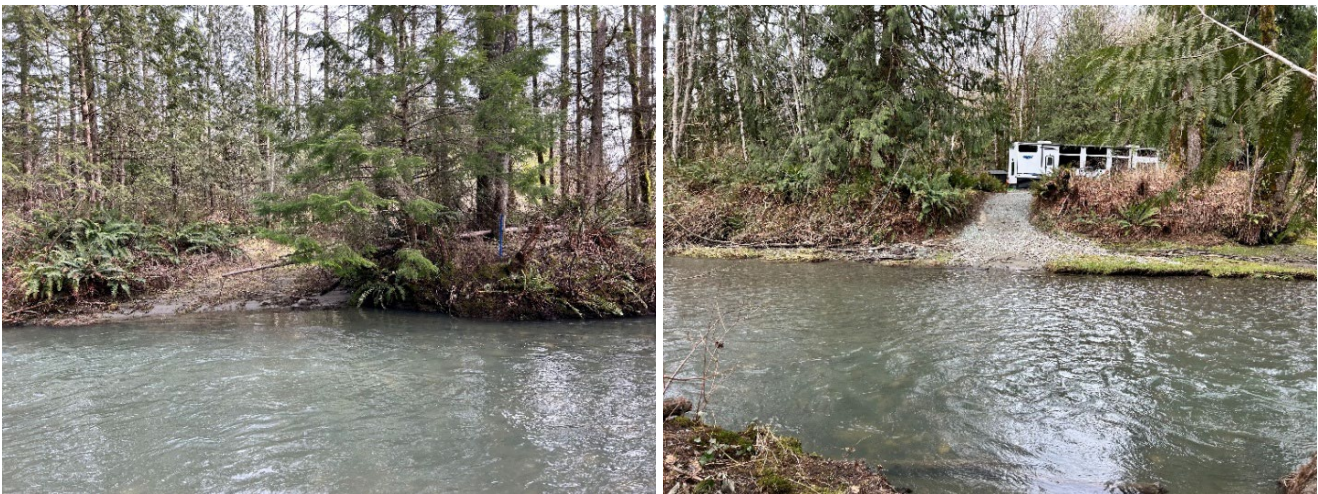
Representative photo of riparian buffer east (left) and west (right) of Side Channel 2.

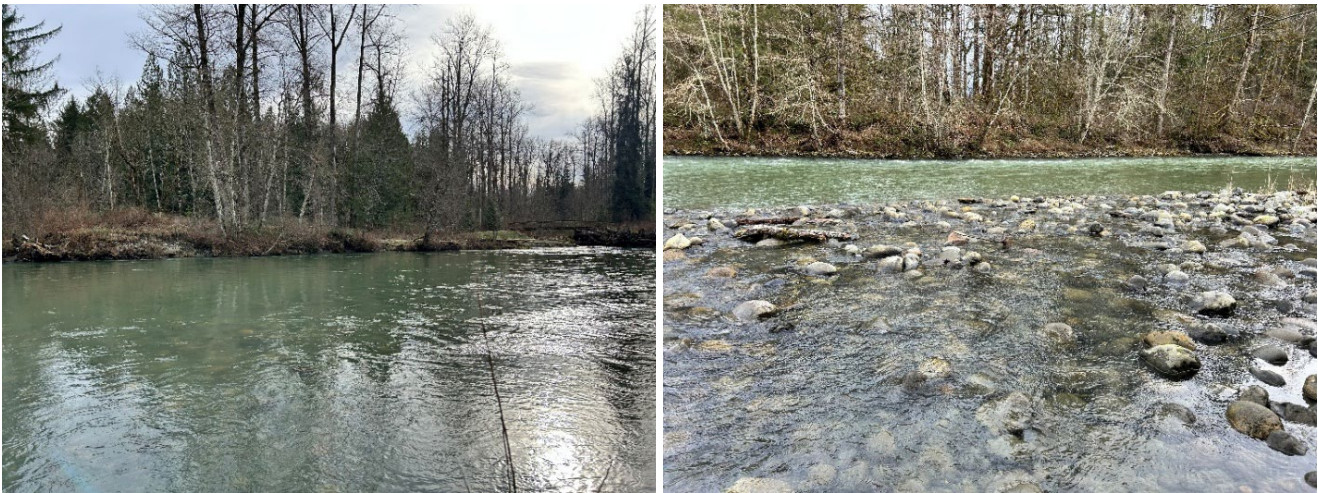
Substrate observed in the Sultan River was primarily large cobbles. Smaller cobbles to gravels, suitable for spawning of large-bodied salmonids, may be present in the river but were not observed in the study area due to high water and turbidity. However, as described in the desktop review portion of this report, this area is documented as spawning habitat for several salmonid species. Near the northern extent of the study area, shallow water flows through exposed cobbles, and likely provides velocity refugia and rearing habitat for juvenile salmonids. Minimal naturally recruited wood was observed. Undercut banks were observed on the left bank, opposite the study area. The healthy forested riparian habitat provides shading and organic matter inputs that support stream ecological functions.

*Deep water provides habitat for adult and juvenile salmon in the Sultan River looking downstream towards Osprey Park (left). Shallow water edge habitat provides rearing habitat for juvenile salmonids in the Sultan River, in the northern extent of the study area (right).*

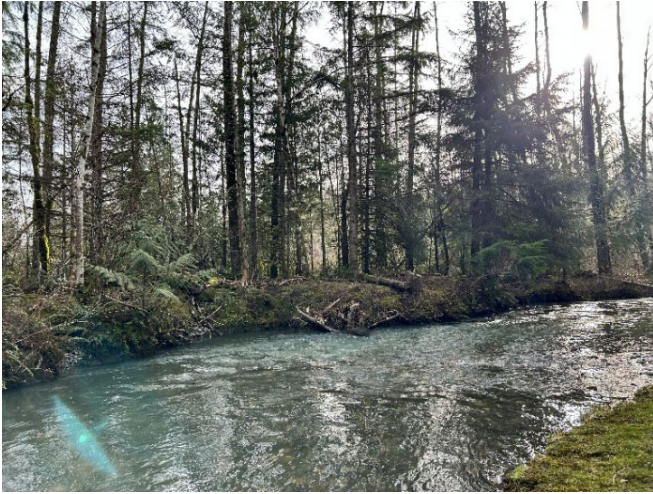
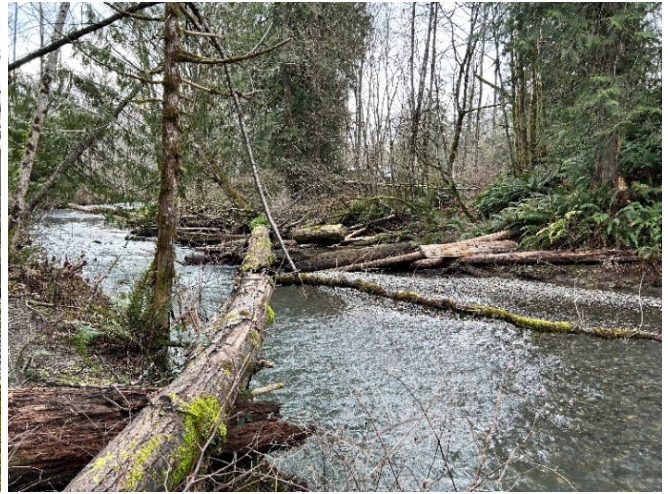
Substrate in Side Channel 2 was dominated by coarse to very coarse gravel with minimal embeddedness, optimal for small and large bodied salmonids including Chinook, chum, coho, pink, steelhead, and cutthroat spawning. Undercut banks provide holding refugia for adult and juvenile fish. Large woody debris accumulation has added to channel complexity. The dense canopy provides thermal refugia of the channel. Herrera biologists observed an adult female coho salmon that appeared lethargic, indicating it had recently spawned nearby.

*Undercut banks (left), and large woody debris (right) in Side Channel 2.*

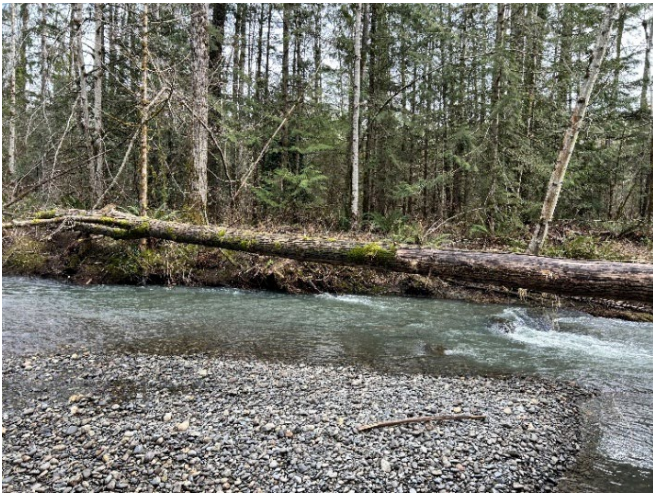
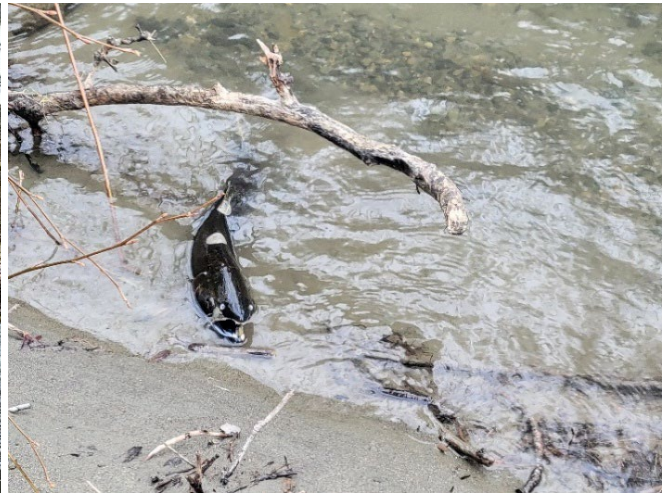
*Salmonid spawning gravel (left), and a live, post-spawn adult female coho salmon observed in Side Channel 2 during the January site visit (right).*
