Re: Jackson Hydroelectric Project, FERC No. 2157-221 License Article 405 – Ramping Rate Evaluation Plan Supplement Final Report

Sultan River Side Channel Enhancements Ramping Rate Evaluation Updated Supplement Final Report

November 2016

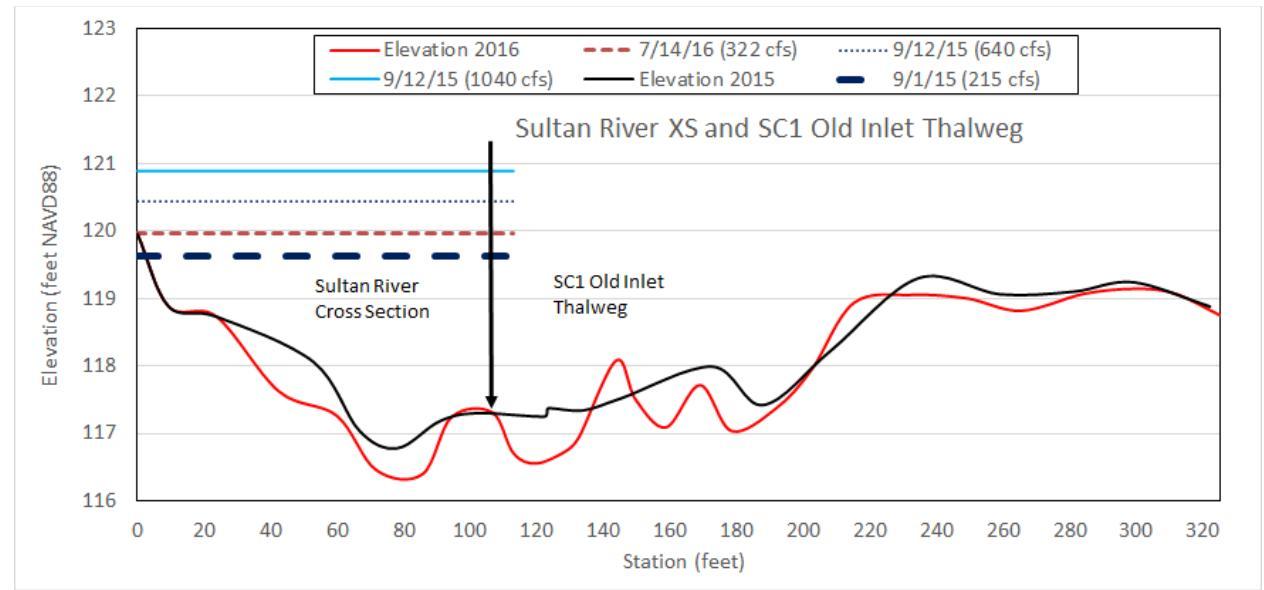
Figure 5. Sultan River Cross Section at SC1 Old Inlet (oriented looking upstream).

A cross section was established that continues the upstream end of the SC1 Old Inlet thalweg across the Sultan River. Some adjustment of the Sultan River cross section and upstream end of the Old Inlet thalweg is apparent between September 2015 and July 2016 measurements (Figure 5, Photo Collection 1). Note that the Sultan River cross section plot (Figure 5) is oriented looking upstream.

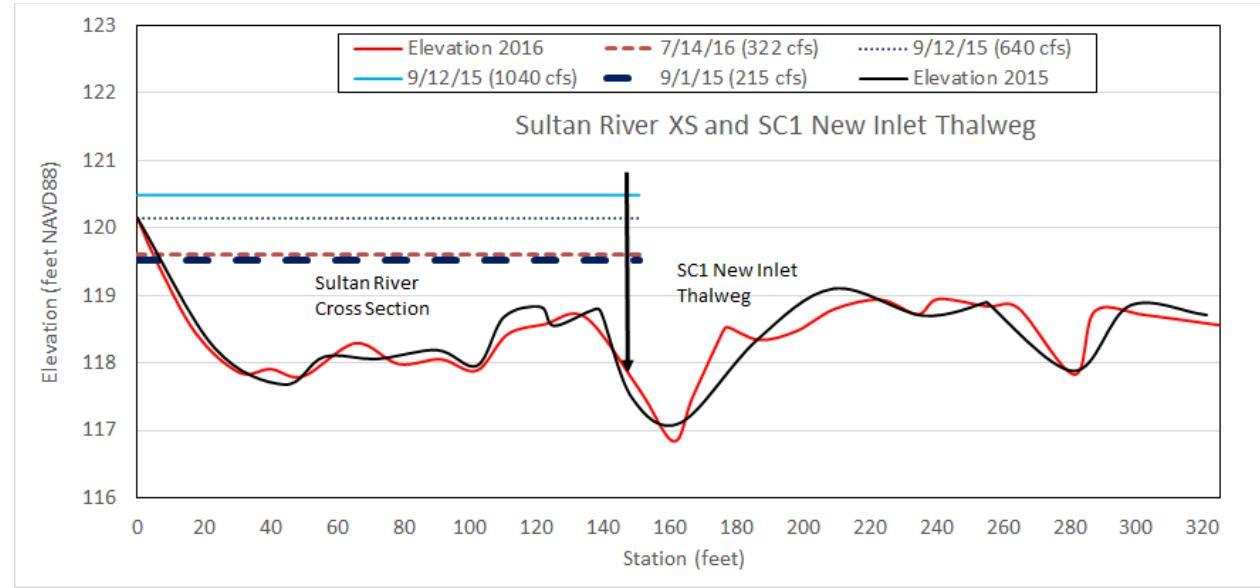
Figure 6. Sultan River Cross Section at SC1 New Inlet (oriented looking upstream).

A cross section was established that continues the upstream end of the SC1 New Inlet thalweg across the Sultan River. Relatively little adjustment of the Sultan River cross section and upstream end of the New Inlet thalweg is apparent between September 2015 and July 2016 measurements (Figure 6, Photo Collection 2). Note that the Sultan River cross section plot (Figure 6) is oriented looking upstream.

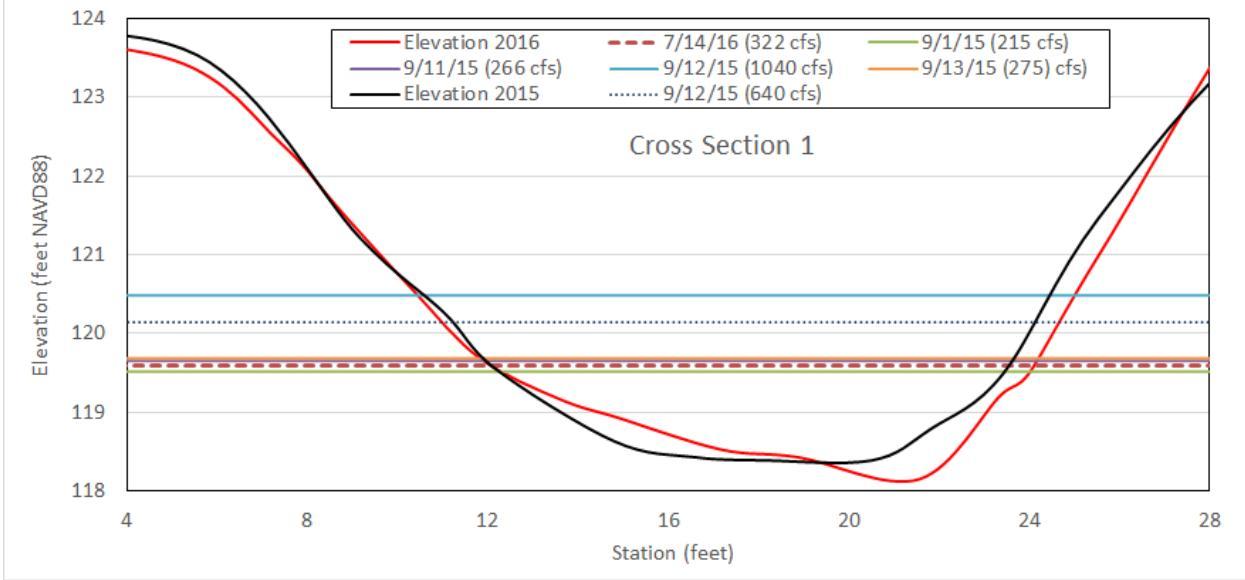
Figure 7. SC1 Cross Section 1 at upstream end of New Inlet.

Cross Section 1 is located at the upstream entrance to the New Inlet; relatively little adjustment of the cross section is apparent between the September 2015 and July 2016 measurements (Figure 7, Photo Collection 3).

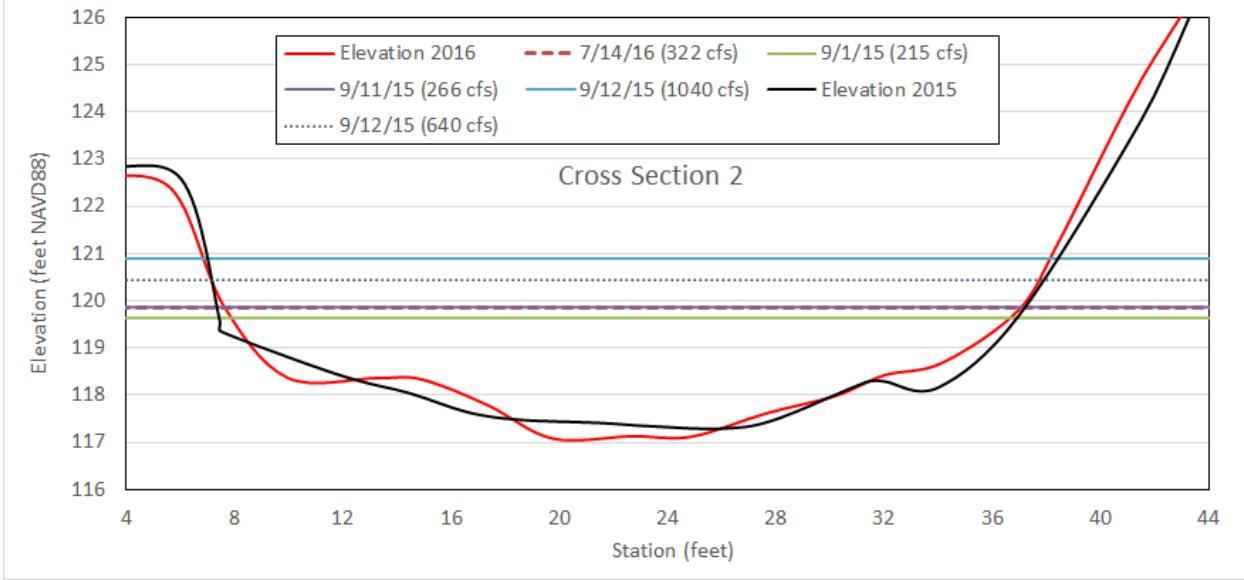
Figure 8. SC1 Cross Section 2 at upstream end of Old Inlet.

Cross Section 2 is located at the upstream entrance to the Old Inlet; relatively little adjustment of the cross section is apparent between the September 2015 and July 2016 measurements (Figure 8, Photo Collection 4).

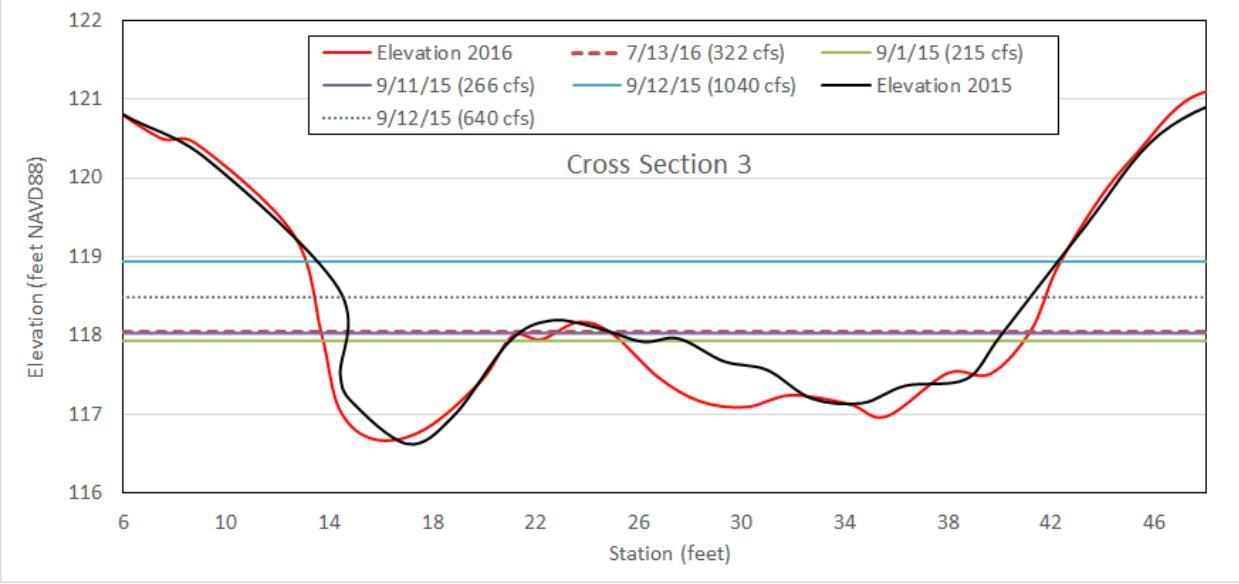
Figure 9. SC1 Cross Section 3 downstream of SC1 Old and New Inlets within the SC1 Middle Mainstem.

Cross Section 3 is located at the Middle Mainstem a short distance downstream of the Old and New Inlet confluence; some adjustment of the cross section is apparent between the September 2015 and July 2016 measurements (Figure 9, Photo Collection 5).

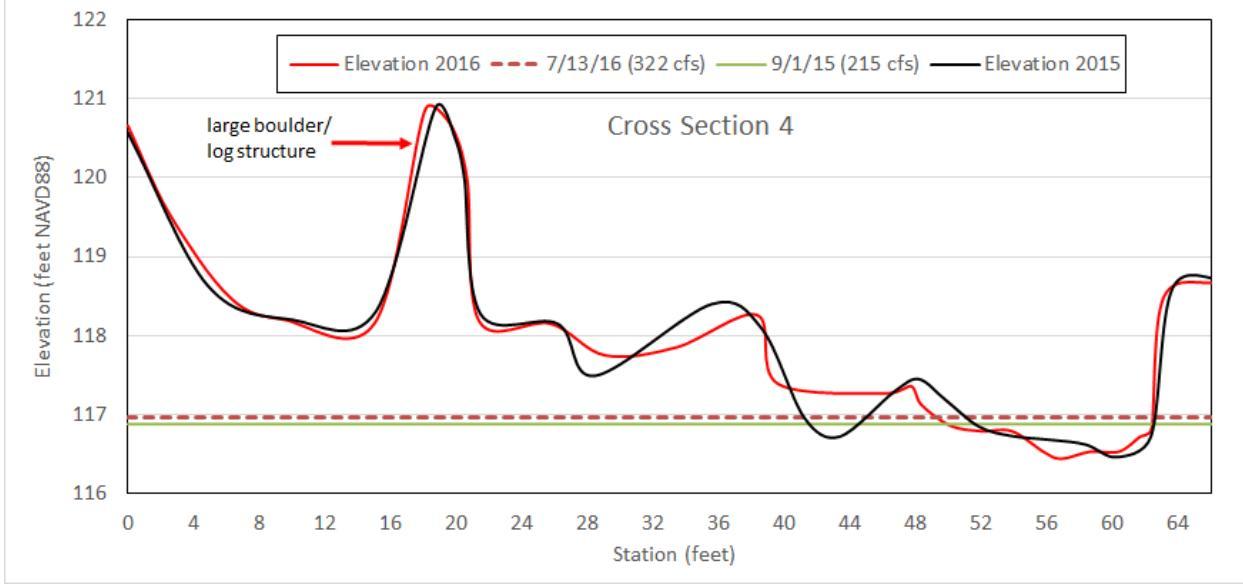
Figure 10. SC1 Cross Section 4 within SC1 Middle Mainstem.

Cross Section 4 is located within the Middle Mainstem in an area with a relatively wide potential floodplain with what appears to be a legacy channel system to the east that has been blocked by a large boulder/log structure. The cross section contains a portion of a small side channel. Some adjustment of the cross section is apparent between the September 2015 and July 2016 measurements (Figure 10, Photo Collection 6).

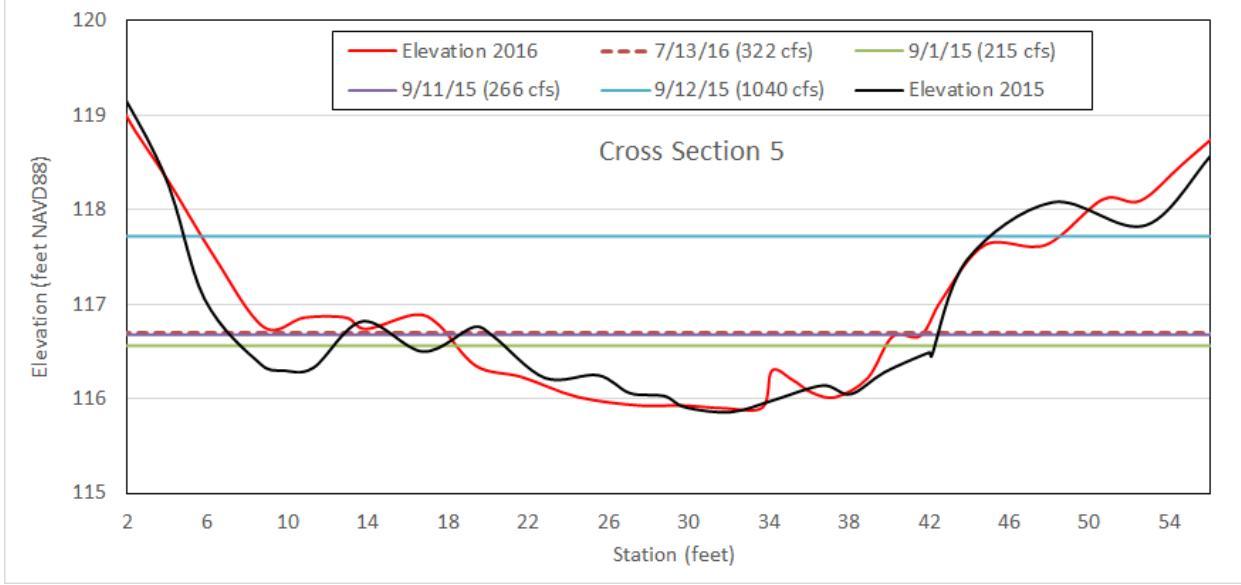
Figure 11. SC1 Cross Section 5 within SC1 Middle Mainstem.

Cross Section 5 is located within the Middle Mainstem in an area with a relatively wide potential floodplain. The cross section contains the inlet to a side channel. Some adjustment of the cross section is apparent between the September 2015 and July 2016 measurements (Figure 11, Photo Collection 7).

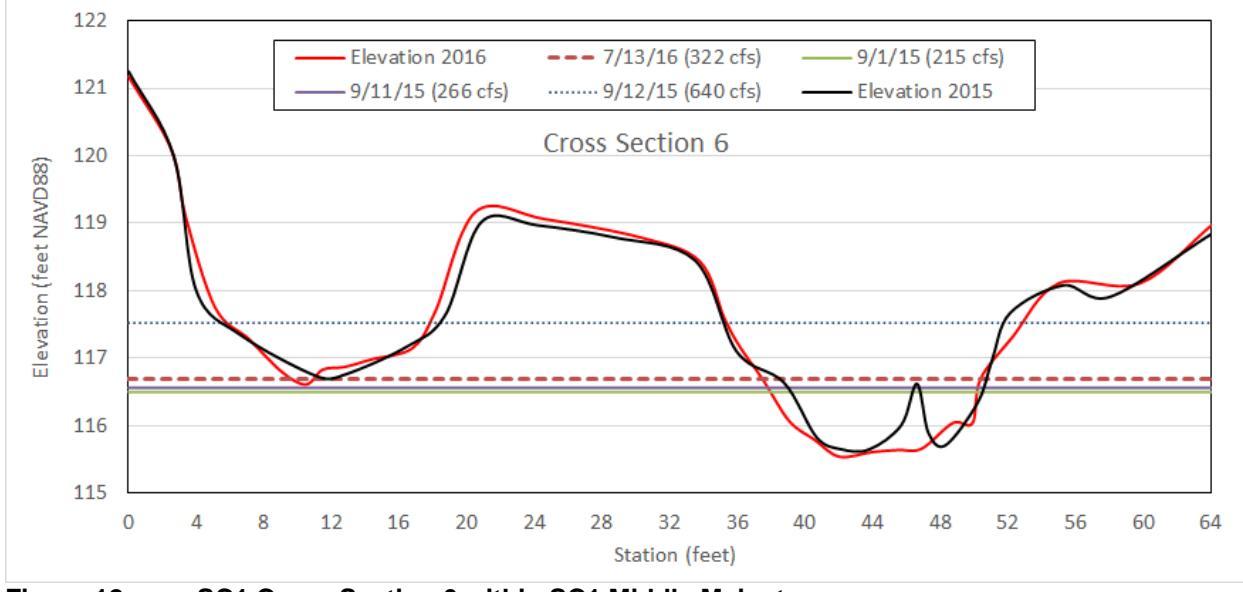
Figure 12. SC1 Cross Section 6 within SC1 Middle Mainstem.

Cross Section 6 is located within the Middle Mainstem in an area with a relatively wide potential floodplain. The cross section contains a side channel (same side channel that is part of Cross Section 5). Little adjustment of the cross section is apparent between the September 2015 and July 2016 measurements (Figure 12, Photo Collection 8).

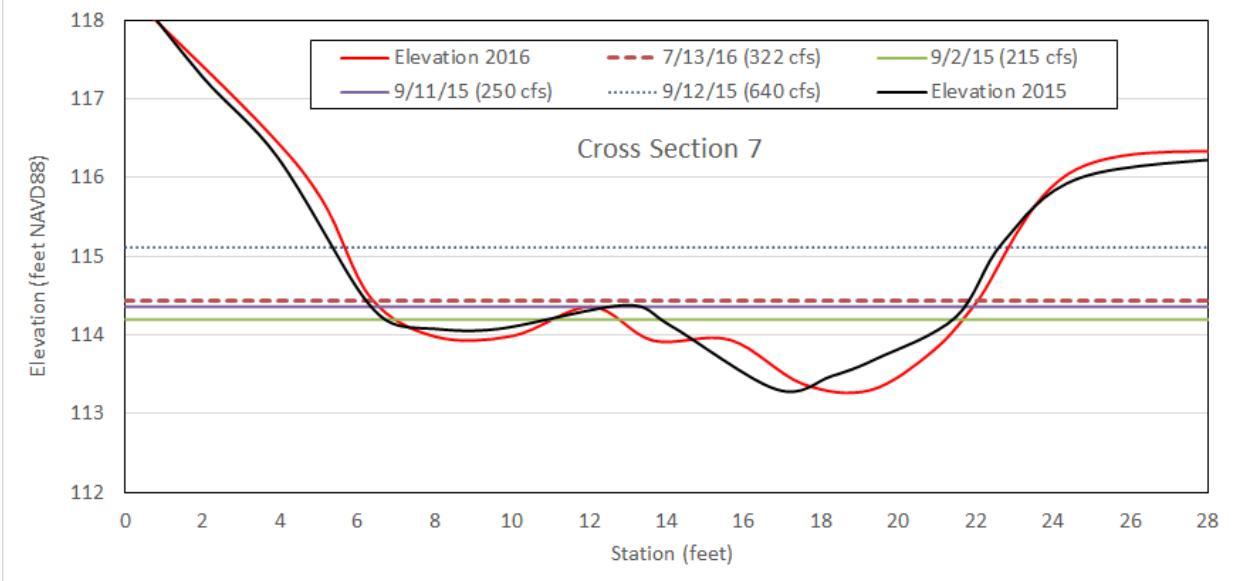
Figure 13. SC1 Cross Section 7 at the upstream end of the Old Outlet.

Cross Section 7 is located at the upstream end of the Old Outlet; little adjustment of the cross section is apparent between the September 2015 and July 2016 measurements (Figure 13, Photo Collection 9).

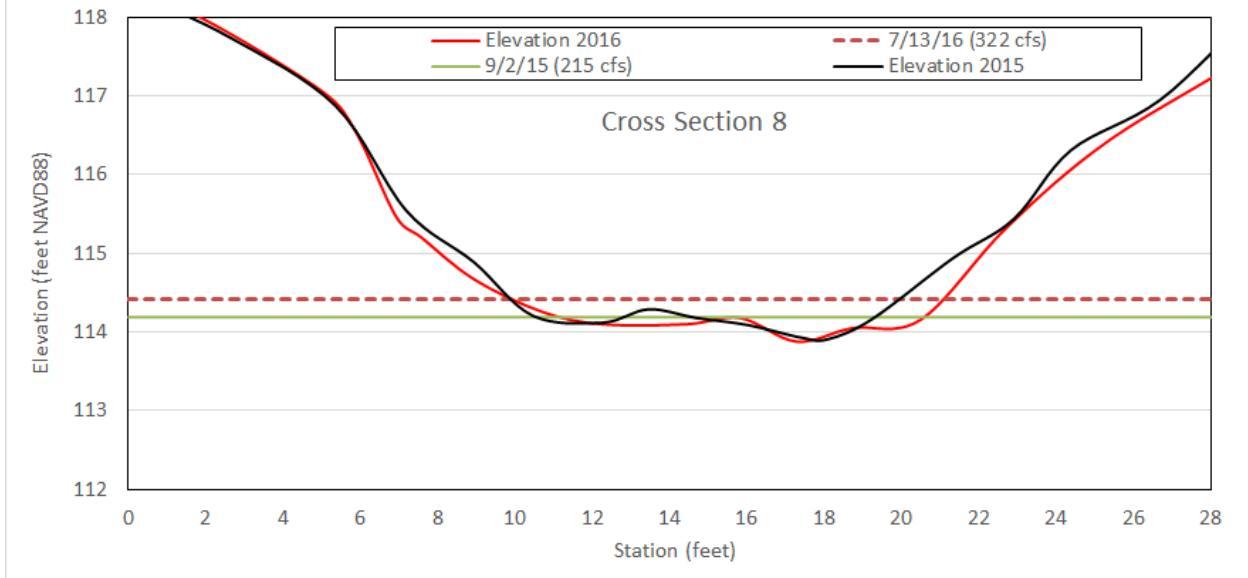
Figure 14. SC1 Cross Section 8 near the upstream end of the New Outlet.

Cross Section 8 is located within the New Outlet a short distance downstream of the Old/New outlet split, near where surface flow ceased during the 2015 survey at 215 cfs. Little adjustment of the cross section is apparent between the September 2015 and July 2016 measurements (Figure 14, Photo Collection 10).

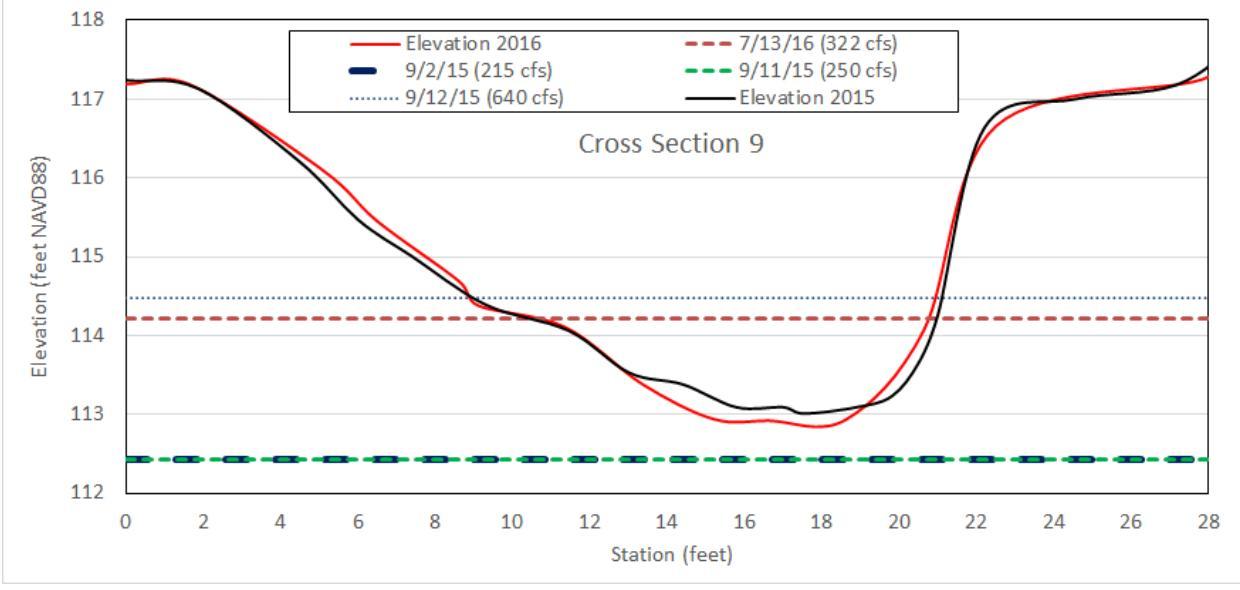
Figure 15. SC1 Cross Section 9 near the upstream end of the New Outlet.

Cross Section 9 is located within the New Outlet a short distance downstream of the Old/New outlet split, where the channel was dry during the 2015 survey at 215 cfs. Little adjustment of the cross section is apparent between the September 2015 and July 2016 measurements (Figure 15, Photo Collection 11).

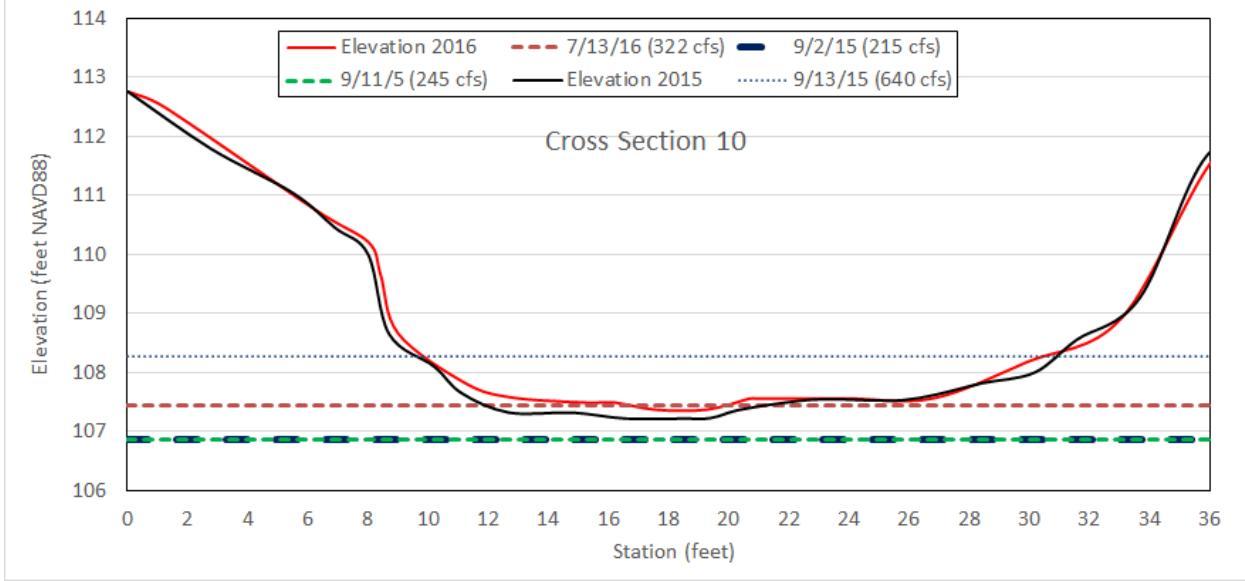
Figure 16. SC1 Cross Section 10 within the New Outlet.

Cross Section 10 is located within the New Outlet where surface flow was intermittent during the 2015 survey at 215 cfs. Little adjustment of the cross section is apparent between the September 2015 and July 2016 measurements (Figure 16, Photo Collection 12).

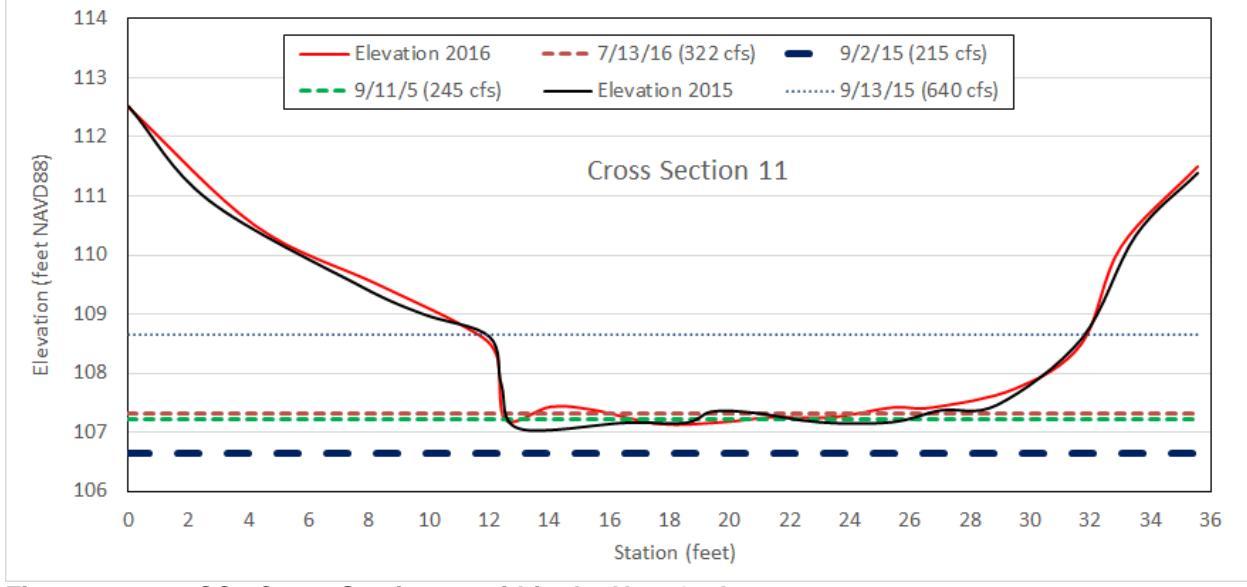
Figure 17. SC1 Cross Section 11 within the New Outlet.

Cross Section 11 is located within the New Outlet where surface flow was intermittent during the 2015 survey at 215 cfs. Little adjustment of the cross section is apparent between the September 2015 and July 2016 measurements (Figure 17, Photo Collection 13).

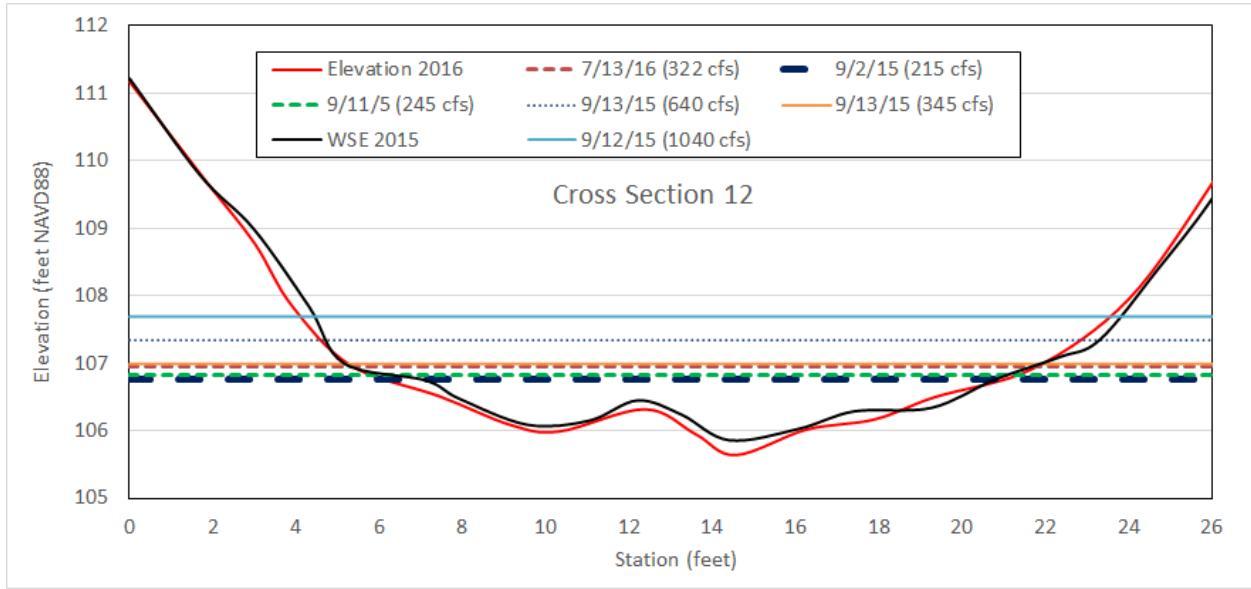
Figure 18. SC1 Cross Section 12 near the downstream end of the New Outlet.

Cross Section 12 is located within the New Outlet where surface flow was continuous to the Sultan River confluence during the 2015 survey at 215 cfs, and is also located at the District's previously established staff gage monitoring site. Little adjustment of the cross section is apparent between the September 2015 and July 2016 measurements (Figure 18, Photo Collection 14).

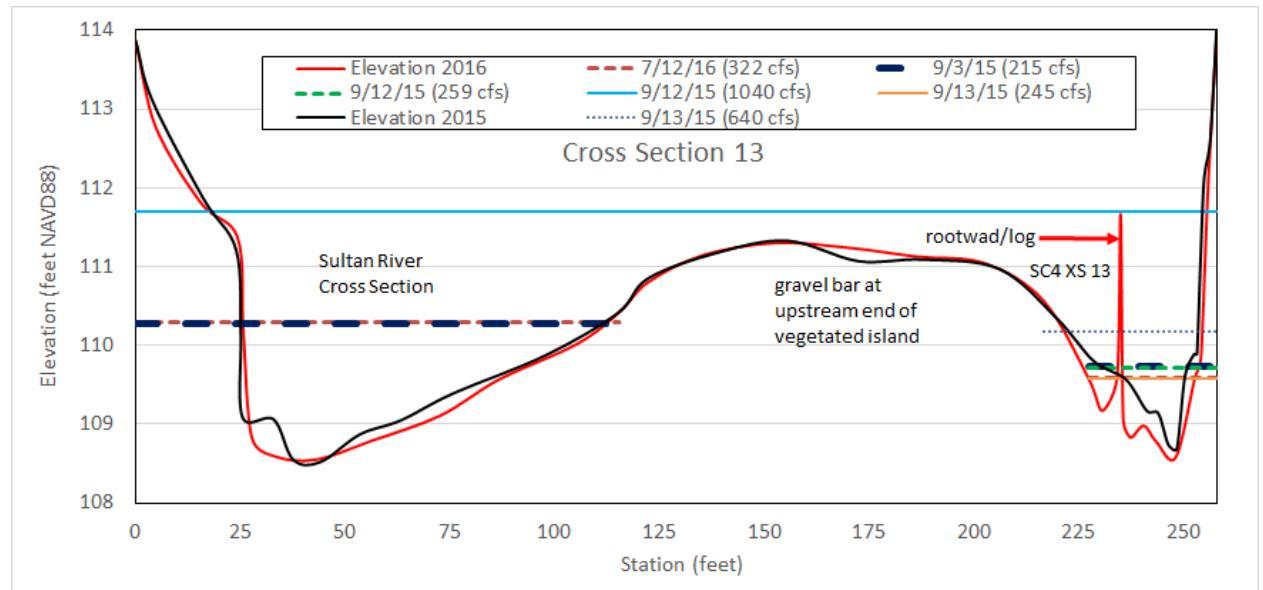
Figure 19. SC4 Cross Section 13 at the upstream end of the Upper Inlet and the Sultan River.

Cross Section 13 is located at the upstream end of SC4 and extends across the SC4 Upper Inlet as well as the mainstem Sultan River channel. Some adjustment of the Sultan River cross section and upstream end of the SC4 inlet is apparent between September 2015 and July 2016 measurements (Figure 19). Adjustments observed included some scouring of the gravel bar along the SC4 Inlet and deposition of a log/rootwad (Photo Collection 15).

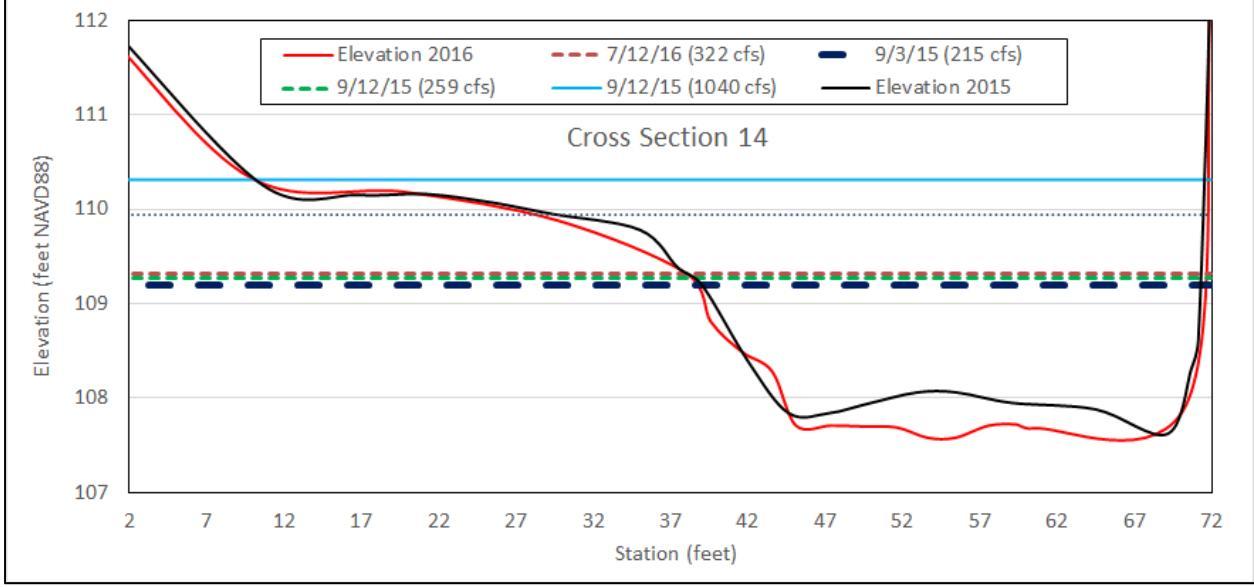
Figure 20. SC4 Cross Section 14 within the Upper Inlet.

Cross Section 14 is located within the Upper Inlet of SC4; some adjustment of this cross section is apparent between September 2015 and July 2016 measurements (Figure 20, Photo Collection 16).

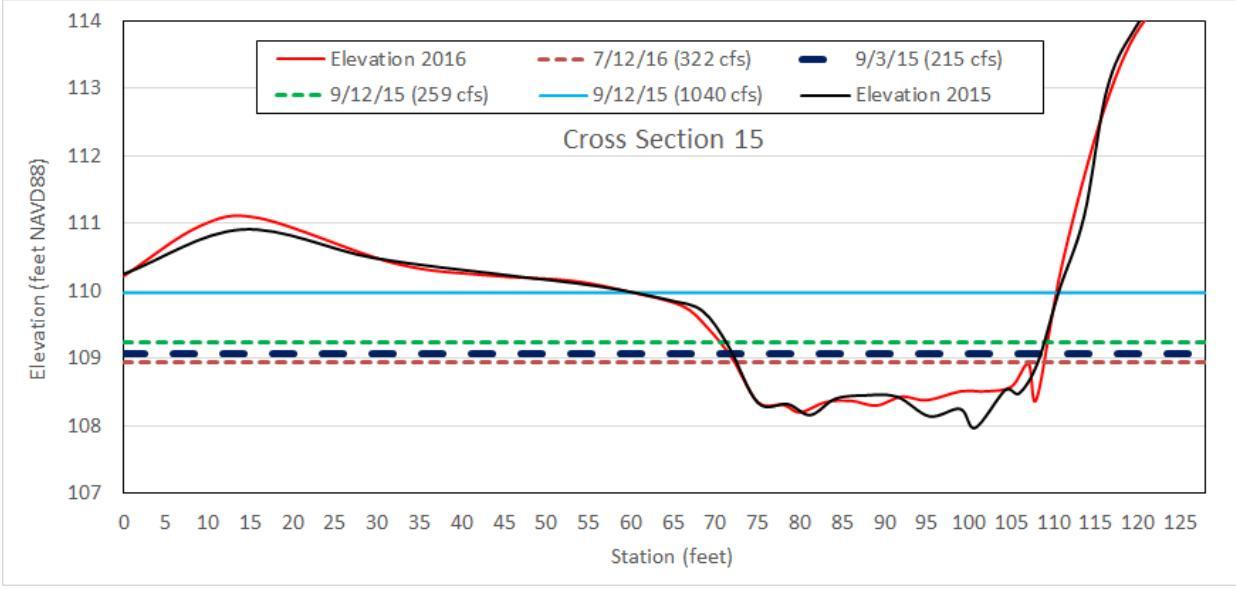
Figure 21. SC4 Cross Section 15 at the downstream end of the Upper Inlet.

Cross Section 15 is located within the Upper Inlet of SC4 just upstream of where the Upper Outlet channel connects to the Sultan River. Some adjustment of this cross section is apparent between September 2015 and July 2016 measurements (Figure 21, Photo Collection 17).

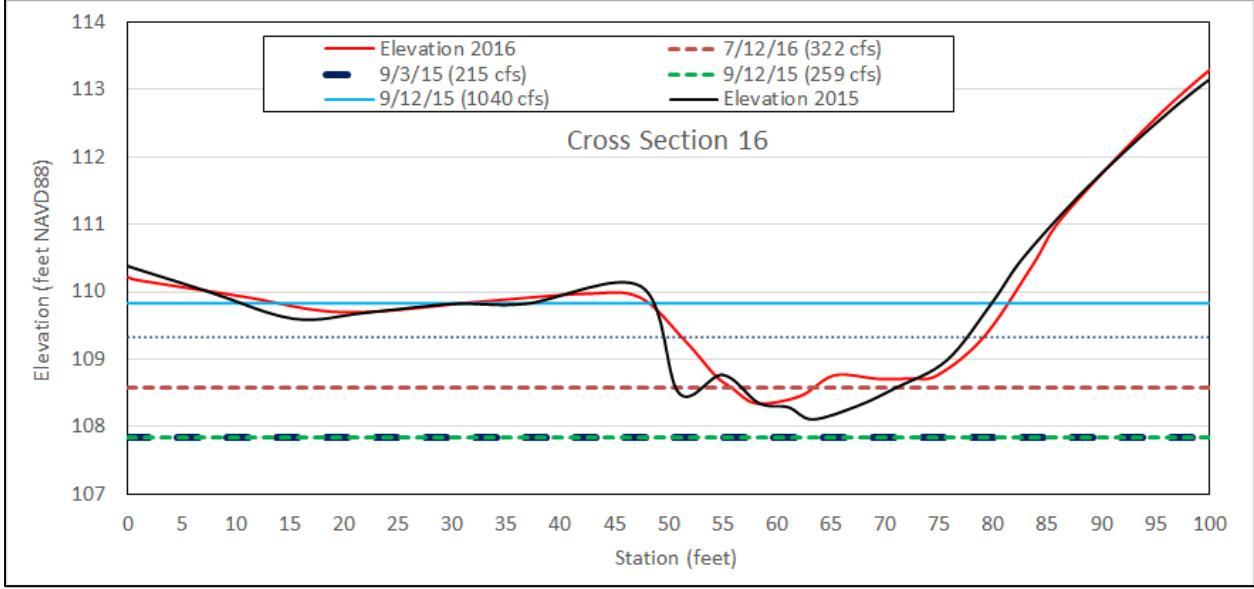
Figure 22. SC4 Cross Section 16 within the Upper Outlet.

Cross Section 16 is located within the short Upper Outlet channel of SC4. This channel was dry during the 2015 measurement and barely flowing during the 2016 measurement. Some adjustment of this cross section is apparent between September 2015 and July 2016 measurements (Figure 22, Photo Collection 18).

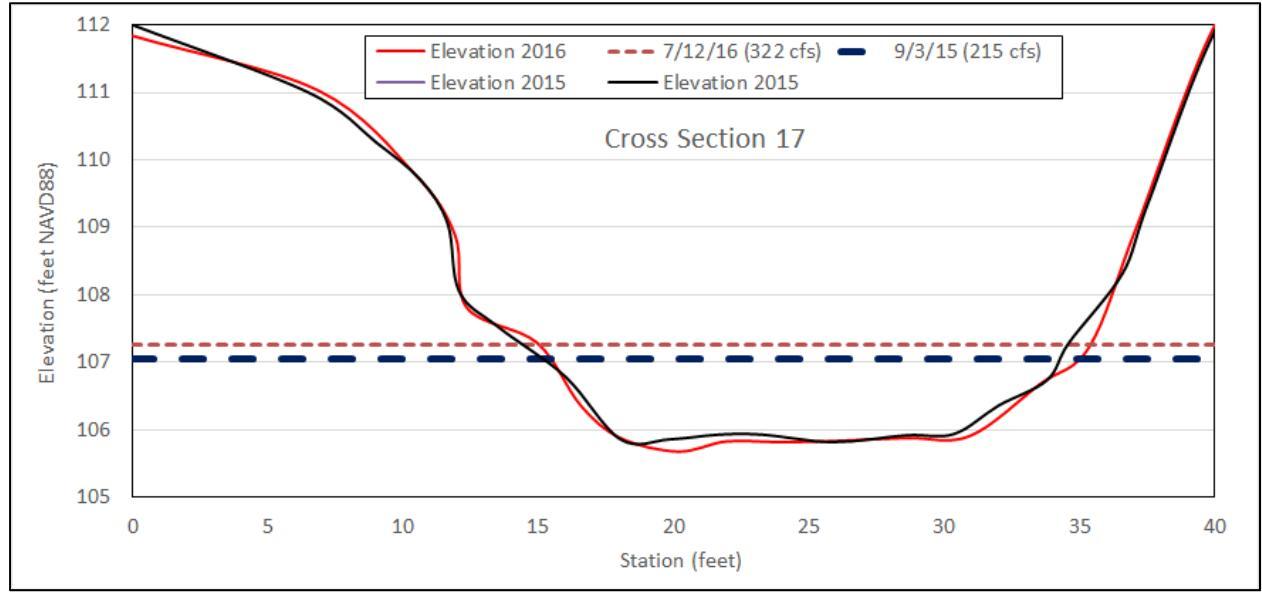
Figure 23. SC4 Cross Section 17 within the Mainstem.

Cross Section 17 is located within the SC4 mainstem downstream of the Upper Outlet. Little adjustment of this cross section is apparent between September 2015 and July 2016 measurements (Figure 23, Photo Collection 19).

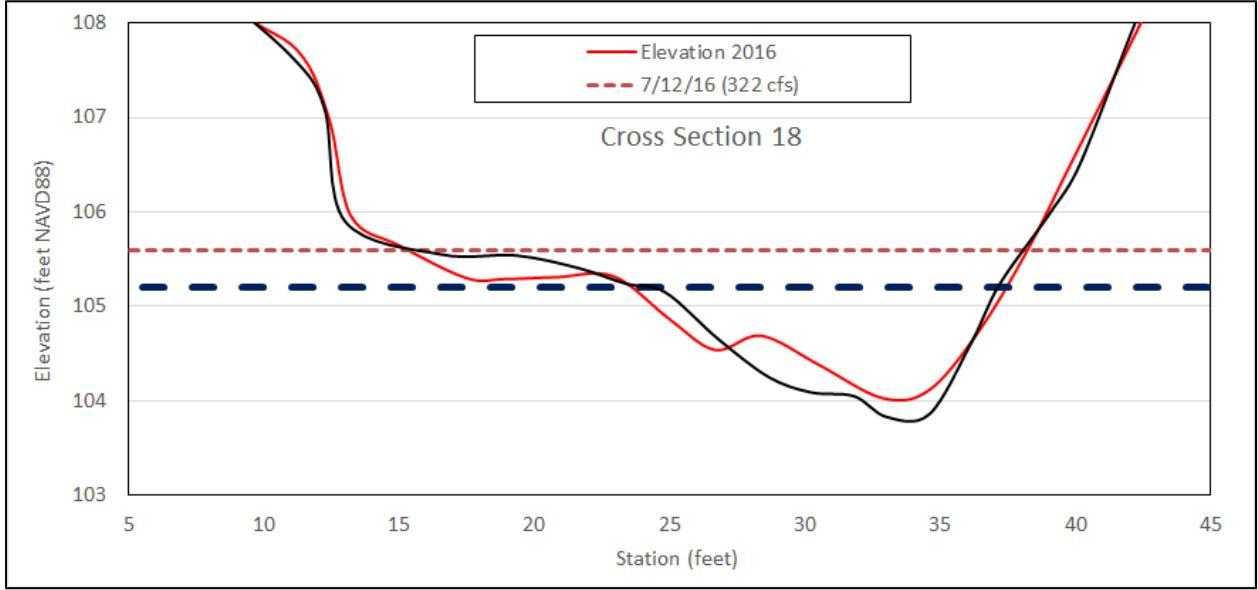
Figure 24. SC4 Cross Section 18 within the Mainstem.

Cross Section 18 is located within the SC4 mainstem. Some adjustment of this cross section is apparent between September 2015 and July 2016 measurements (Figure 24, Photo Collection 20).

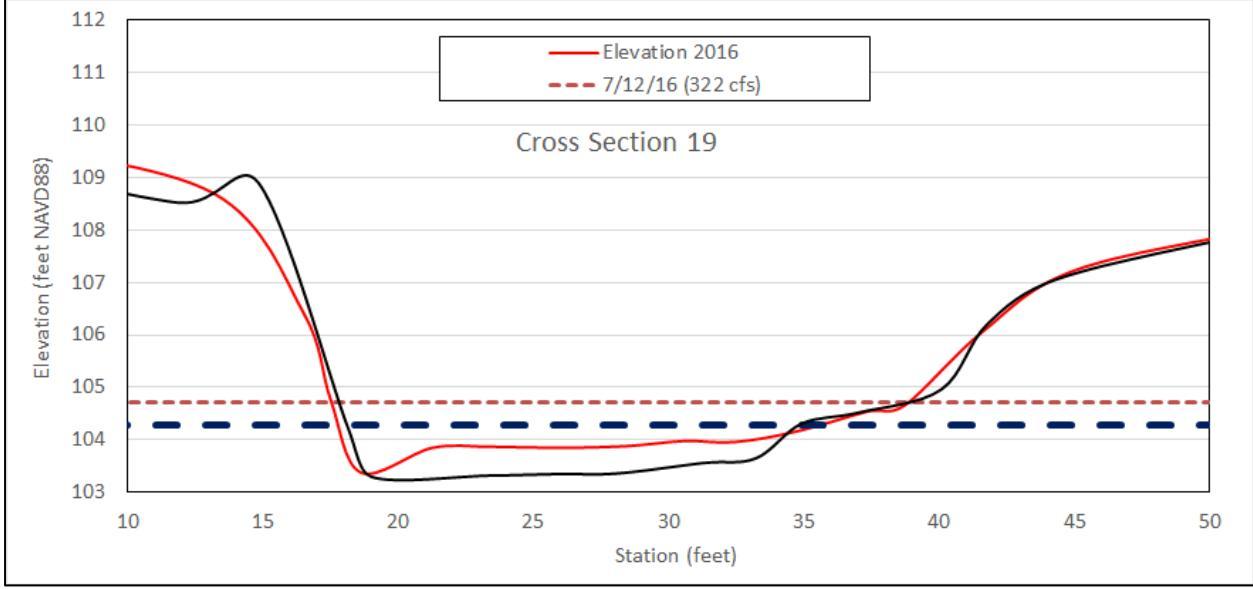
Figure 25. SC4 Cross Section 19 within the Mainstem.

Photo Collection 20. SC4 Cross Section 18 within the Mainstem.
Cross Section 19 is located within the SC4 mainstem. Some adjustment of this cross section is apparent between September 2015 and July 2016 measurements (Figure 25 Photo Collection 21).

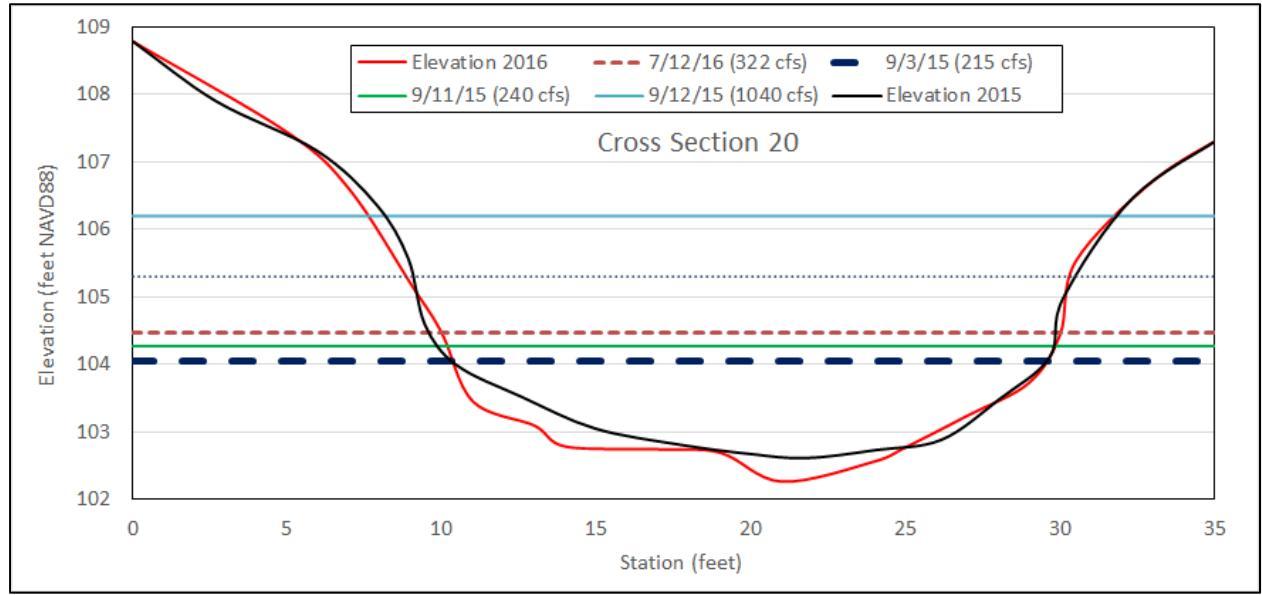
Figure 26. SC4 Cross Section 20 near the Mainstem outlet to the Sultan River.

Cross Section 20 is located in a scour pool at the downstream end of SC4 mainstem, just upstream of the Sultan River confluence. Some adjustment of this cross section is apparent between September 2015 and July 2016 measurements (Figure 26 Photo Collection 22).

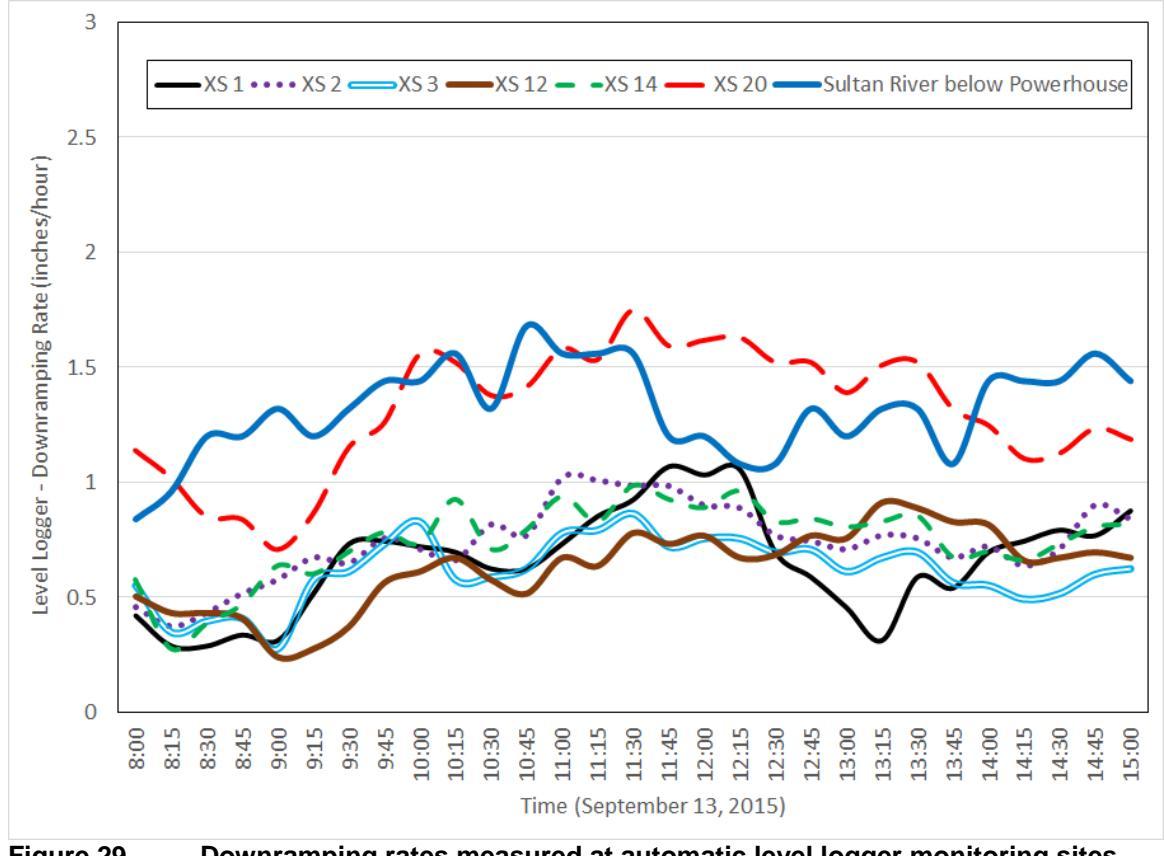
Figure 29. Downramping rates measured at automatic level logger monitoring sites (September 13, 2015).

The ramping rate test was conducted from about 7:30 am to 3:00 pm on September 13, 2015. In general, the rate of stage decline (slope of the stage decline) was less (i.e., somewhat attenuated) at most cross sections compared to the mainstem Sultan River downstream of the Powerhouse gage (Figures 27 and 28), except at Cross Section 10 in SC1 and Cross Section 13 in SC4 (Figure 28). The downramping test results show that most sites had downramping rates less than 1.5 inches/hour throughout the test (Figures 29 and 30), except Cross Section 10 in SC1 and Cross Section 13 in SC4 which slightly exceeded two inches/hour (Figure 30). The Sultan River below the Powerhouse gage site experienced downramping rates also general below 1.5 inches/hour (Figure 29).

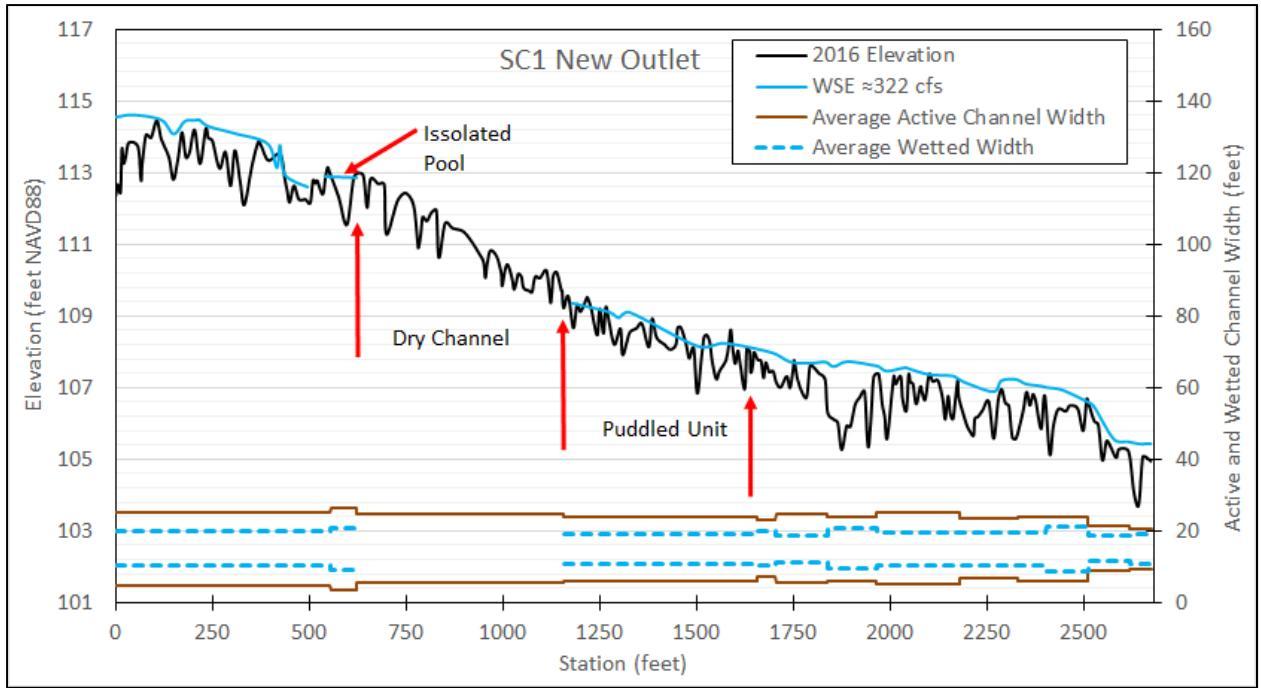
Figure 35. SC1 New Outlet profile and active/wetted channel dimension (July 2016).

The SC1 New Outlet was substantially dewatered during the 2015 survey at 215 cfs as well as during the 2016 survey at 322 cfs. Based on the 2016 bed thalweg elevation within the New and Old Outlets and the stage discharge relationship at the upstream end of the Old Outlet at Cross

SC1 from the upstream end of the old inlet to the downstream end of the new outlet is nearly 1 mile long. Plotting the profile of this length on one page would lose a lot of resolution and would be about twice as compressed as Figure 35. The location of channel cross sections has been added to the profile figures, as suggested.
8	Figure 34. How much water is exiting the Old Outlet versus the new outlet? Reactivating the old outlet was not in the original plan for recreating side channel habitat. The ARC may consider remedies to the issue of the SC 1 New Outlet dewatering or downramping rates may need to be reduced to prevent stranding	The routing and delivery of flow between the Old Outlet and the New Outlet has been an issue since construction. Since construction, the District has monitored the distribution of flow at the flow split and has observed a trend towards a reduced percentage of flow being routed down the New Outlet. Once the issue of dewatering under low flow was apparent, the District recognized the importance and immediately implemented a plan to resolve the issue. The District will continue to monitor the distribution of flow at this location.

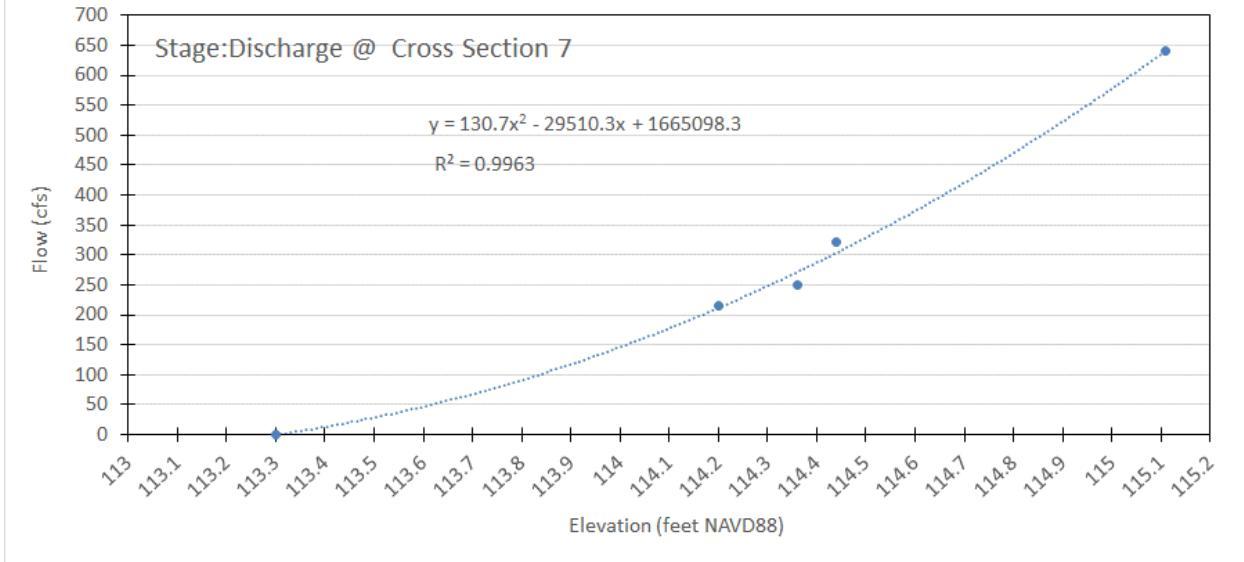
Figure 38. Cross Section 7 stage:discharge relationship (upstream end of SC1 Old Outlet).

Section 7 (Figure 38), the SC1 New Outlet would be activated with continuous surface flow at about 385 cfs at the Sultan River below Powerhouse gage. This is because the SC1 Old outlet thalweg is lower than the SC1 New Outlet thalweg. During the July 2016 survey, the highest thalweg bed elevation in the Old Outlet was 113.79 feet (NAVD88), while the highest elevation within the New Outlet was 114.45 feet (NAVD88), about 8 inches higher, located about 106 feet downstream of the New/Old Outlet split. The water surface elevation at about 300 cfs at Cross Section 7 equates to about 114.42 feet (NAVD88) (i.e., lower than the highest thalweg bed elevation 114.61 feet (NAVD88) (about 2 inches higher than the highest thalweg bed elevation in the New Outlet).

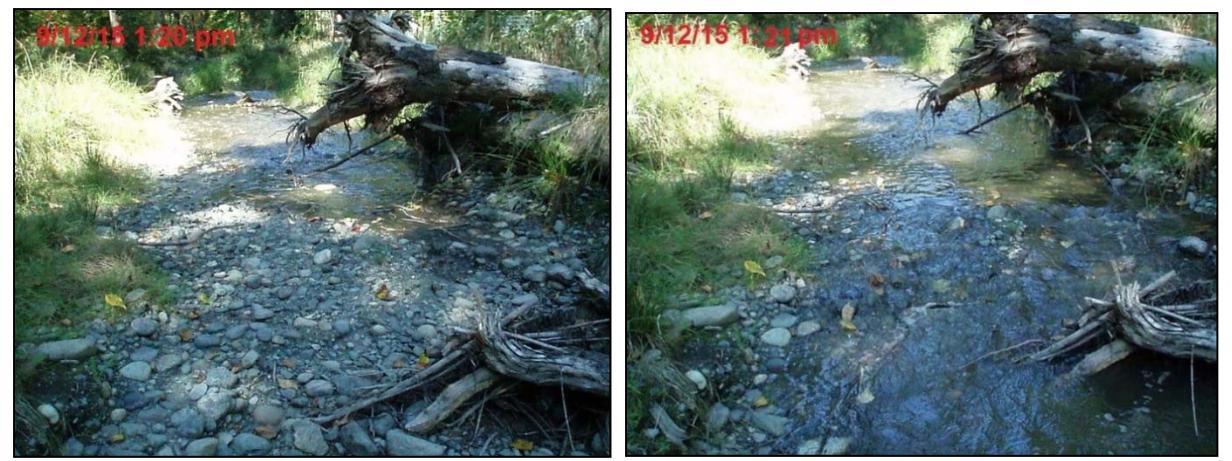
Photo Collection 31. Flow observation wave within the SC1 New Outlet at 1:20 pm on September 12, 2015.

Coincidently, a study biologist was walking the SC1 New Outlet when the flow increased to over 1,000 cfs in preparation for the downramping test the following day. The biologist was within the dry portion of the SC1 New Outlet just as the wave of surface flow was wetting the previously dry channel on September 12, at 1:20 pm. Flow travel time from the Sultan River below Powerhouse gage is about 2 hours to reach the downstream end of the SC1 New Outlet; the upstream end of the New Outlet should have somewhat less travel time. Flow on the Sultan River gage was 240 cfs at 11:00 am, but 384 cfs at 11:15 am, further suggesting that about 385 cfs results in continuous surface flow in the SC1 New Outlet.
