# TECHNICAL MEMO

**TO:** Jackson Hydroelectric Project (FERC No. 2157) file

**RE:** License Article 404: Side Channel Enhancements, Maintenance 2016

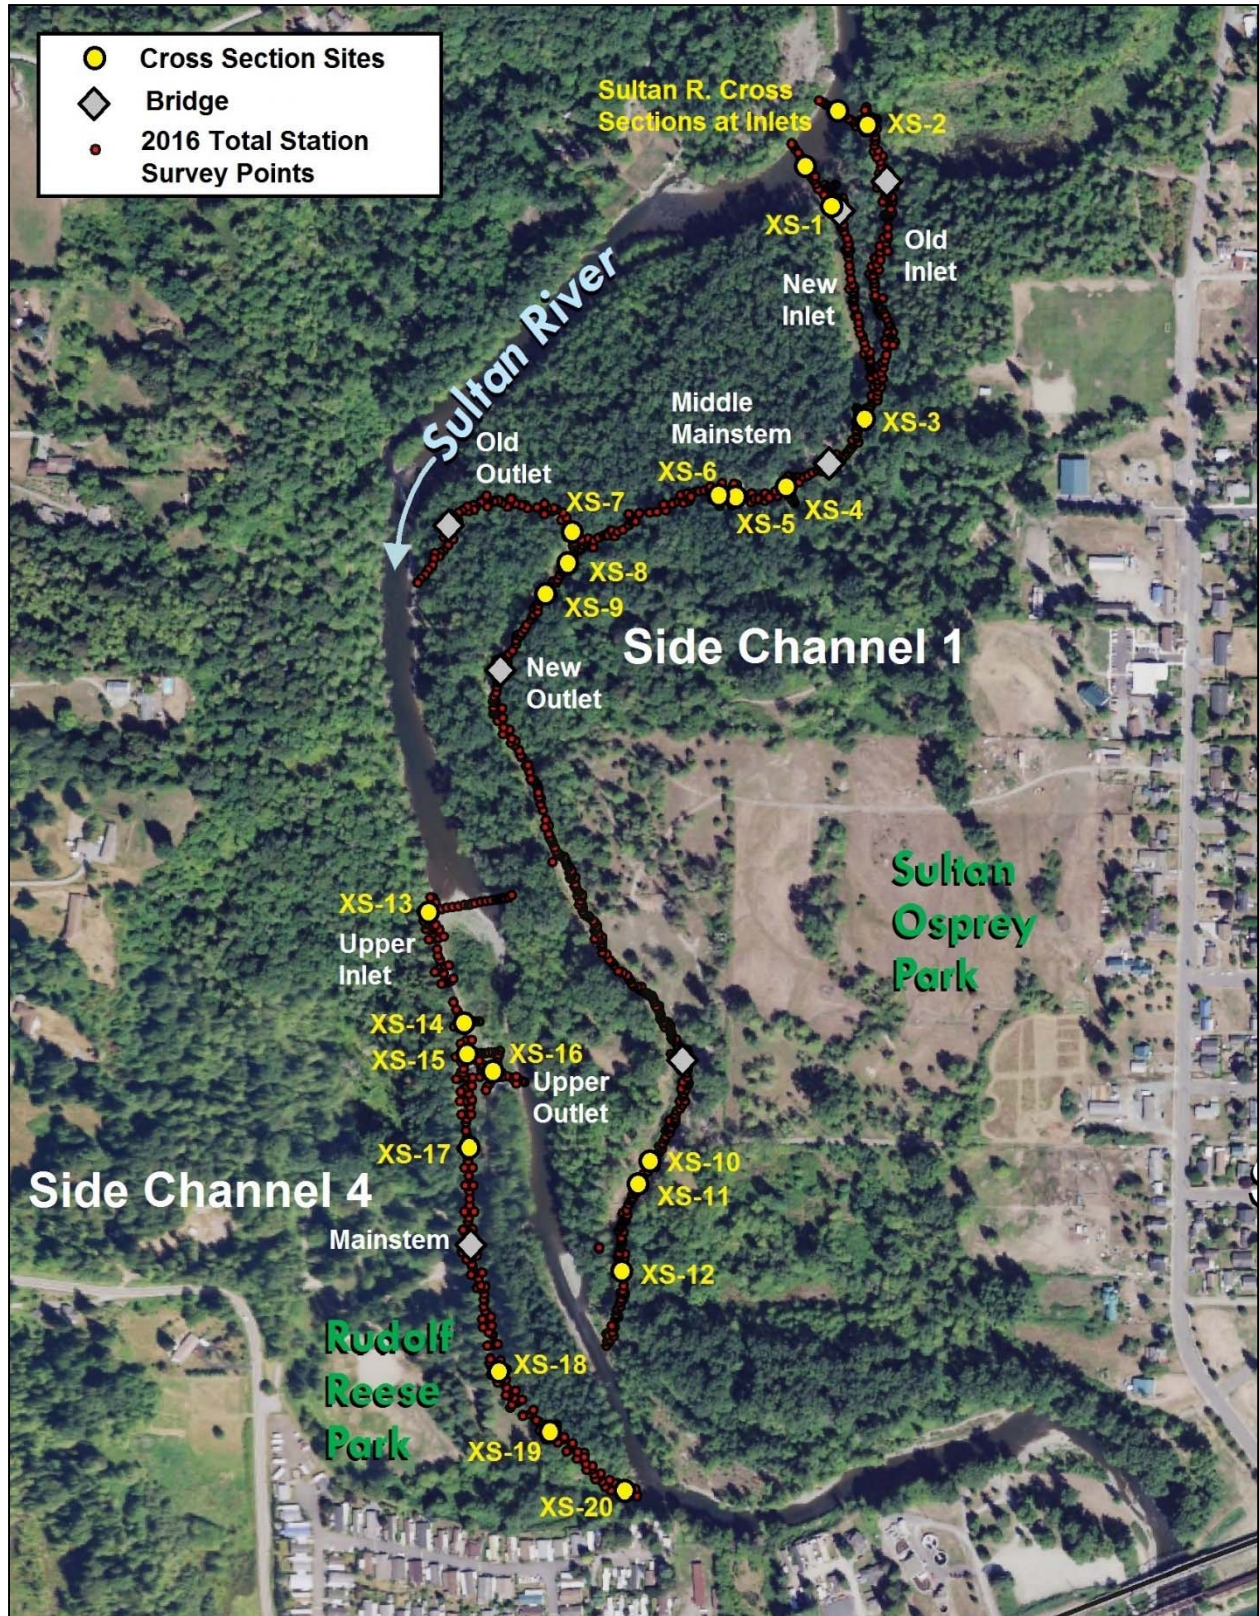
The routing and distribution of flow within the Side Channel 1 (SC 1) complex has been closely monitored since the completion of the construction of side channel enhancements. The SC 1 complex has two inlets and two outlets (Figure 1). A second inlet, referred to as the “new” or “redundant” inlet, was created to ensure water delivery in the event that the original inlet became blocked or compromised. The original “old” inlet is adjacent to a large wetland where beaver have been observed. Historically, beaver activity has resulted in flow reductions within SC 1 under low flows. Since construction, no significant flow related problems have been identified at the inlets other than the occasional damming of the channel by people during the summer.

Figure 1. Map of the lower Sultan River, including the old and new outlets to Side Channel 1.

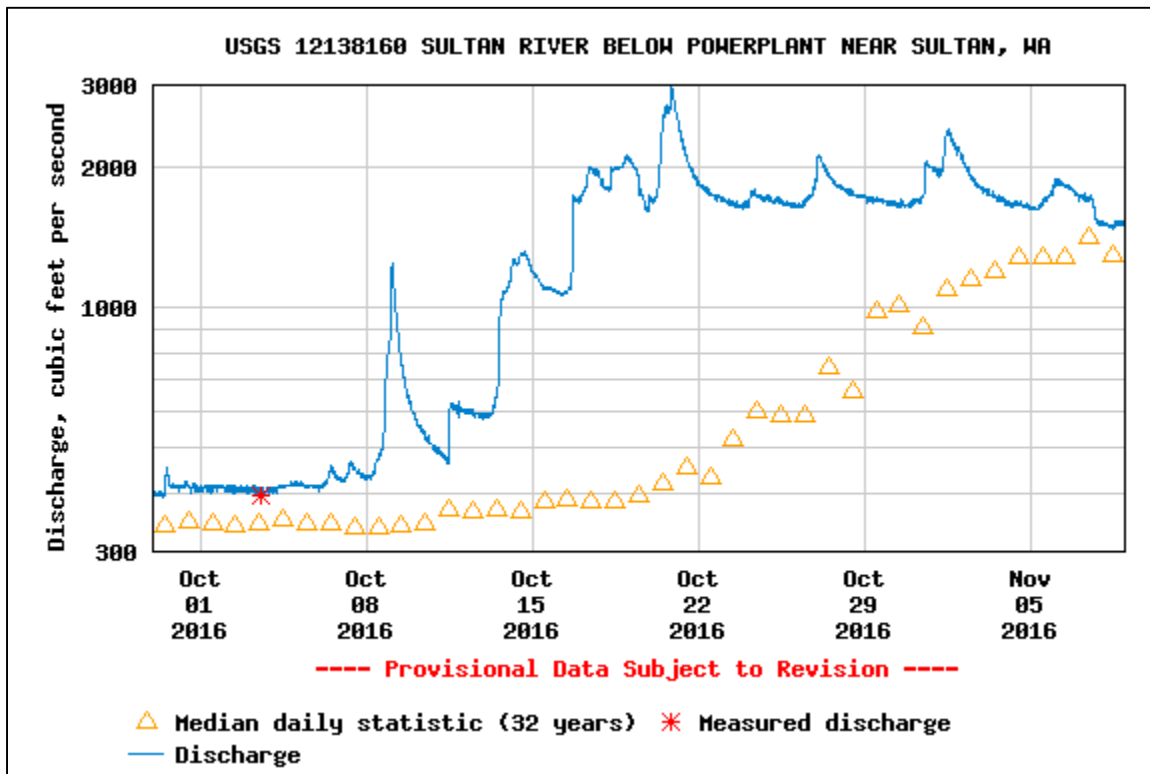
Figure 3. Hydrograph of the lower Sultan River depicting flows experienced prior to post construction topographic survey.
