**Re: Jackson Hydroelectric Project, FERC No. 2157
Side Channel Enhancement Ramp Rate Evaluation Report
License Article 405**

Jackson Hydroelectric Project
(FERC No. 2157)

**Side Channel Enhancement
Ramp Rate Evaluation Report
(License Article 405)**

October 2013

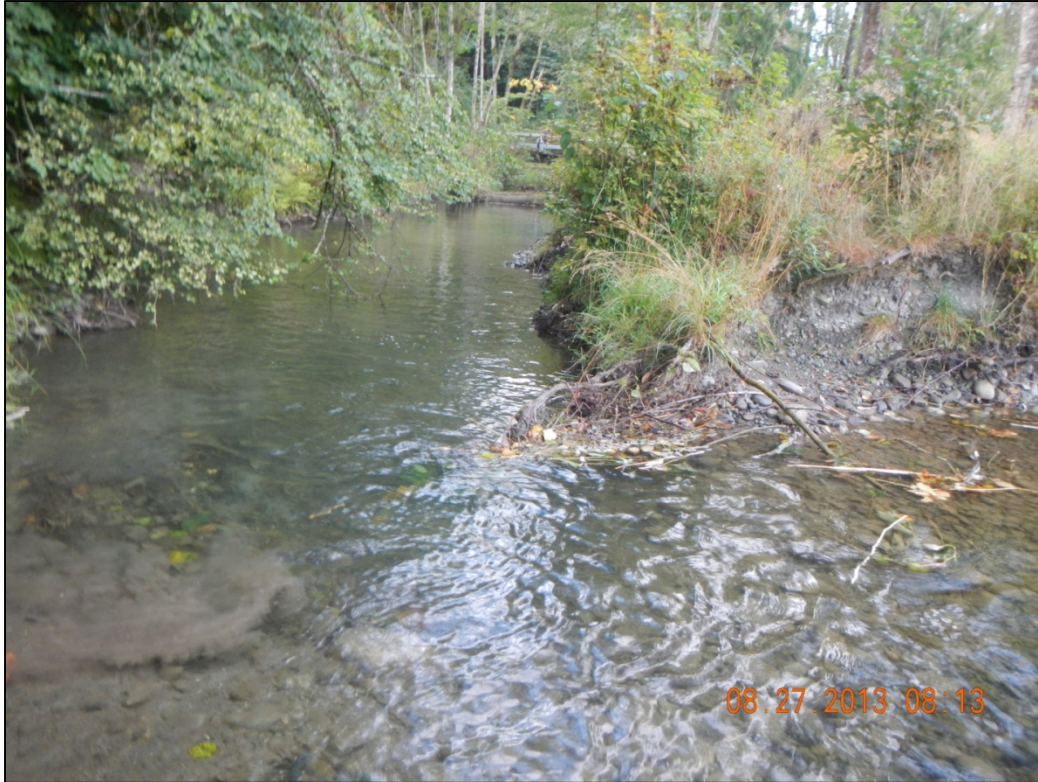
Figure 4-2. Historic inlet to SC 1, looking downstream into side channel from main river, mainstem discharge of 400 cfs.

As previously stated, SC1 is unique among the Sultan River side channels in that it has two inlets and two outlets. The constructed, redundant inlet (Figure 4-1) works in concert with the historic inlet (Figure 4-2) to ensure the adequate delivery of sufficient flow volumes throughout the side channel network. Downstream, streamflow is split and routed down one of two pathways: 1) down the historic channel to its outlet (Figure 4-3), or 2) down the constructed extension to SC1 to its outlet (Figure 4-4). Management of the flow split for proper flow routing is a focal point of ongoing monitoring. Racking of woody debris and evolution of the split under high flows will be closely observed.

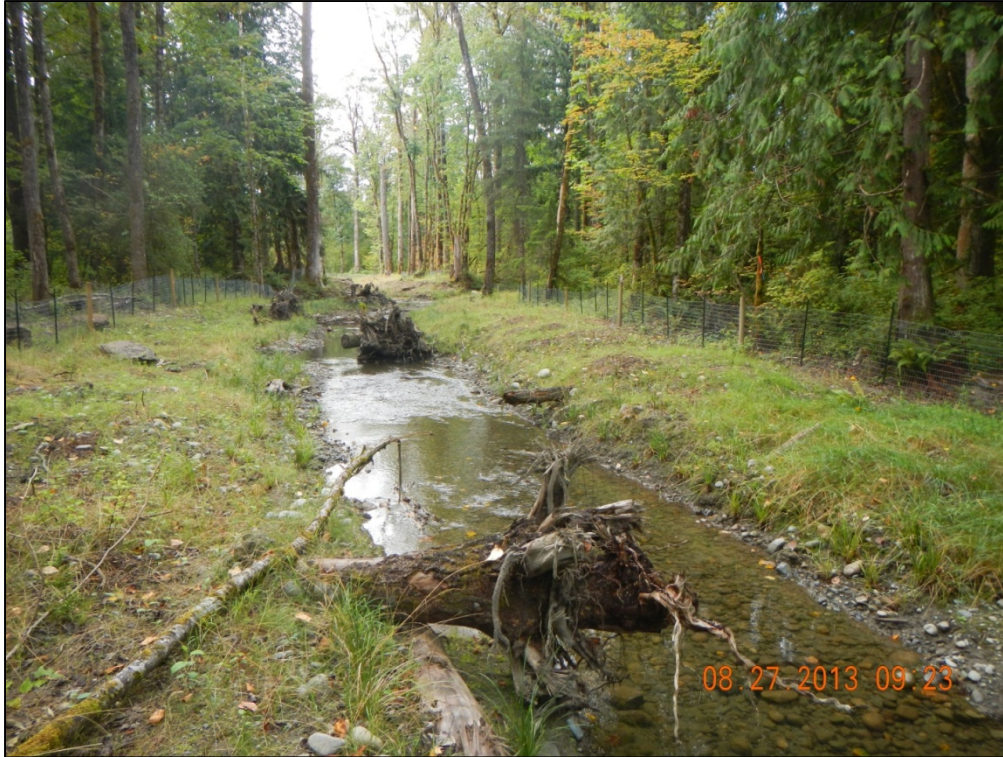
Figure 4-4. Extension to SC1, looking downstream from near new pedestrian bridge within Osprey Park, mainstem discharge of 400 cfs.

Similarly, channel width in the created extension to SC1 ranged between 4.3 and 21.6 feet with a mean measured width of 12.7 feet. All low flow width measurements within the historic channel were not equivalent to the toe-width, as documented in Appendix 1 and Appendix 2. Deposition has been documented in the wide portion of the extension near the wetland and Stations 9+00 to 10+00 (Figure 4-12). This area will be monitored and may be a location for the longitudinal placement of LWD to retain appropriate confinement of the channel. Maximum water depth

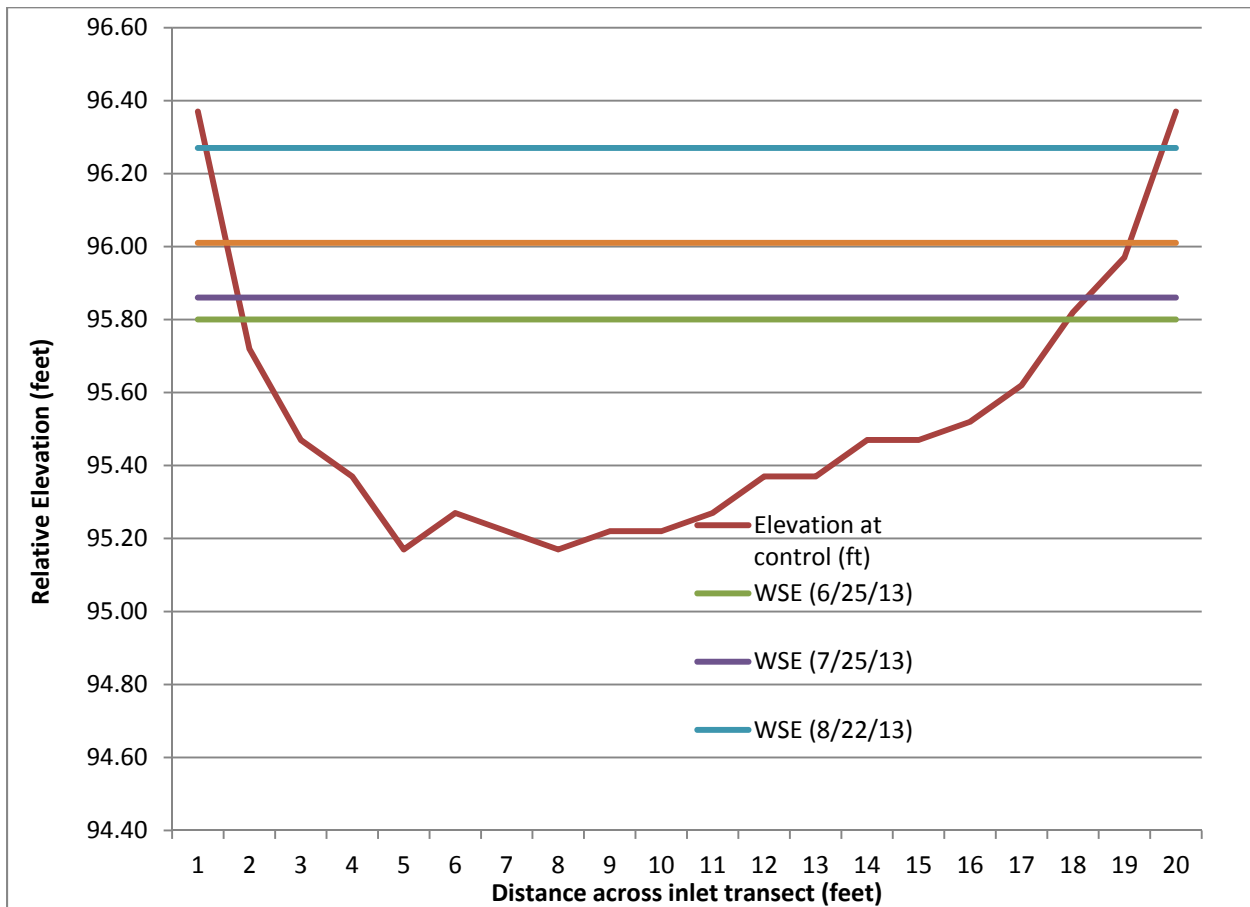
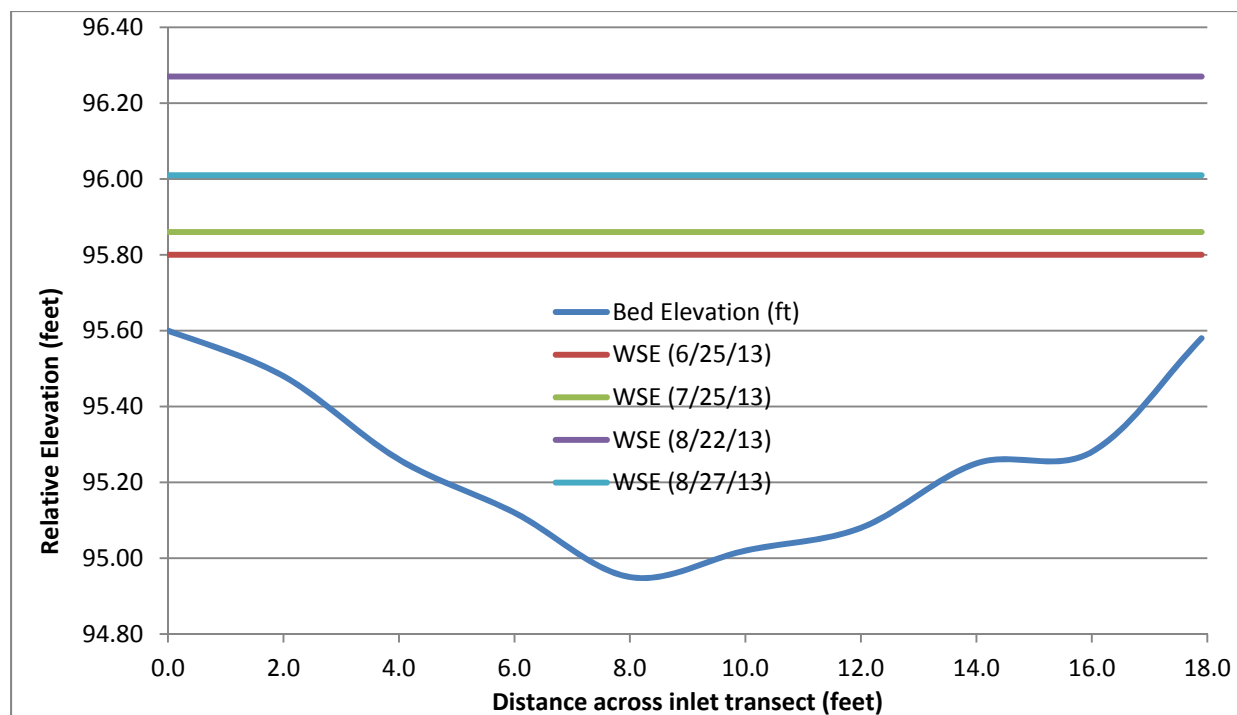
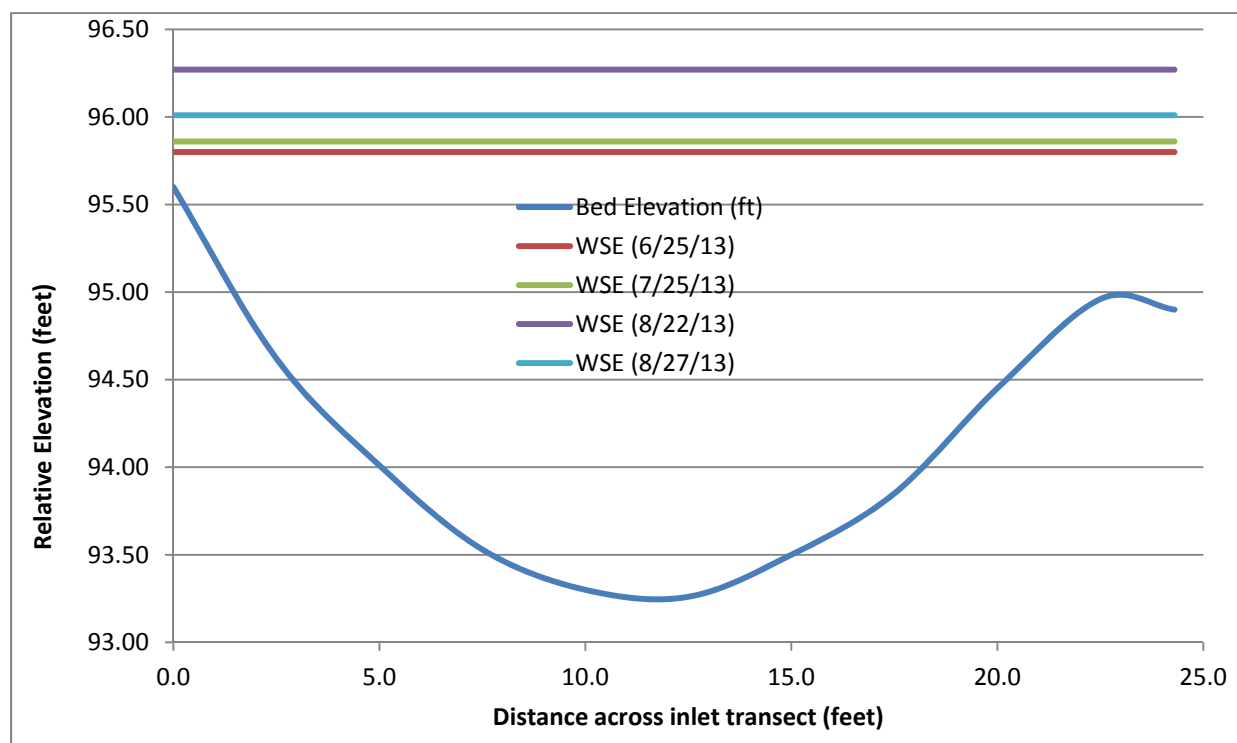
During the summer, bed elevation was surveyed at the inlet connection with the main river and at the hydraulic controls further downstream for the historic channel (Figures 4-5, 4-6, and 4-7) as well as the redundant inlet (Figure 4-8 and 4-9). Survey at the river interface was to document anticipated channel changes tied to the deformation of a small island at the head of the historic inlet (Figure 4-6 and 4-7) as well as other anticipated high flow induced changes to both the historic inlet and redundant inlet (Figure 4-9). Water surface elevation, relative to bed elevation, was also measured and recorded during each survey. Across the control for the historic inlet, water depth averaged 0.43 feet with a maximum of 0.63 feet at a mainstem discharge of 338 cfs (Table 4-2). At the control for redundant inlet, water depth averaged 0.38 feet with a maximum of 0.46 feet (Table 4-2).

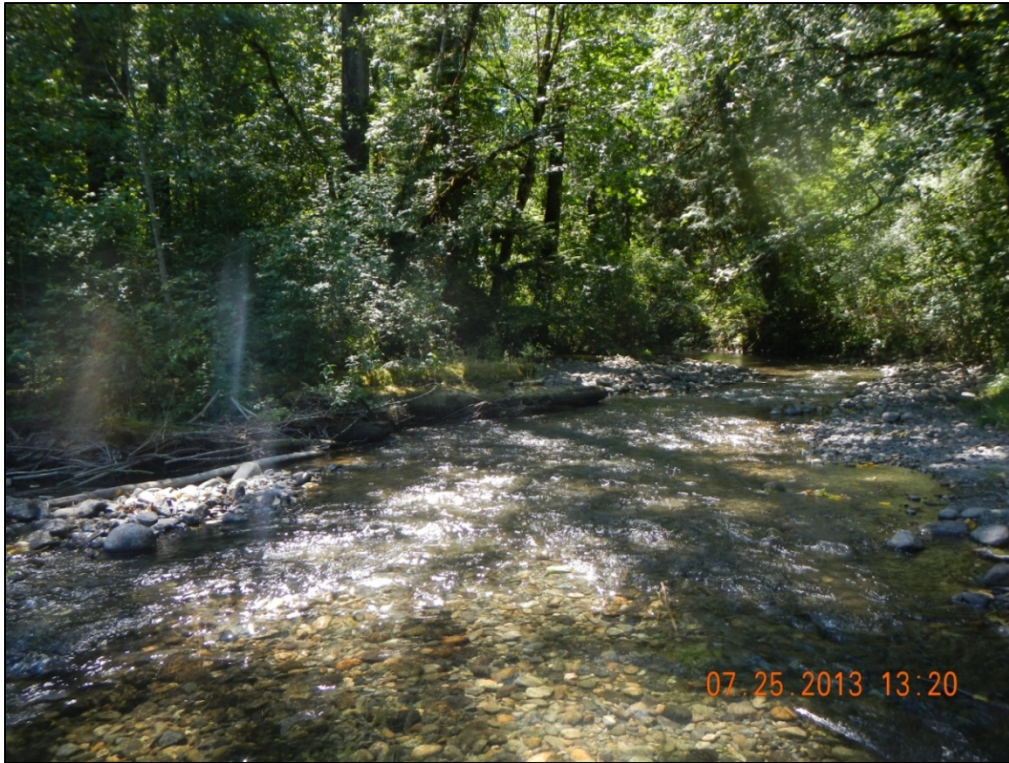
Figure 4-14. Inlet to SC 2, looking downstream from main channel, mainstem discharge of 369 cfs.

Construction within SC2 focused on enhancing functionality through improved flow connectivity at the inlet coupled with strategic placements of large woody debris downstream (Figure 4-14 and 4-15). During summer 2013, SC2 was surveyed on three occasions (Figure 4-16). During these surveys, mainstem discharge, as measured at USGS Gaging Station No. 12138160, ranged between 369 and 581 cfs (Table 4-4). Total inflow to SC1 ranged between 8.0 and 21 cfs during the surveys accounting for between 2.1 and 3.6% of the mainstem flow. Measurements of outflow were within 2% of inflow and ranged between 7.9 and 20.6 cfs (Table 4-4).

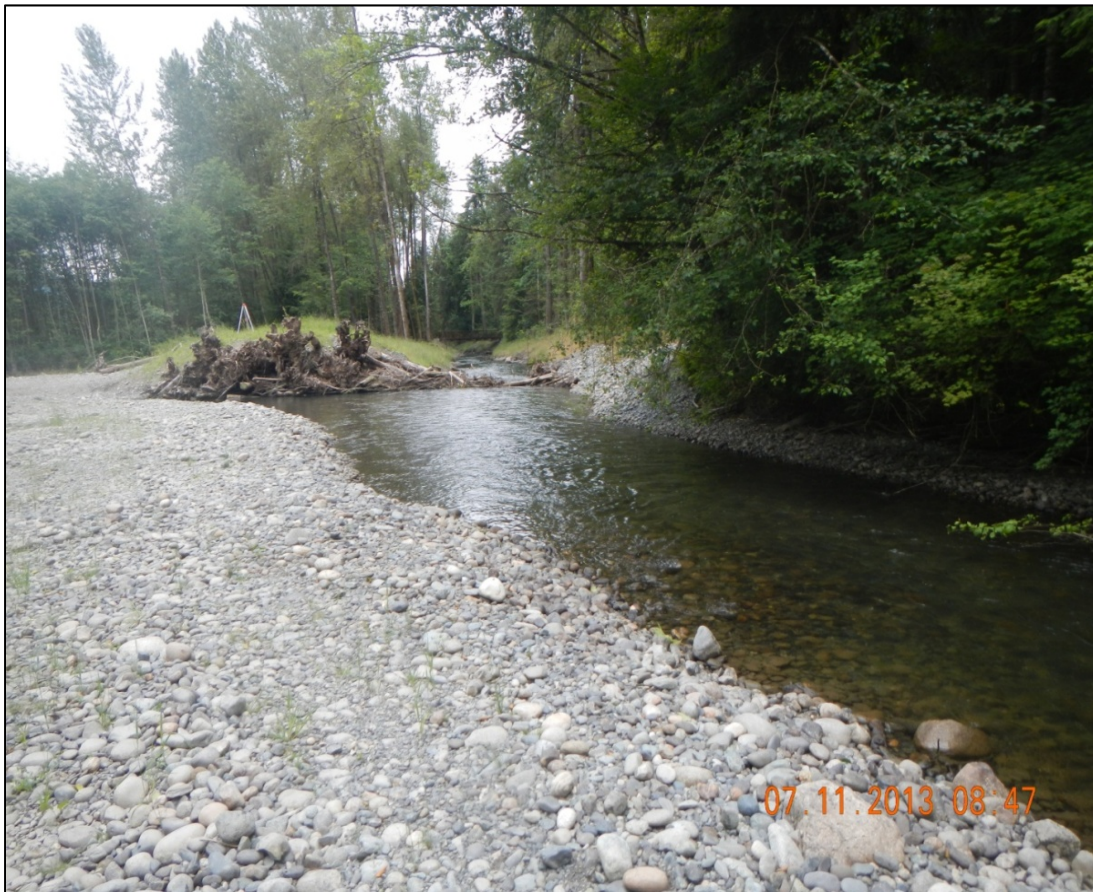
Figure 4-22. Starter channel to SC4, looking d/s to ELJ 1, mainstem Q of 357 cfs.

SC4 is unique among the Sultan River side channels in that it has one inlet and two outlets. The constructed starter channel (Figure 4-22) routes flow from the inlet to an ELJ (ELJ 1) where streamflow is split and routed down one of two pathways: 1) a primary route to the right of the ELJ and through the length of Reese Park before returning to the main channel (Figure 4-23, 4-24), and 2) a secondary route to the left of the ELJ down a short channel that immediately returns to the river (Figure 4-25).
