Henry M. Jackson Hydroelectric Project (FERC No. 2157)

Relicensing Study Plan No. 24

Feasibility of Marsh Creek Slide Modification to Improve Fish Passage

March 2009

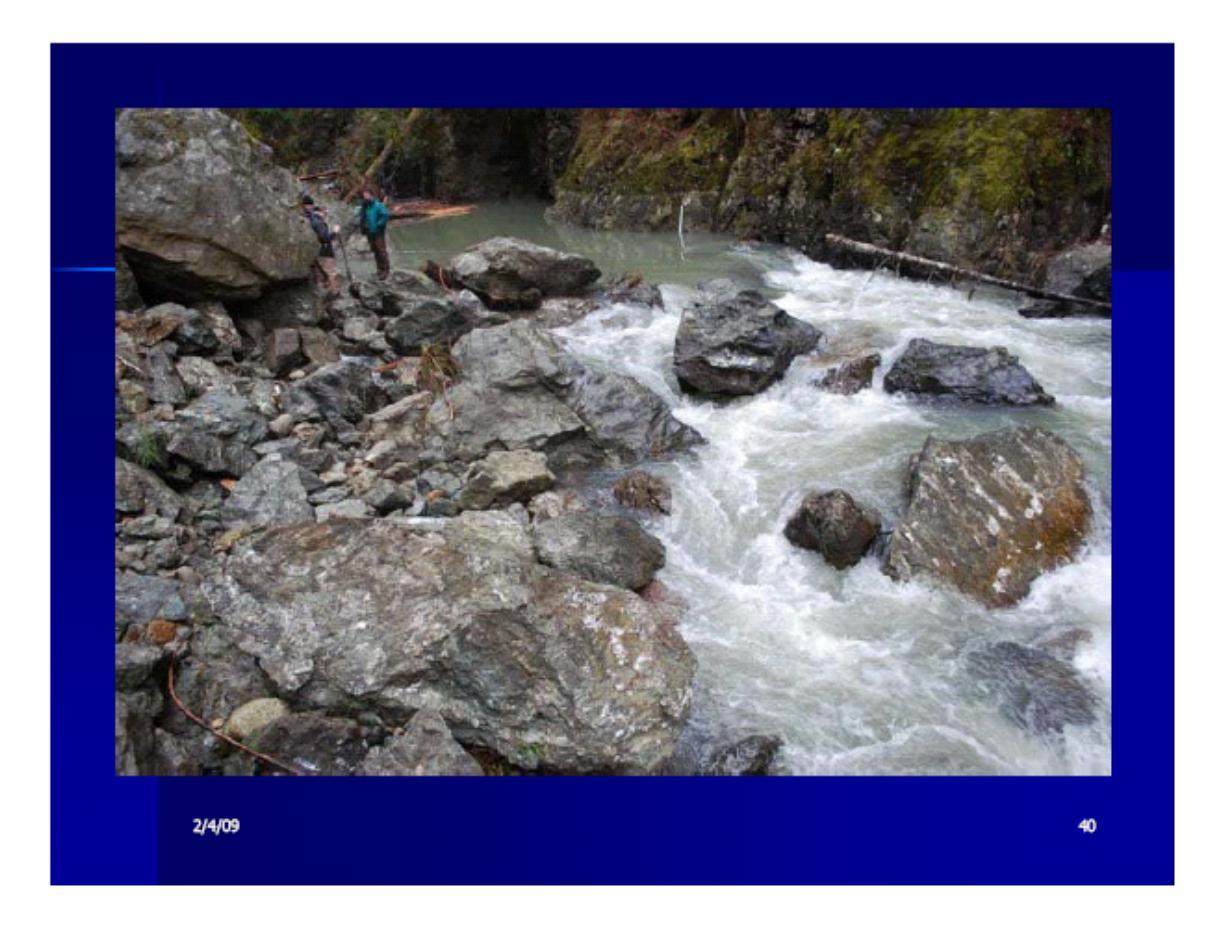
Figure 4. Alternative view of Right bank of slide area. Rock #12 on right of picture?

These are a couple of variations on an option that both Keith Binkley and myself mentioned at the last meeting (2.12). The basic premise is to reduce the amount of flow moving down the left side of the channel (looking downstream) by creating or enlarging some gaps between the rocks on the right bank of the channel. This would not only reduce turbulence and velocity in the main channel thalweg that is currently restricting fish passage but also open up the potential for passage along the right bank near the toe of the slide area. The intent is to redirect flow from the pool tailout area around rock #17 downstream and routing it back into the main channel below rock # 4. The arrows show some of the flow routing options that might be available.
