## 2005 ANNUAL PROGRESS REPORT

## WILDLIFE HABITAT MANAGEMENT PROGRAM

## HENRY M. JACKSON HYDROELECTRIC PROJECT

## FEDERAL ENERGY REGULATORY COMMISSION Project Number 2157 - License Article 53

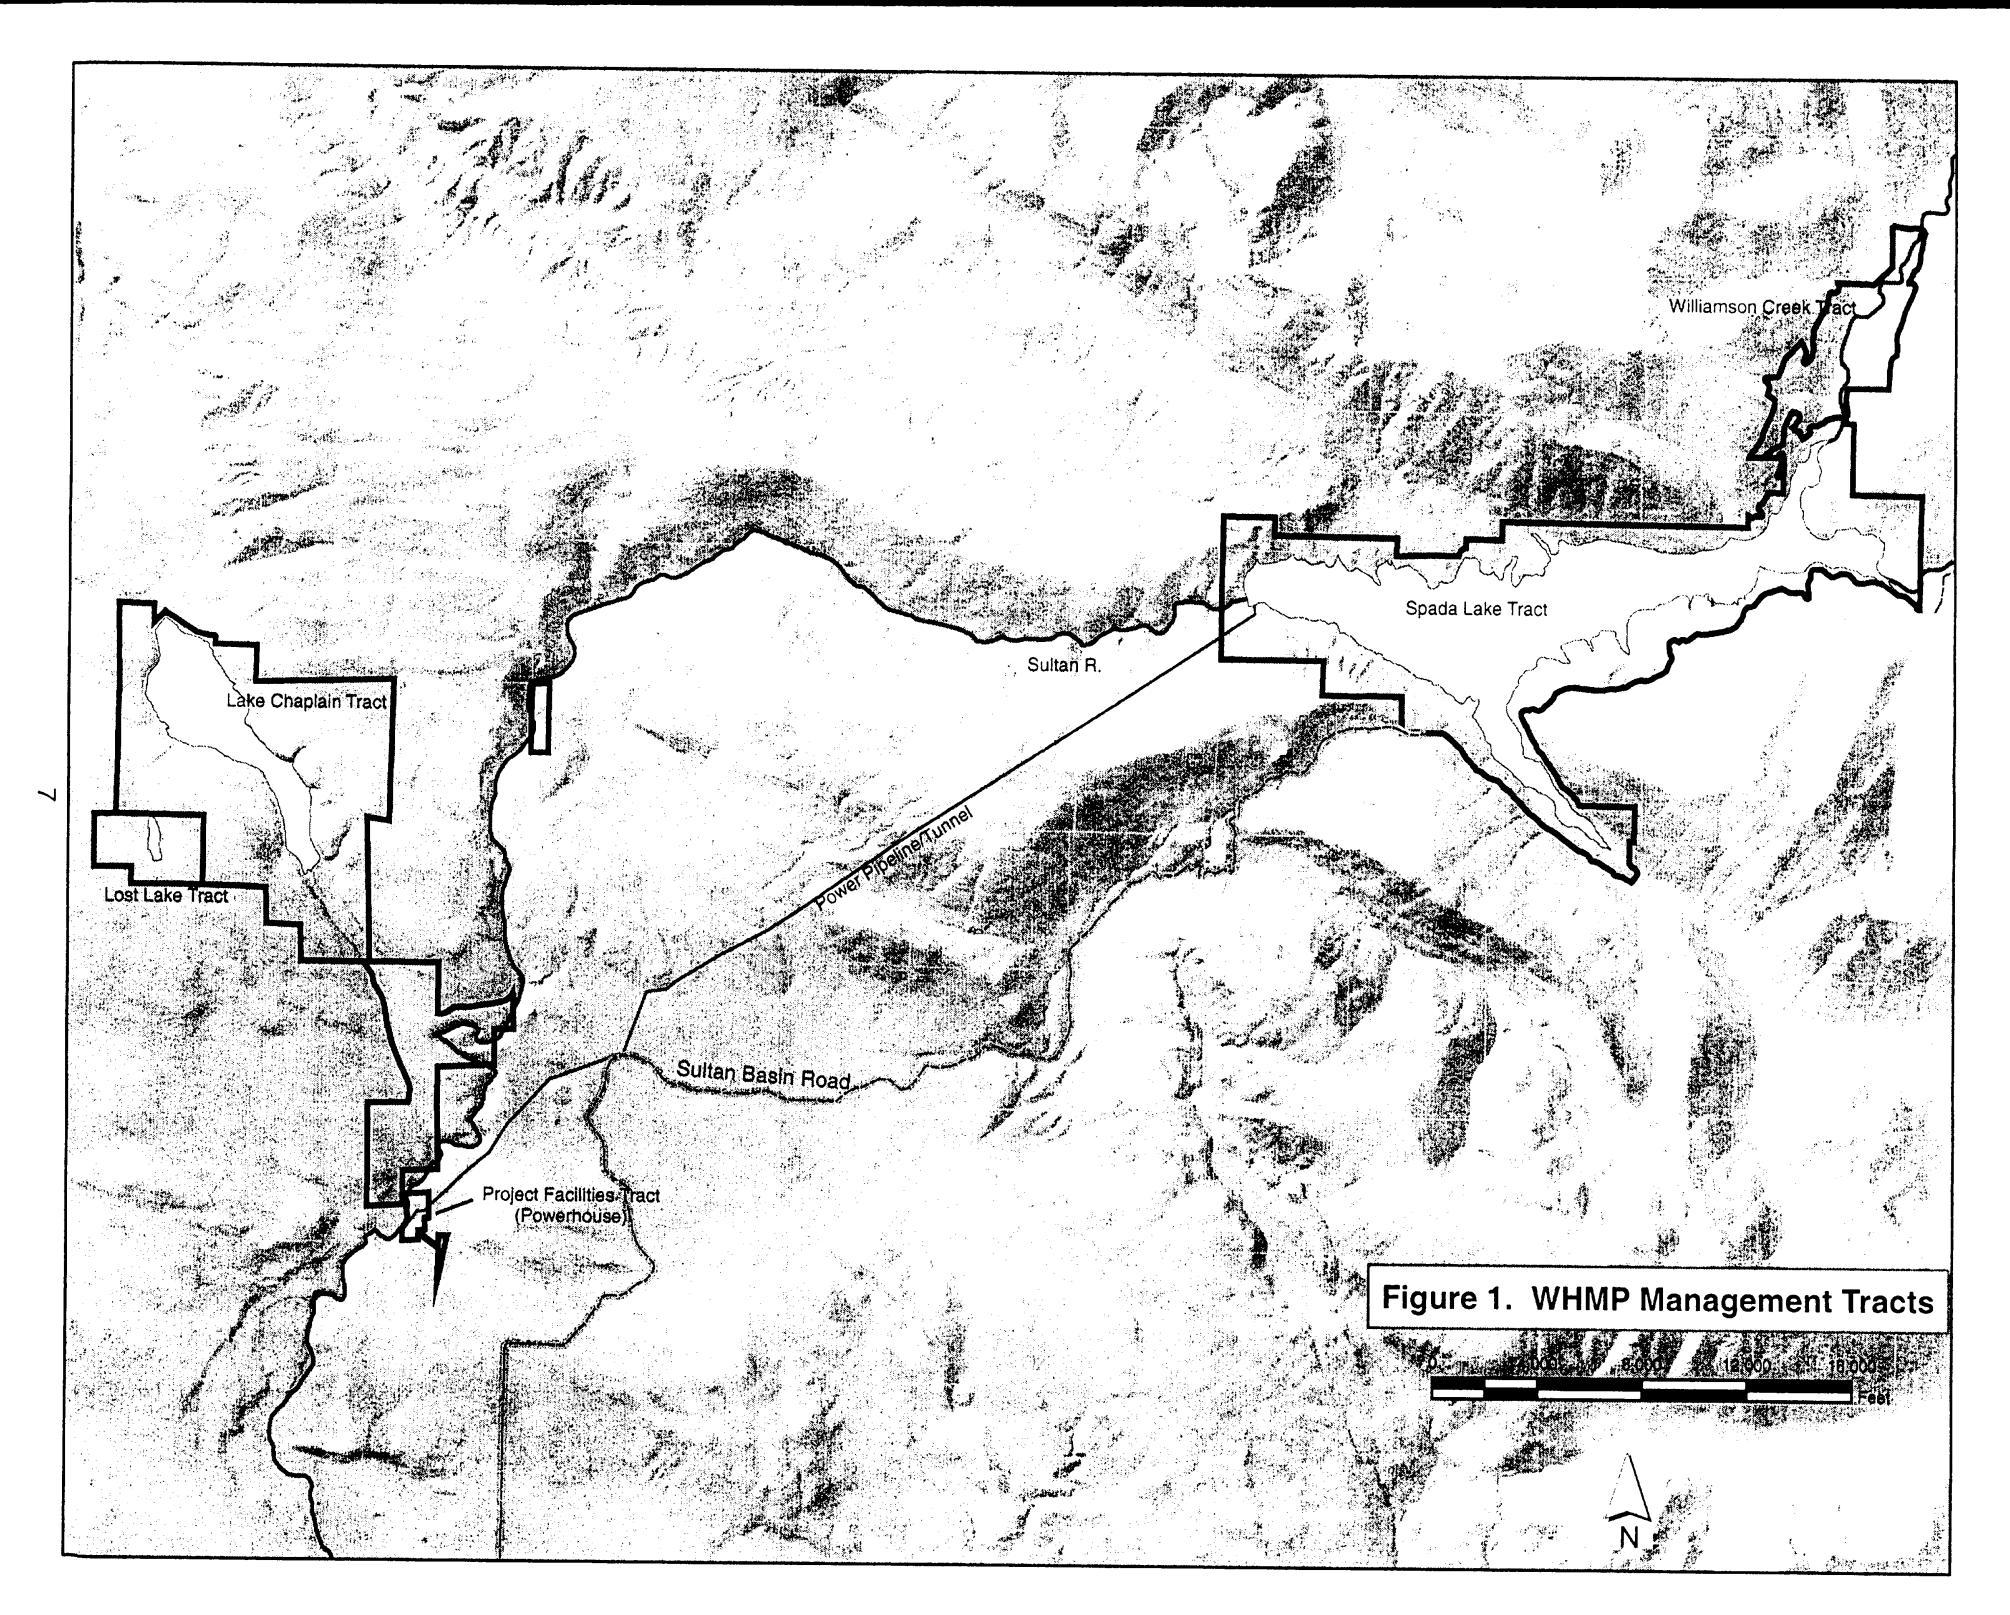
The 2005 Annual Progress Report on the Wildlife Habitat Management Plan (WHMP) for the Henry M. Jackson Hydroelectric Project was prepared by Public Utility District No. 1 of Snohomish County (District) and the City of Everett (City), who are co-licensees in the Project. The WHMP project area and management tracts are shown in Figure 1.

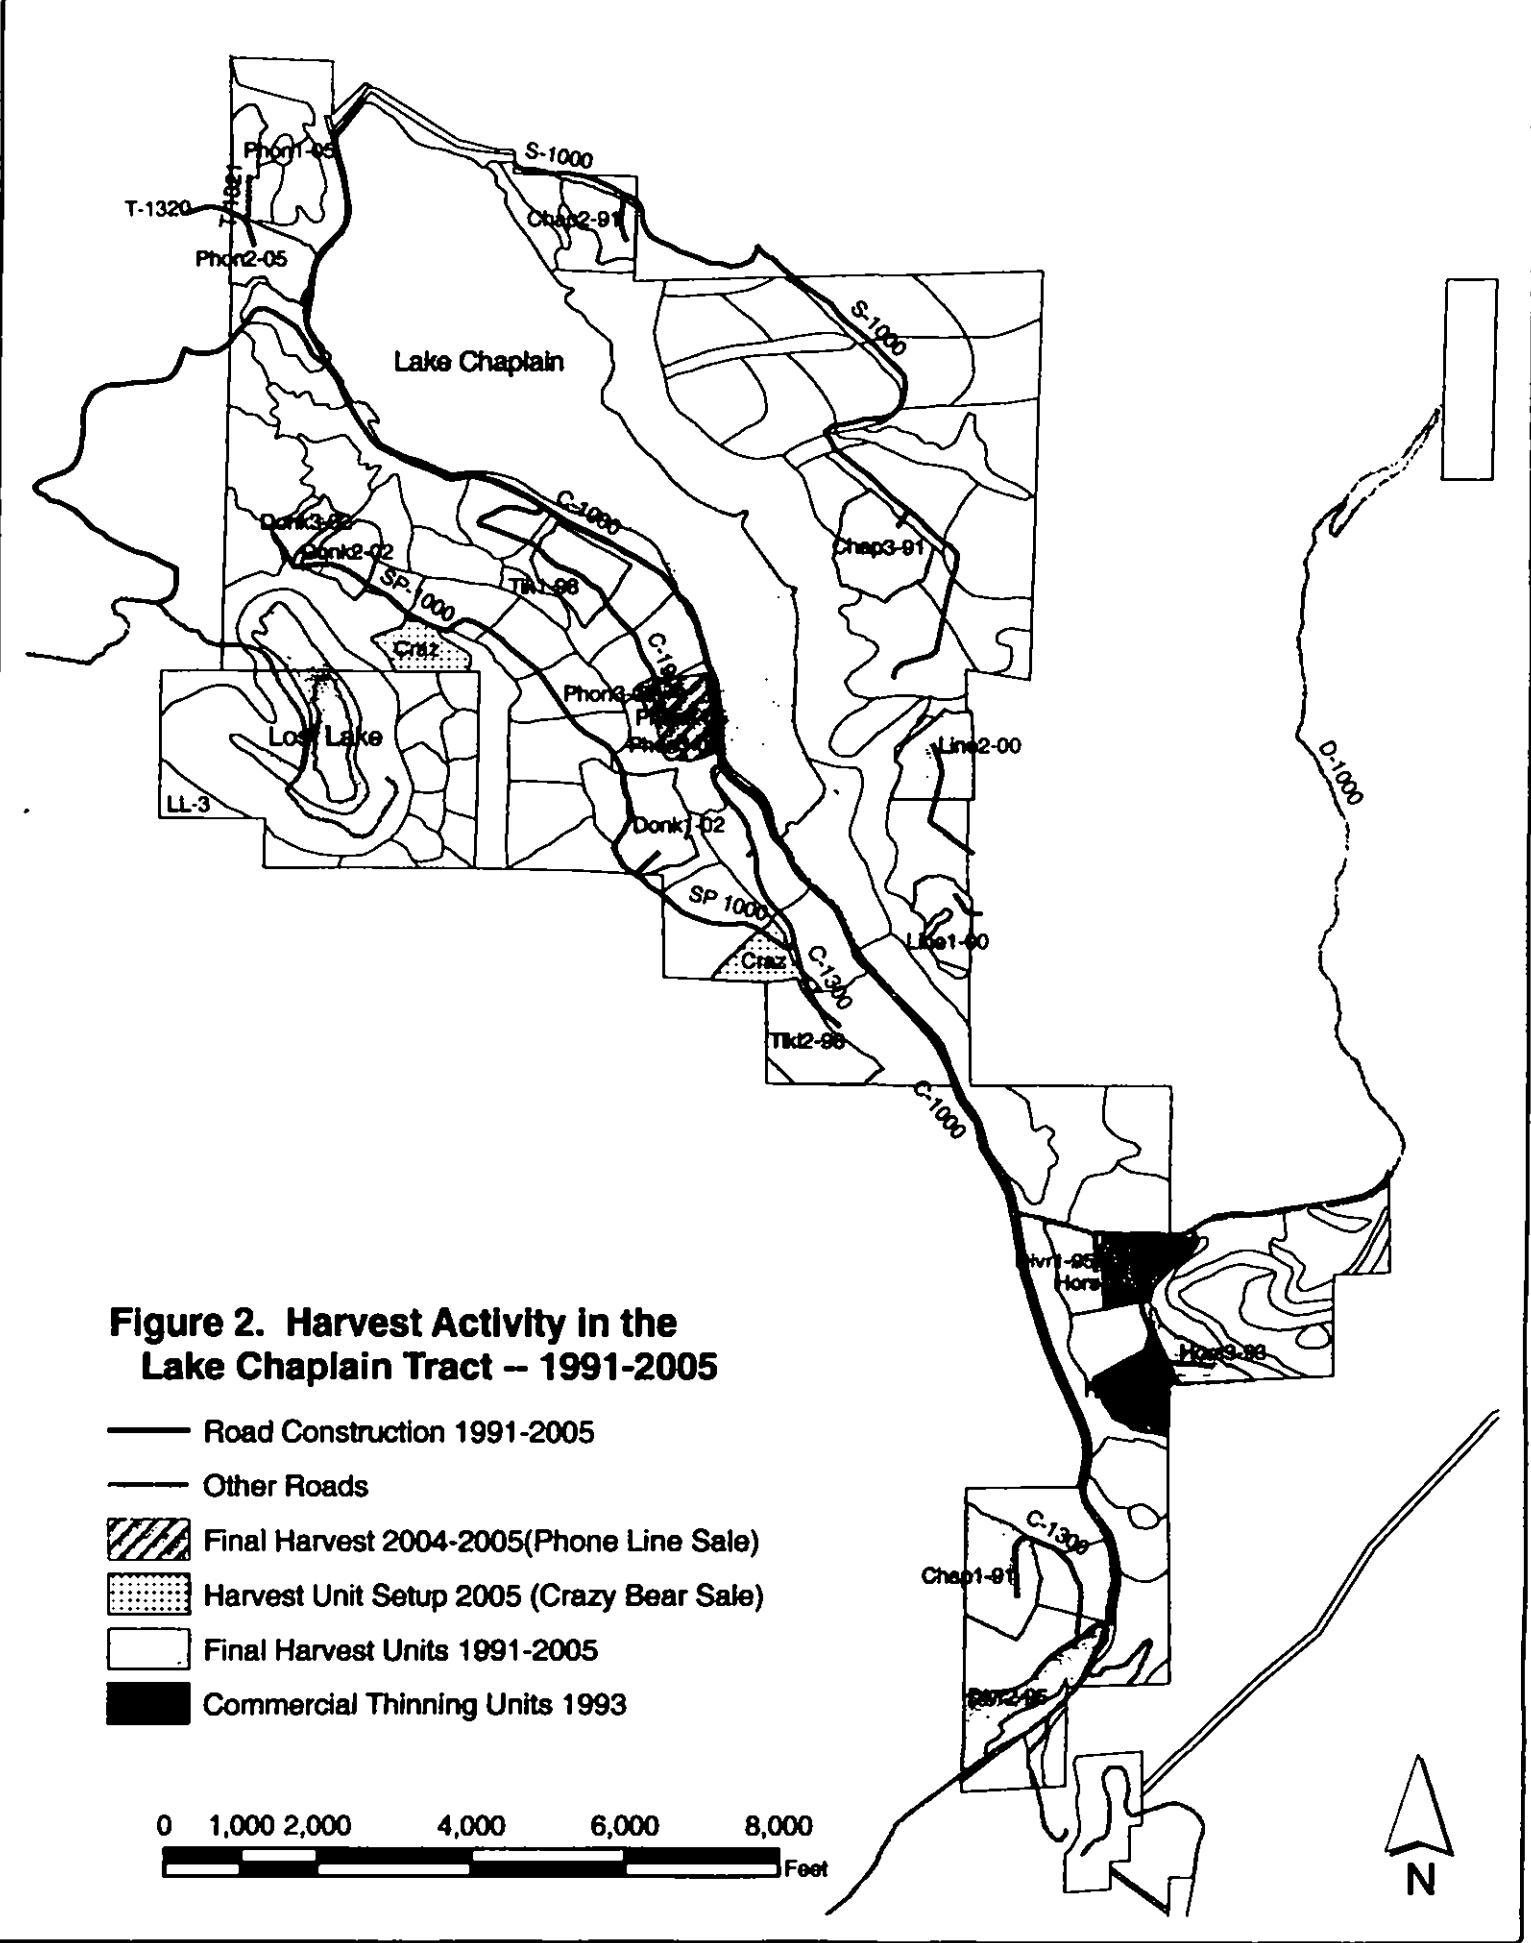
Harvest of Unit 3 of the Phone Line Sale began in 2004 and was completed in 2005, for a total of approximately 18.3 acres (Figure 2). The landing area was re-seeded following the completion of harvest and clean-up in 2005. The access road right-of-way was seeded in 2004. Most of the yarding was completed on this unit with sufficient lift to avoid much disturbance to the ground, therefore minimal re-seeding on the unit was required.

Units 1 and 2 of the Phone Line Sale were completely harvested in 2004, and were planted in 2005 with a mixture of 300 Douglas fir and 50 western red cedar seedlings per acre (Figure 2).

Layout of two units of the Crazy Bear Sale was completed in 2005 (Figure 2). This sale will consist of only these two units. Layout work for Unit 1 consisted of selecting snag and coarse woody debris trees (CWD), and marking selected hardwoods for retention; (other layout activities were completed in 2004). Unit 2 required marking of the sale boundary, a buffer zone boundary, GTA location, and selection of snags, CWD and hardwoods.

Deer forage availability was sampled in late June-early July on Chap1-91 and Line1-00 on the Lake Chaplain Tract (Figure 2). Fifteen years after harvest, Chap1-91 was dominated by Douglas fir >6ft, although various *Rubus* species, huckleberry, bracken fern and sword fern are present in the understory on most transects (Figures 11 and 12). Bear damage and mountain beaver burrows were widespread in the unit.

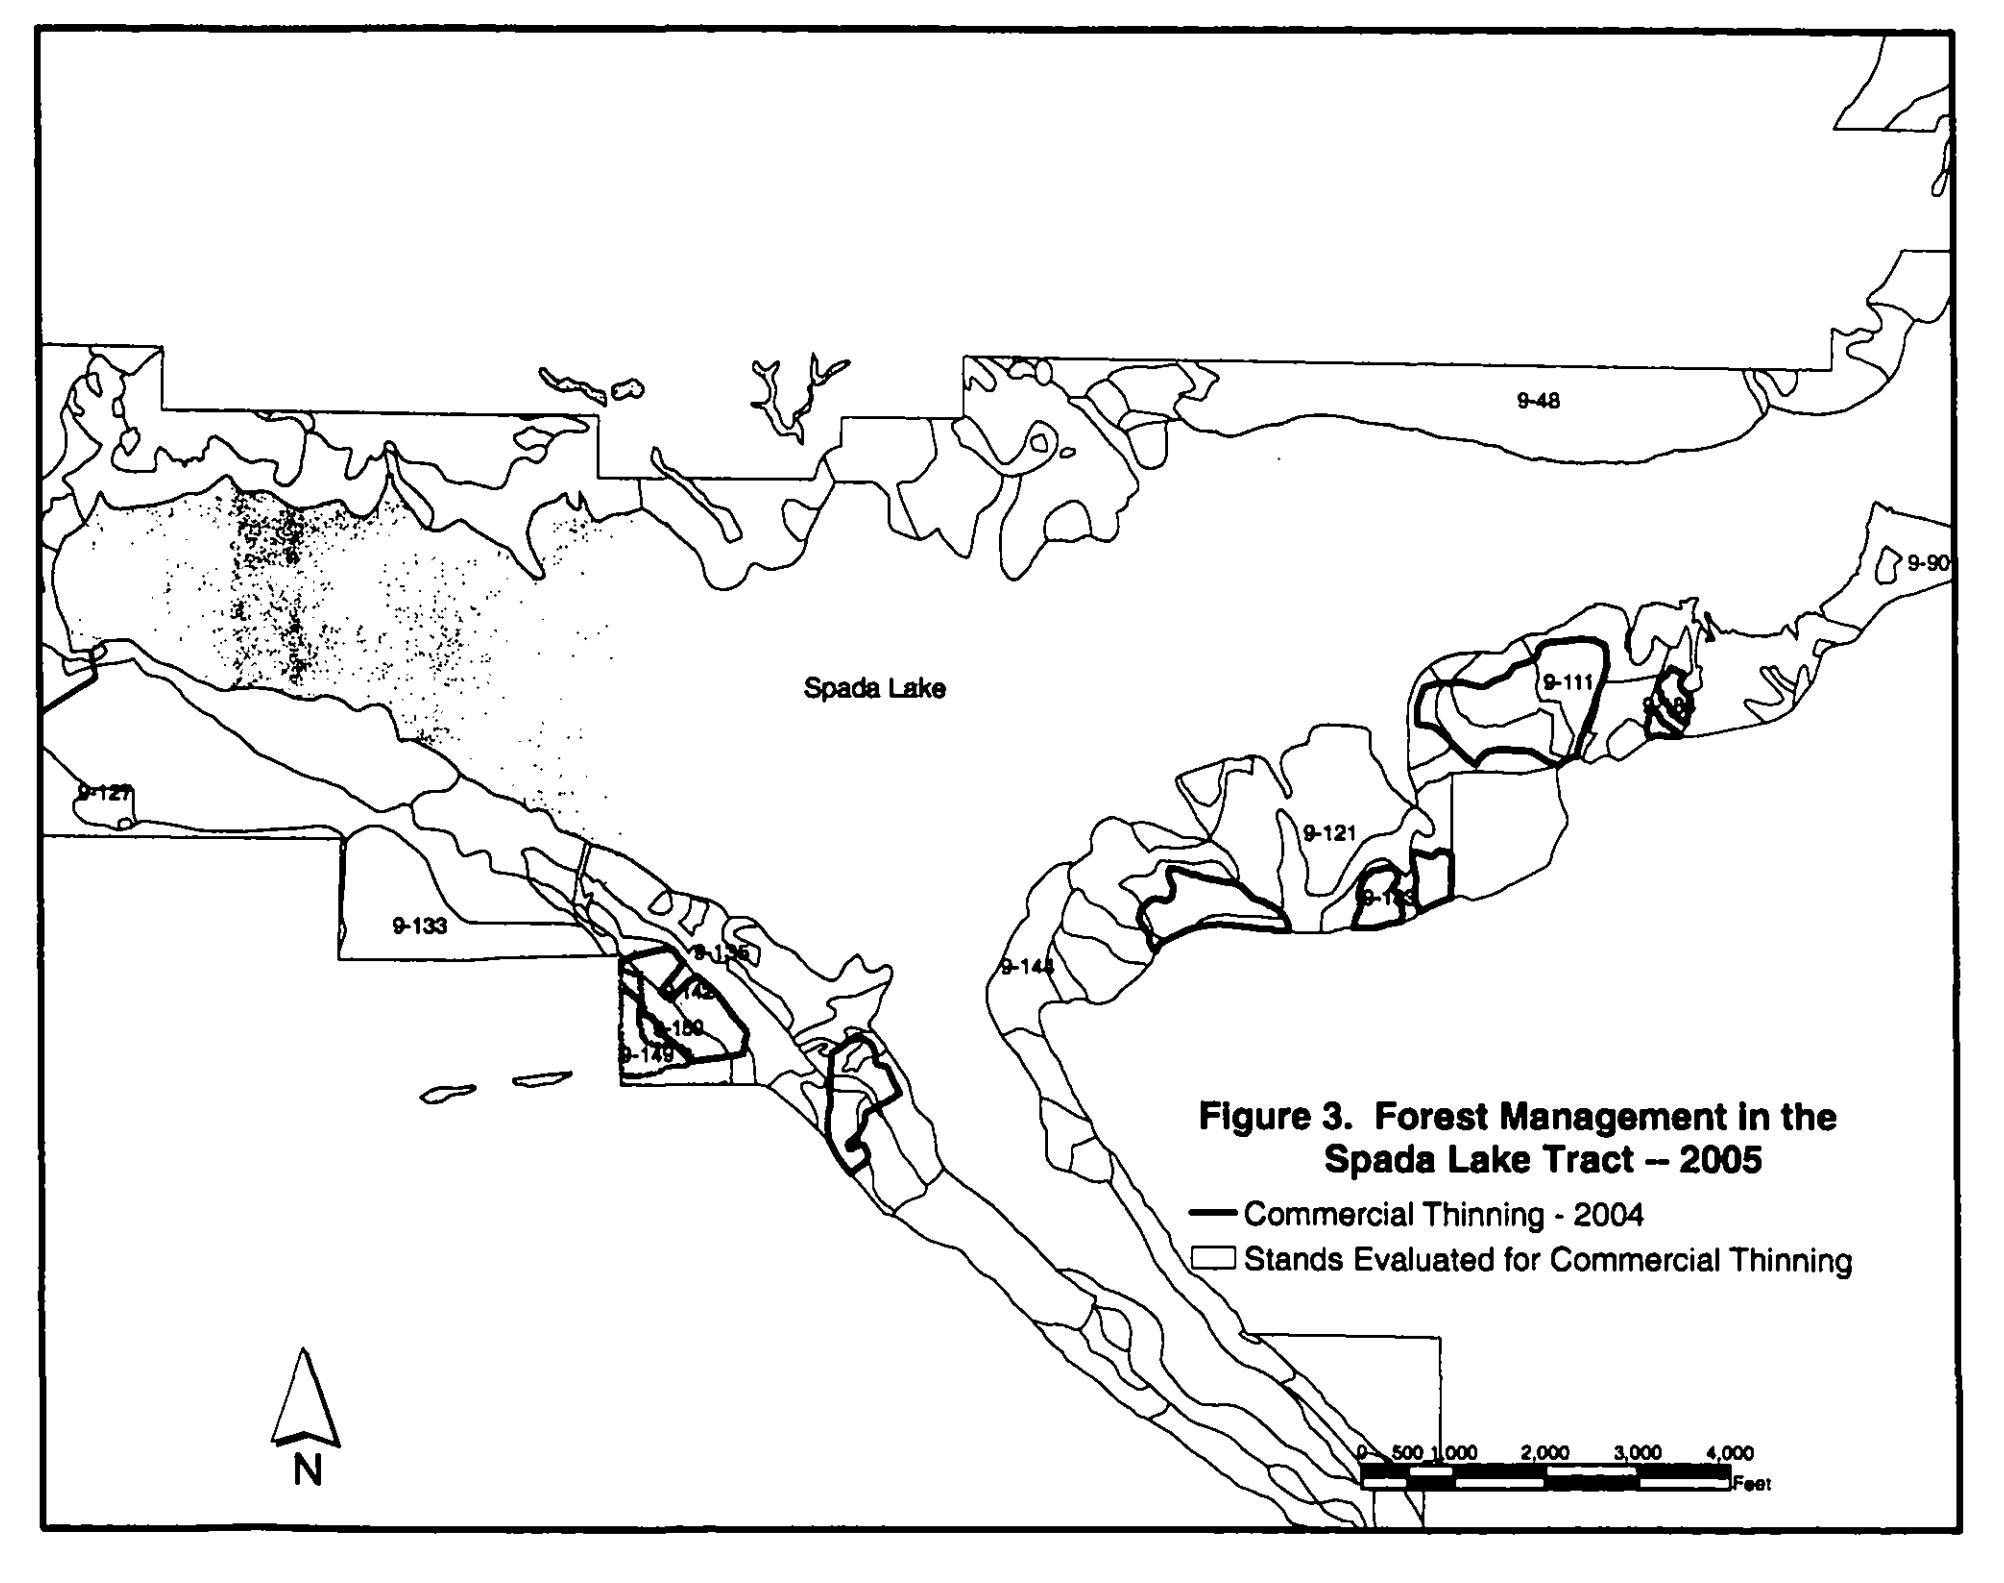
Several stands were considered for silvicultural management, including 9-90, 9-133, 9-127, 9-149 and 9-144 (Figure 3). Small portions of stands 9-90 and 9-144 were considered for commercial thinning, and may be feasible if combined with a larger unit (9-48). Other portions of 9-90 and 9-133 would be better suited for precommercial thinning, but it was decided that the stands' canopy can be more efficiently managed through snag/gap creation (see Section 3.3) because the
