Wildlife Habitat Management Plan 2004 Annual Report Jackson Hydroelectric Project – FERC #2157 License Article 53

2004 ANNUAL PROGRESS REPORT

WILDLIFE HABITAT MANAGEMENT PROGRAM

HENRY M. JACKSON HYDROELECTRIC PROJECT

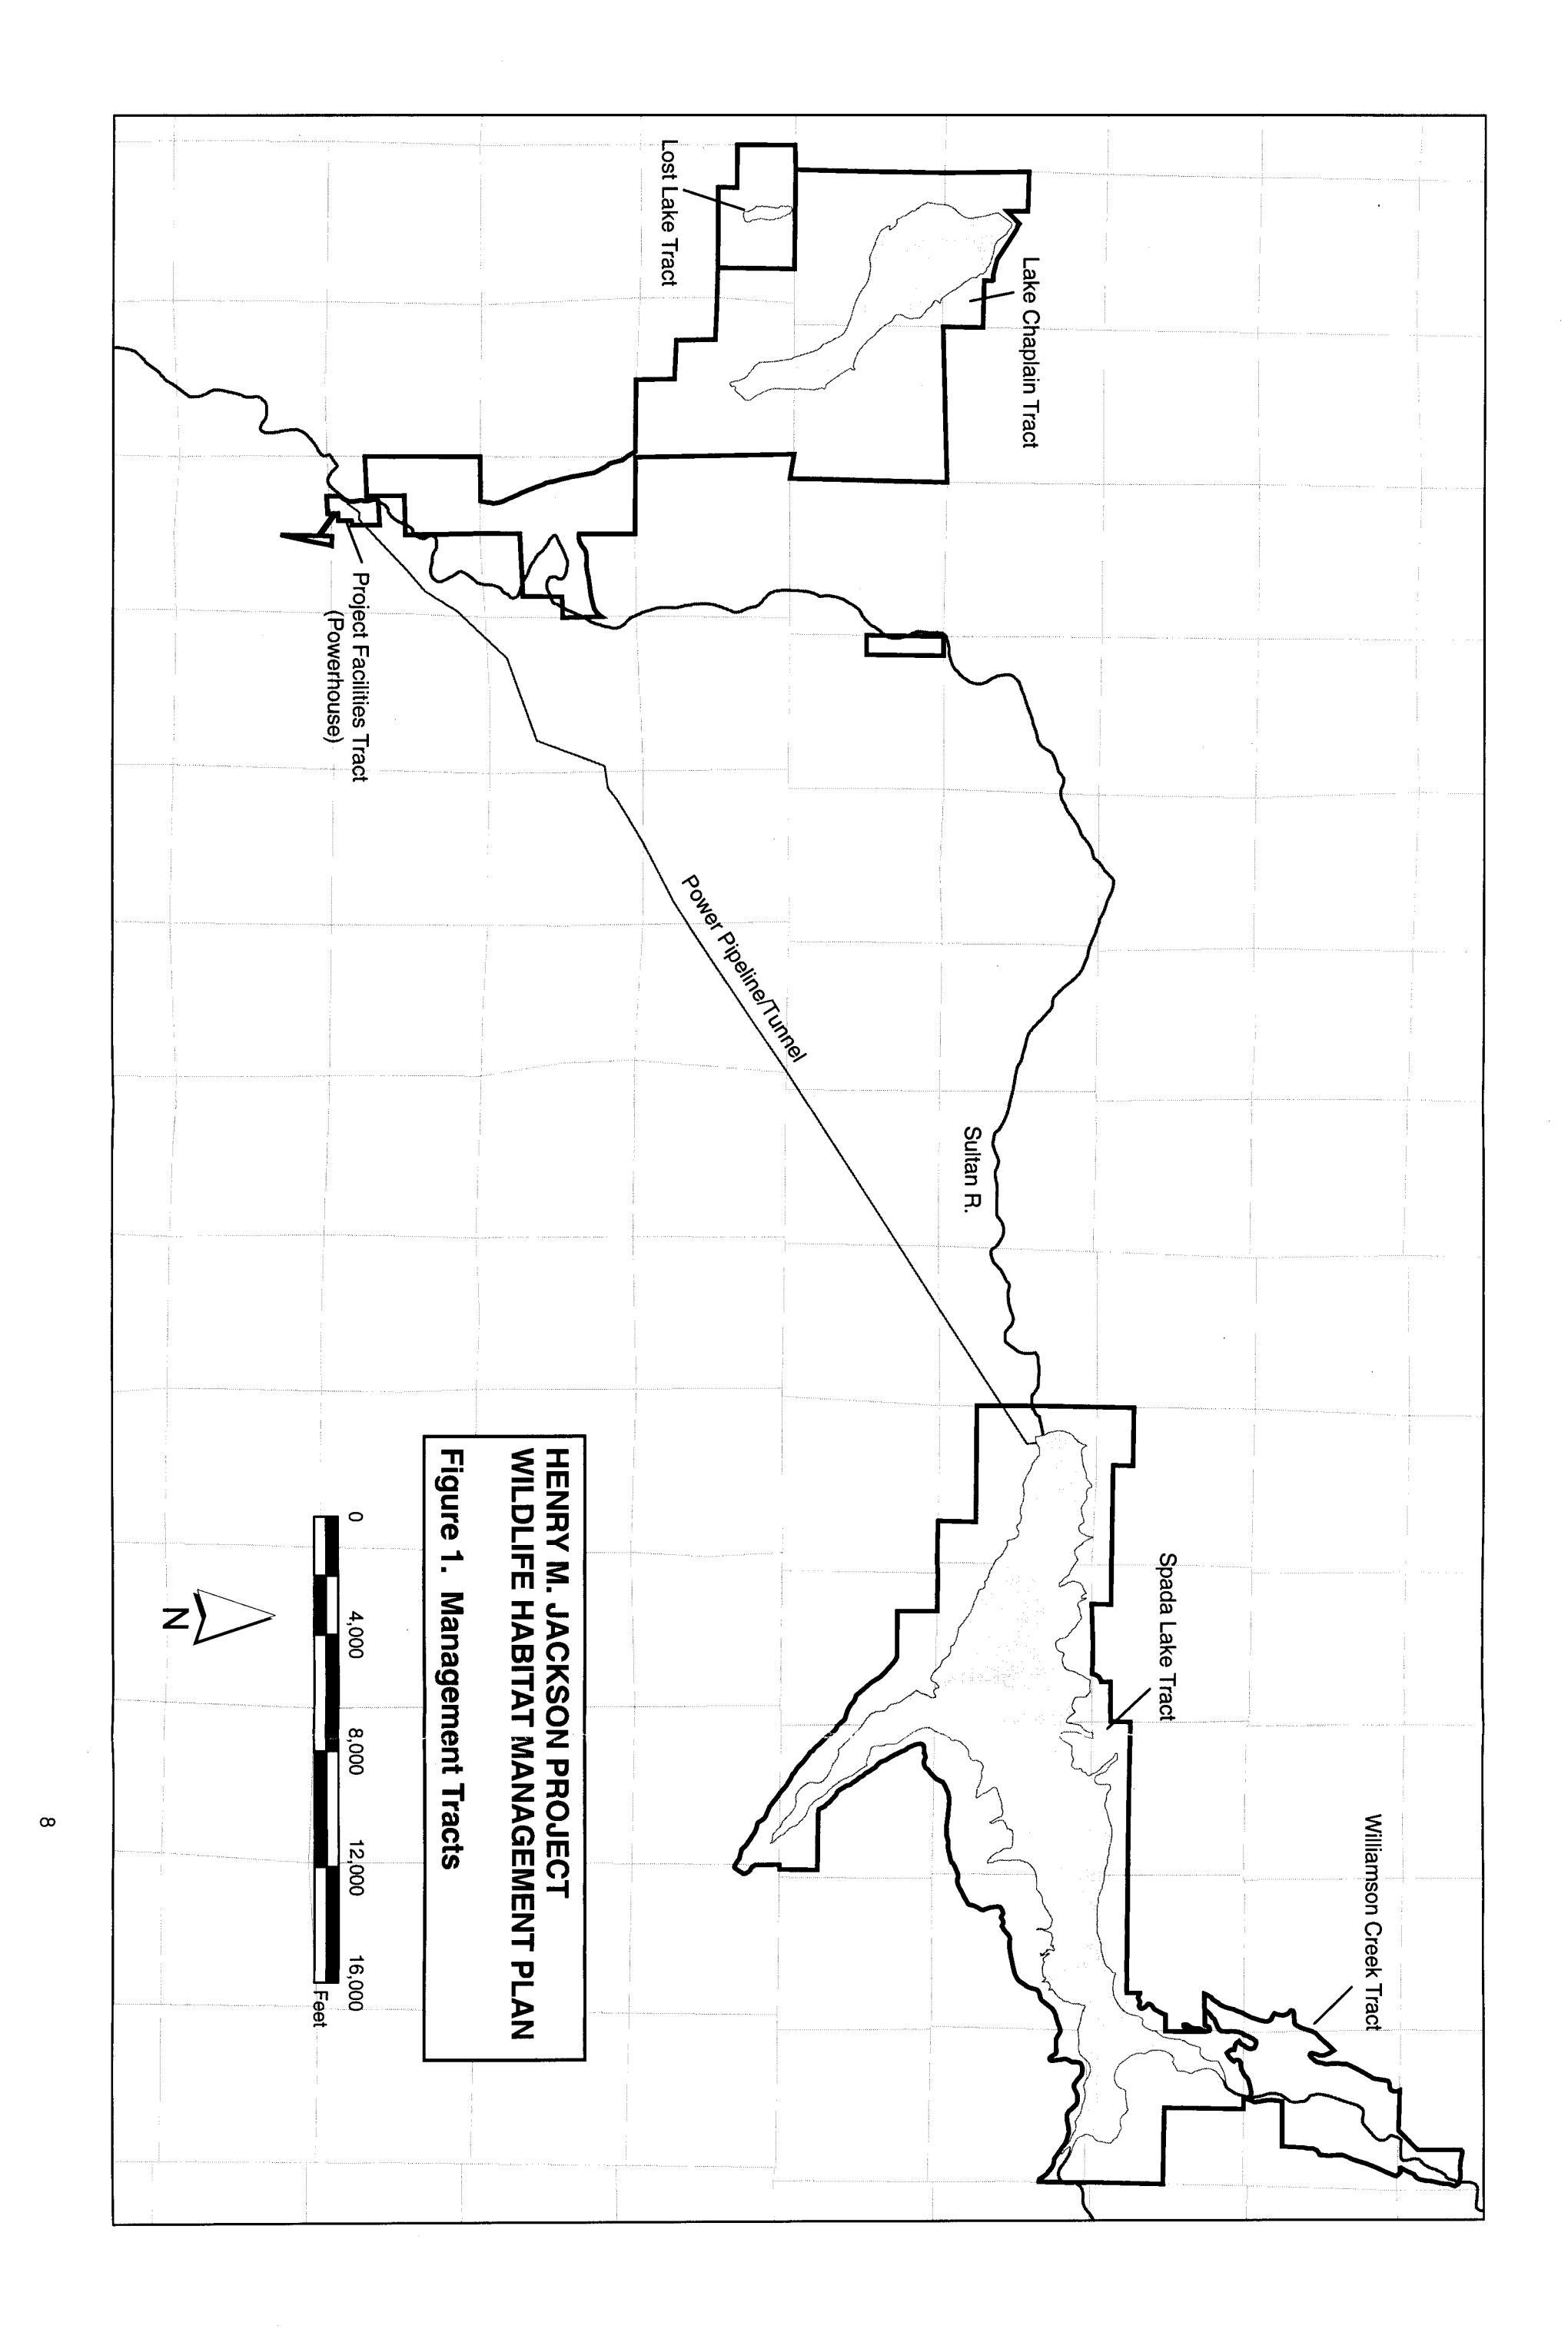
The 2004Annual Progress Report on the Wildlife Habitat Management Plan (WHMP) for the Henry M. Jackson Hydroelectric Project was prepared by Public Utility District No. 1 of Snohomish County (District) and the City of Everett (City), who are co-licensees in the Project. The WHMP project area and management tracts are shown in Figure 1.

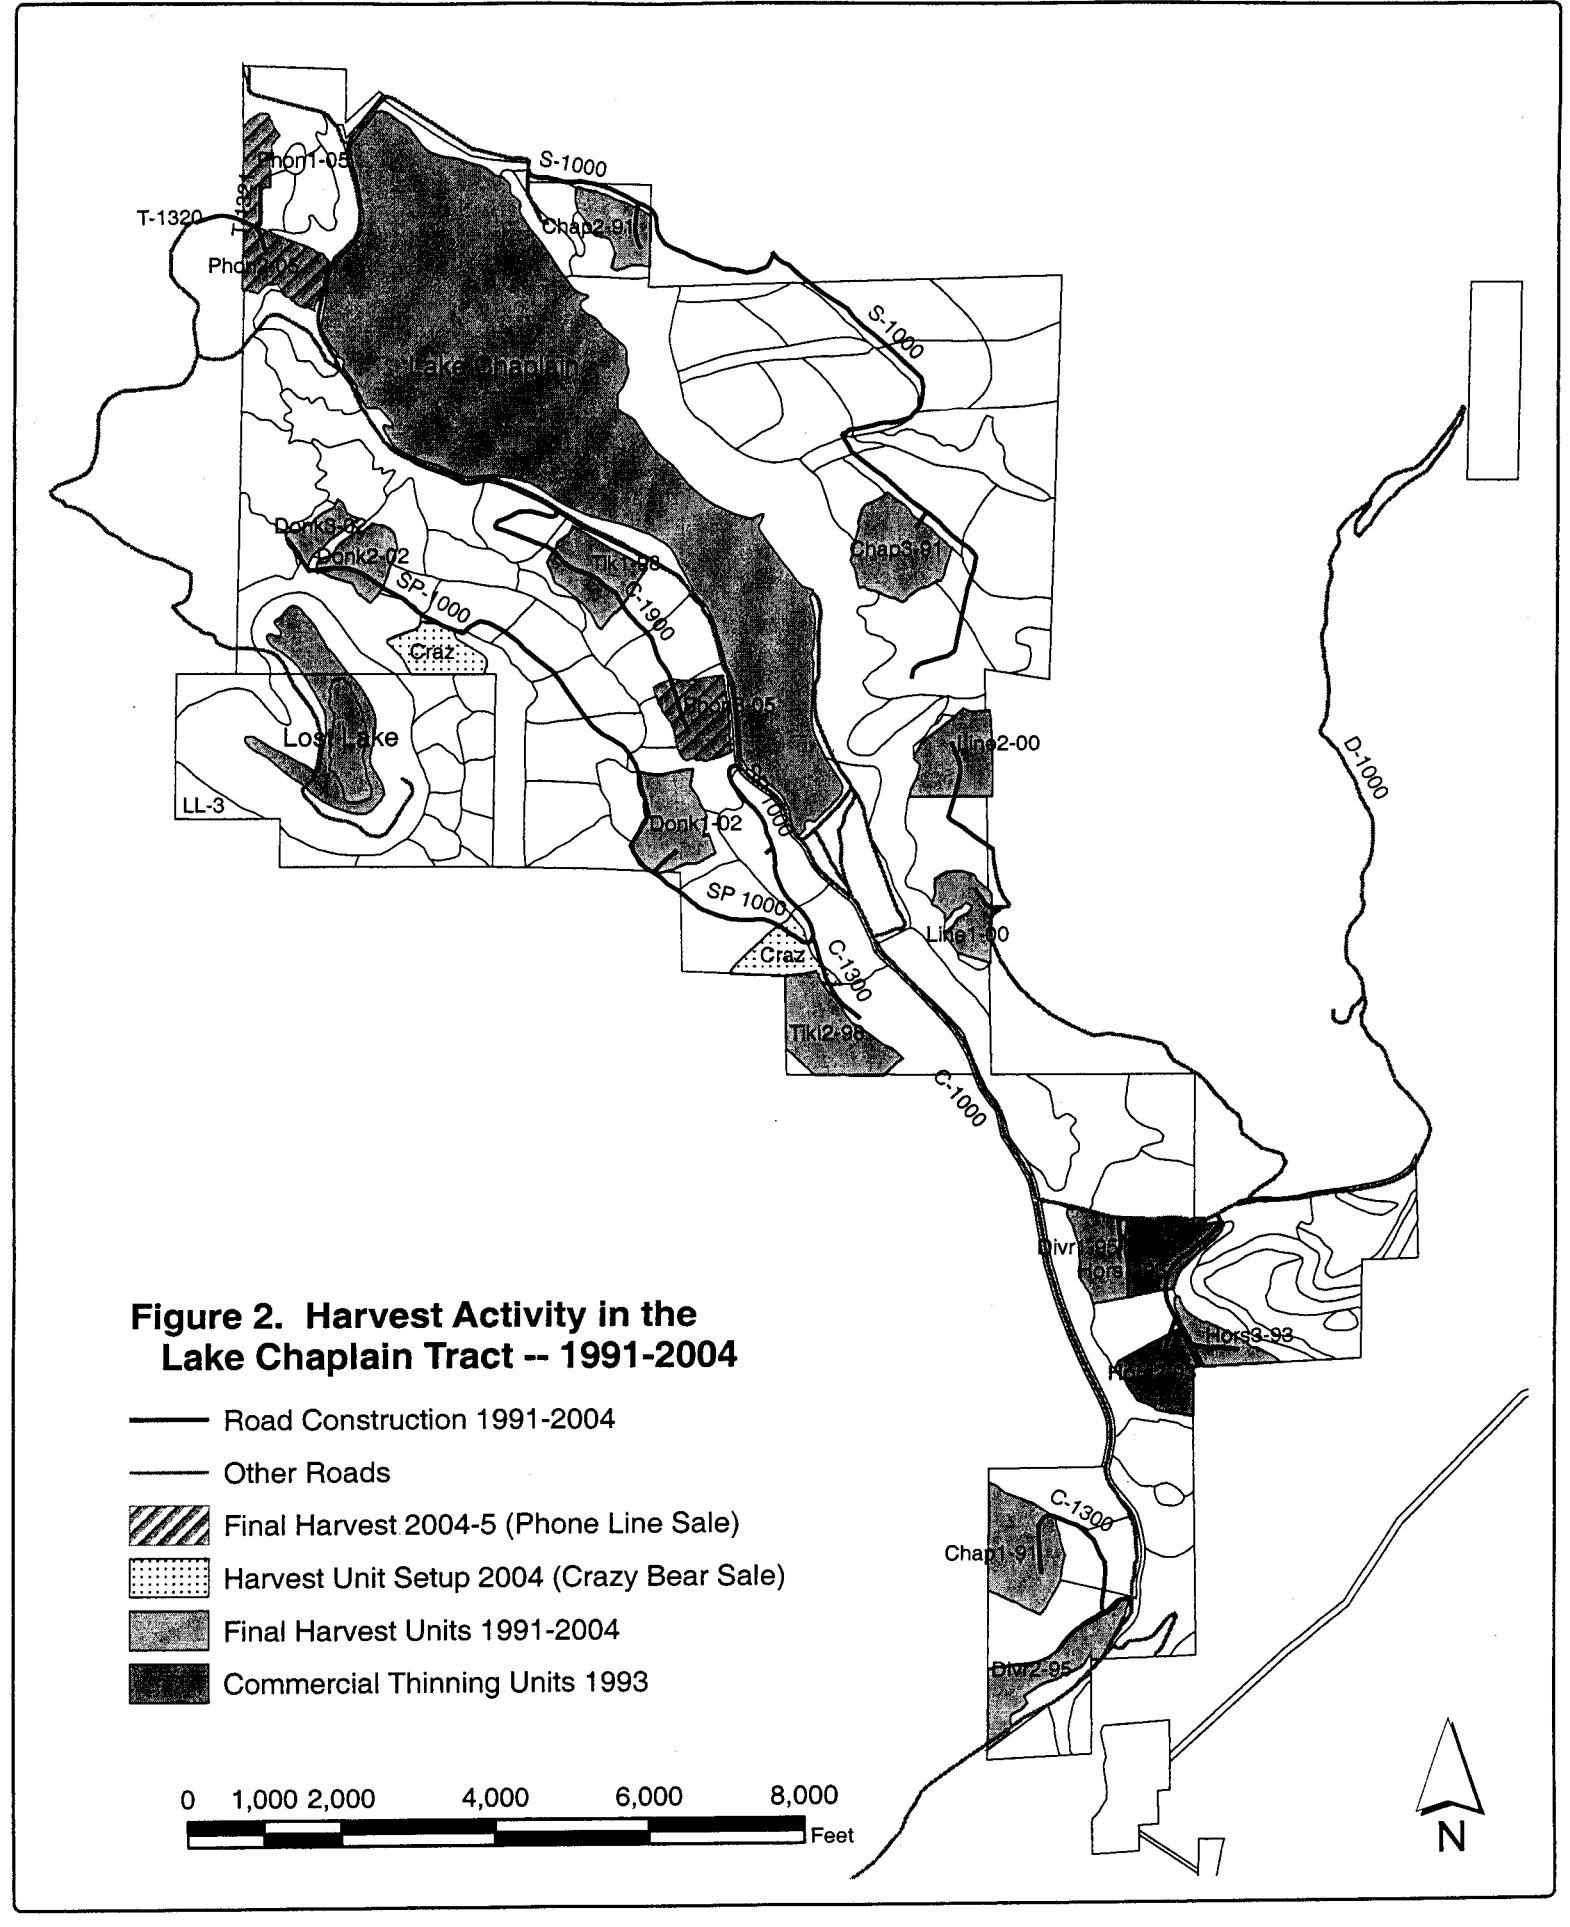
Layout work for the Phone Line Sale was completed in 2004 (Figure 2) and the three units were sold in June 2004 to Miller Shingle Co. Road construction into Units 1 and 2 started in August, and logging started in September 2004. The harvest of Units 1 (10.5 ac.) and 2 (18.1 ac.) was completed in October, and about 4 acres of Unit 3 (18.3 ac. total) were also harvested.

Blowdown along some of the forest roads and harvest units led to a salvage sale in 2004. The roads most affected by windstorms early in the year included spurs off D-1000 into the Horseshoe Sale units, spurs off C-4000 into the Line Tree Sale units, the SP-1000 road serving the Donkey Damper Sale units, and the C-1900 road into Tiki1-98 and Phon3-05 (Figure 2).

Layout work began on two units of this sale (Figure 2). There may be a third unit, depending on the volume expected from the first two units. The work completed on Unit 1 includes property line location, marking of the unit boundary, GTA location and selection of logging method (ground based for both units). Some preliminary work was started on Unit 2 of this sale.

The City of Everett monitored water quality in Chaplain Creek in relation to biosolids applications on units Hors1-93, Hors2-93 and Divr1-95 in 1996 and 2000 (Figure 2). The units and the application procedures were described in the 1996 Annual Report. Water quality data has been collected from August 1996 through December 2004. Results obtained in 2004 indicate the same patterns of seasonal variations for contaminants, all within the acceptable range, that have been found in previous years. These patterns were reported for fecal coliforms, nitrates and ammonia in the 2002 Annual Report, Section 3.10, Figure 12-14).

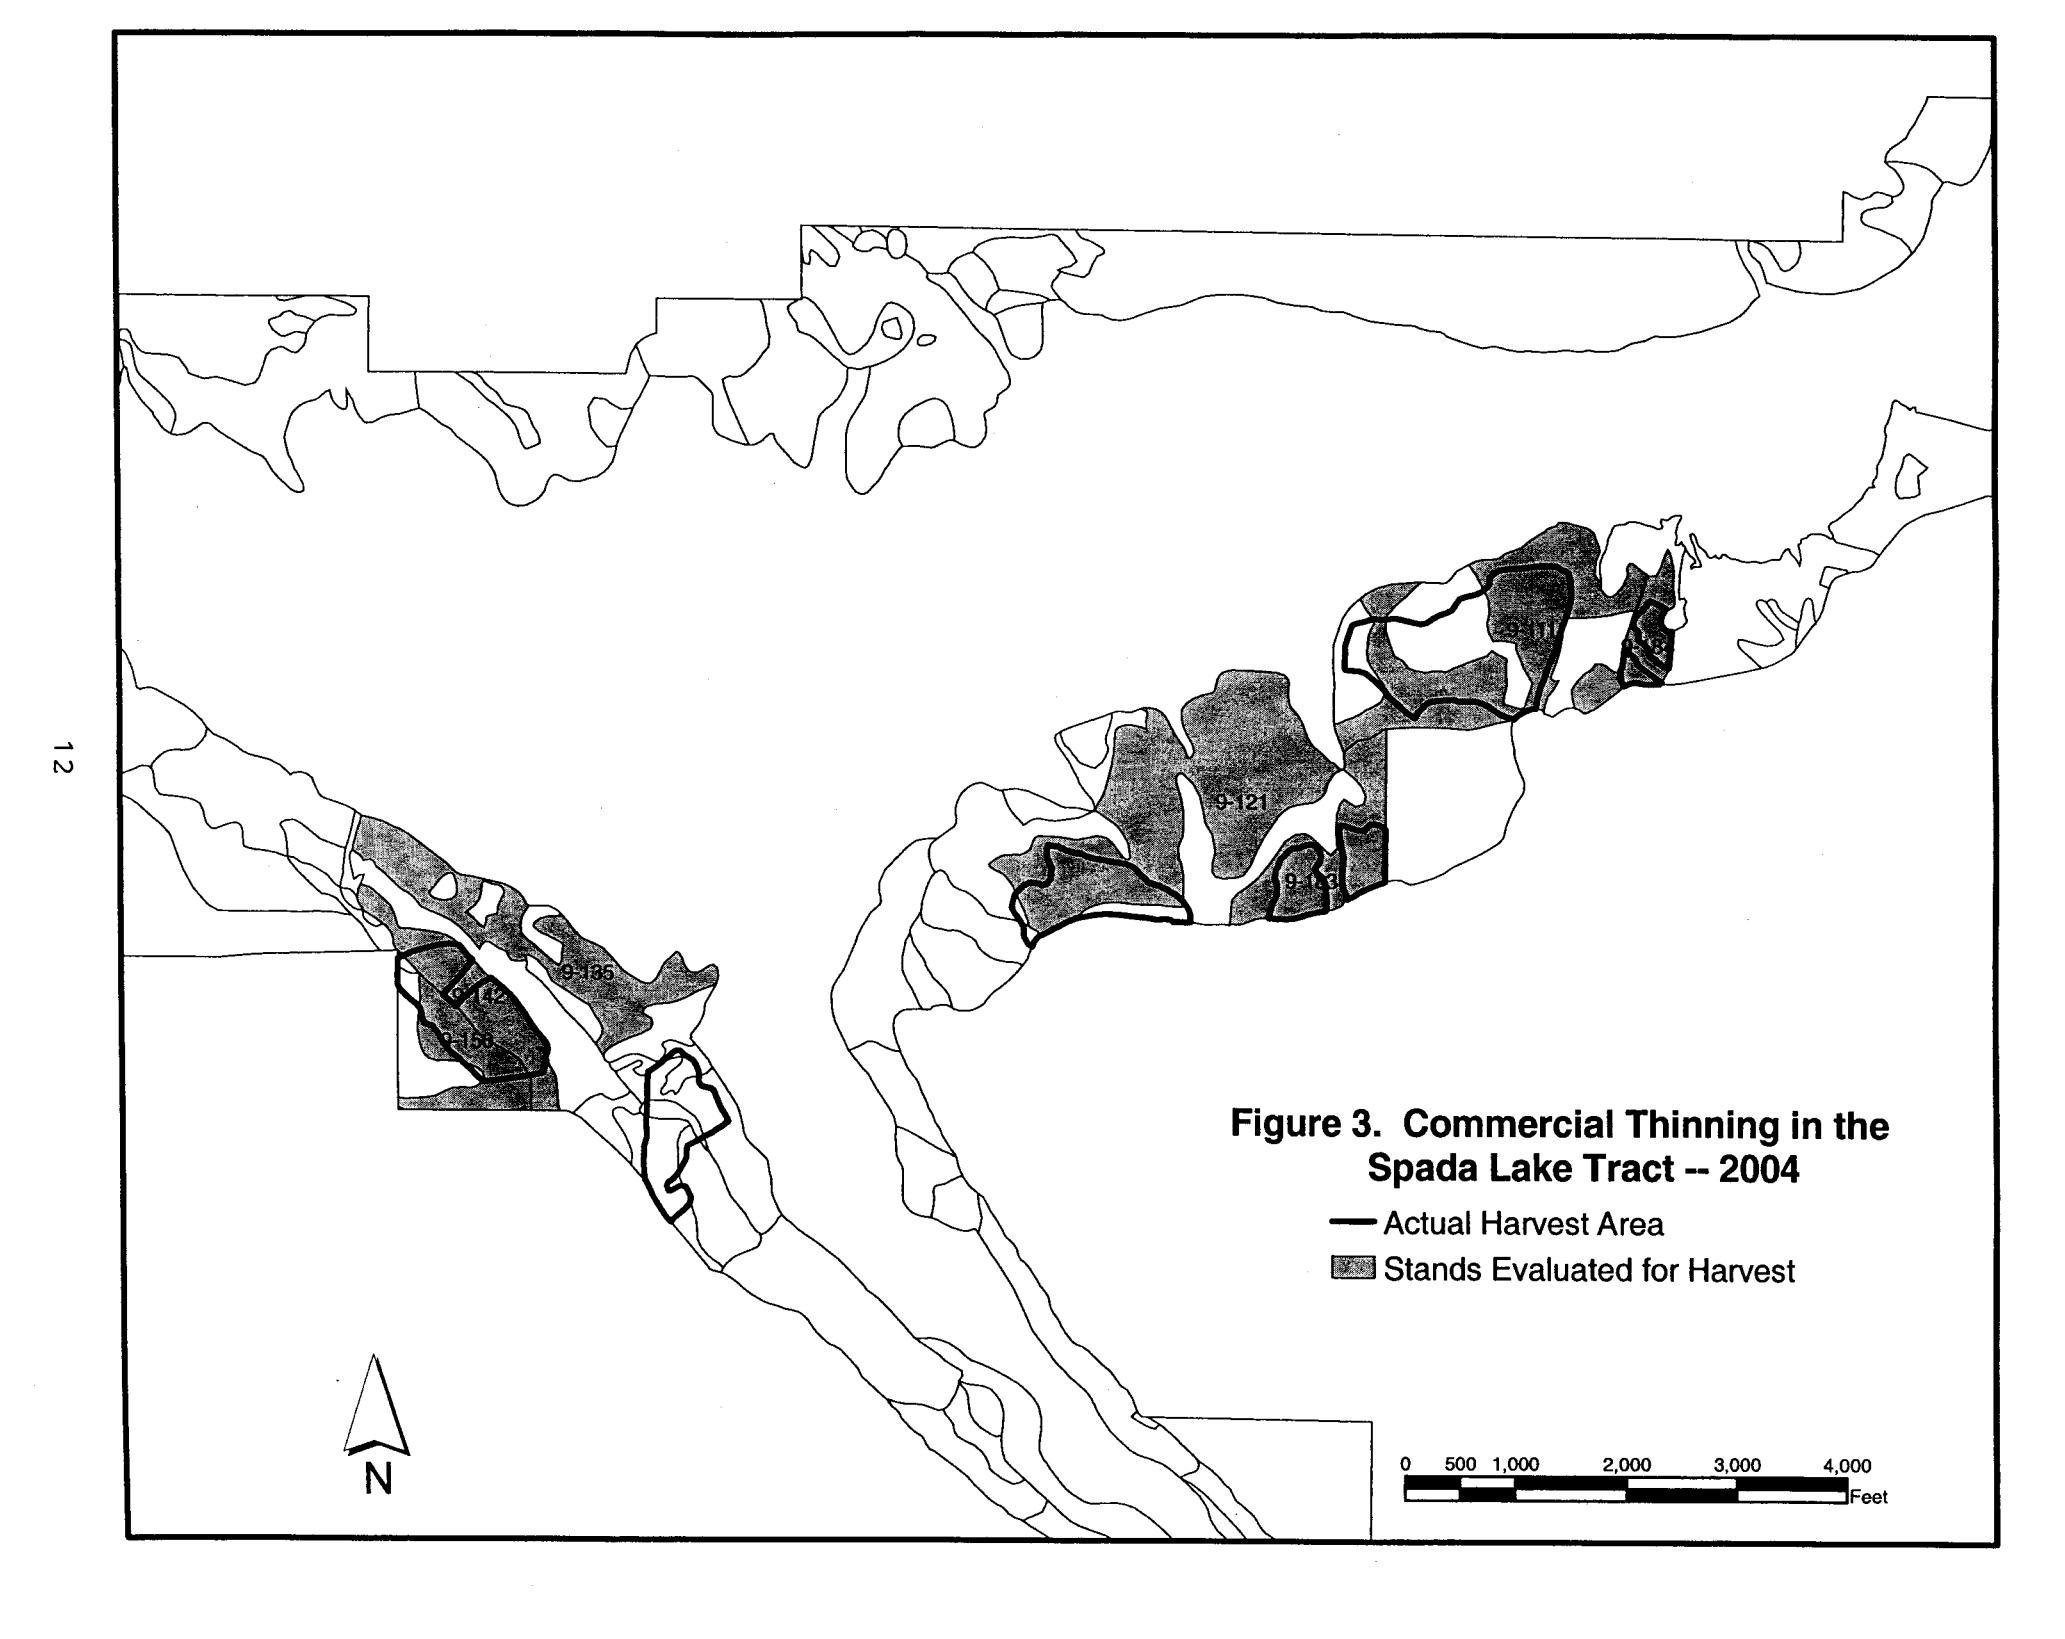
Commercial thinning of 8 second growth timber stands (Units 9-111, 9-120, 9-121, 9-135, 9-142, 9-150, 9-183, 9-184) in the Spada Lake Tract began in October 2003 and was completed in May 2004 (Figure 3). A total of approximately 100 acres was thinned in these units with final target density of 150 trees per acre and basal areas in the range of 120-140 sq. ft per acre. A mixture of conifers and hardwoods was retained, and no trees with diameter greater than 18 inches were removed. Details of harvest setup were described in the 2002 and 2003 Annual Reports.

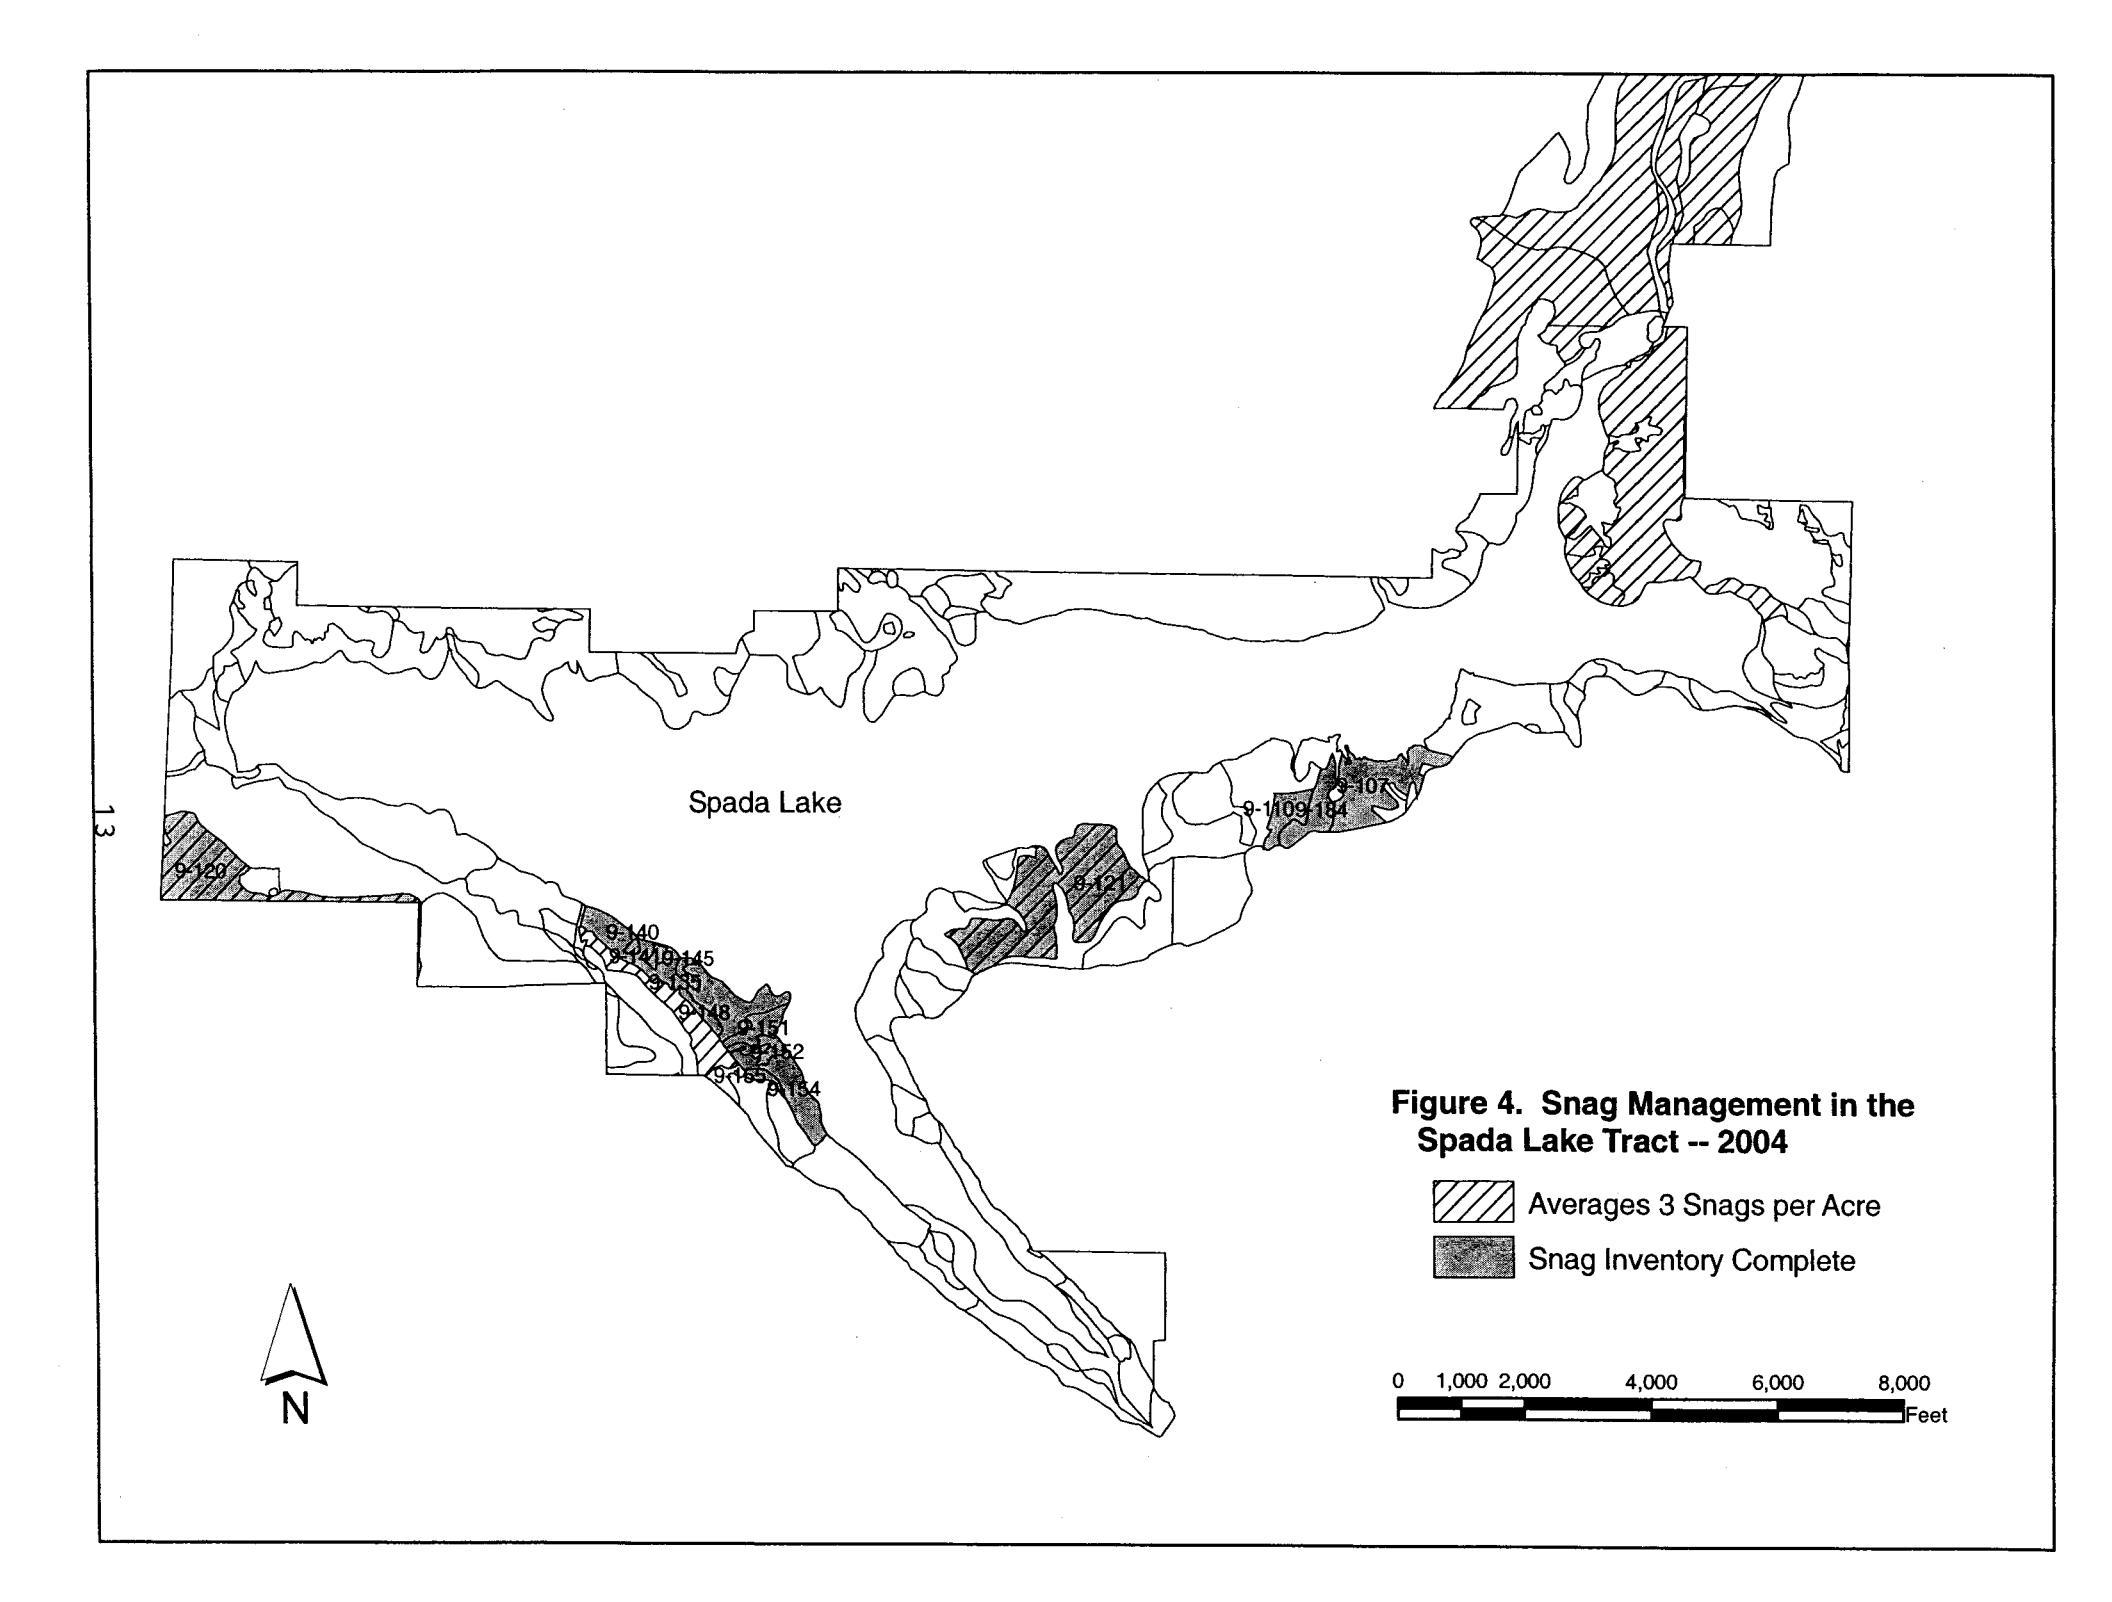
Snag management in 2004 consisted exclusively of work on the Spada Lake Tract (Figure 4). This was necessitated by the DNR's indication of a desire to abandon the south shore road system within 2 years. Planning for snag inventory and creation within all units accessed by this road will be conducted in 2005, to ensure that road abandonment, if it occurs, does not impede snag management.

With regard to snag and canopy gap creation, sixteen stands (244 acres comprising 8 stand complexes) were evaluated for potential benefits from snag and gap creation (Table 1). One of these stands (9-90, 32 acres) had only a walk through exam performed, and was determined to be a good candidate for pre-commercial or commercial thinning in the foreseeable future with snag creation to follow a year or two after harvest. Five stands or stand complexes (stands 9-107, 9-110, 9-135 and surrounding small stands, 9-151 and surrounding small stands, and 9-184, totaling 117 acres) were inventoried, and snag/gap creation will occur in 2005. Stand 9-184 was commercially thinned in 2004. In this stand, one year will be allowed to elapse after management activities, prior to snag or gap creation, to allow for initial blowdown to occur. Snag and gap creation occurred in the remaining two stand complexes (stands 9-120, 9-121 and 9-183, totaling 95 acres).
